SITE ASSESSMENT
5123 – 5TH STREET EAST
CLARESHOLM, AB

Project No. 18076

March 28, 2018

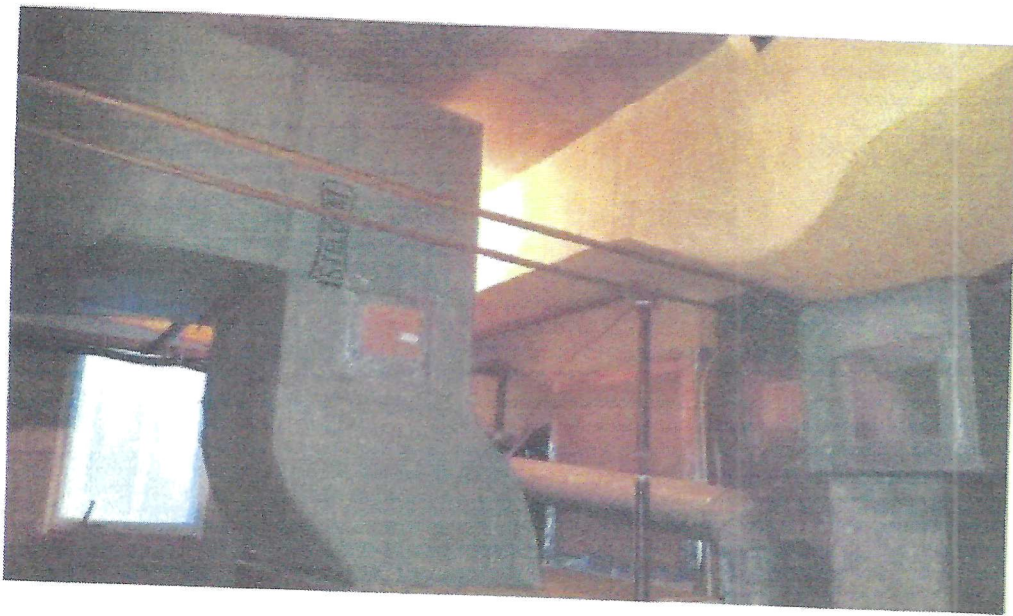
View: Furnace room located on the north side of the basement

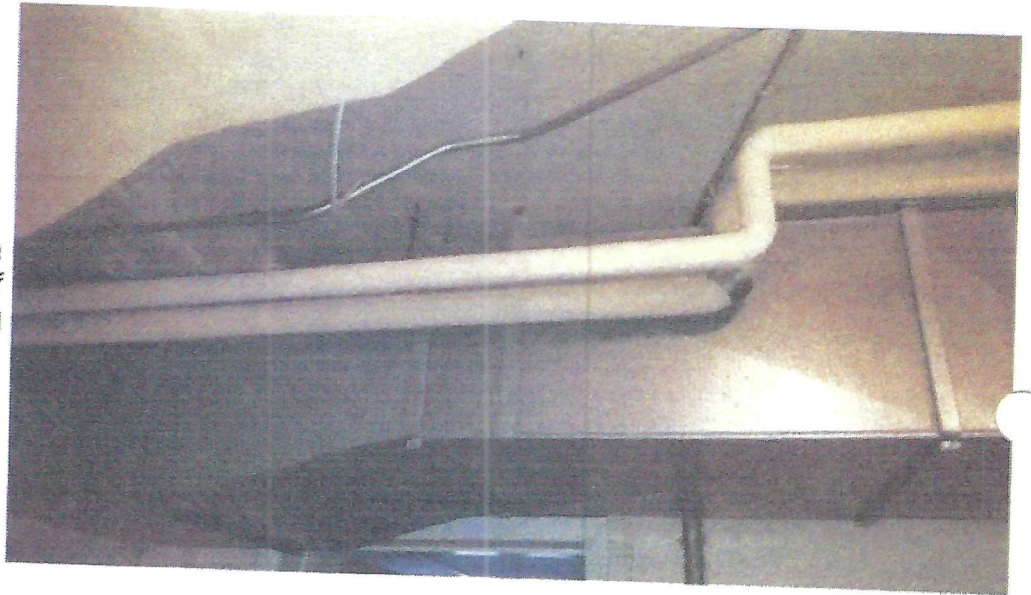
View: Pipe insulation located in the furnace room on the north side of the site building

- Asbestos-containing parging cement was reported on pipe fittings and ducting controls in the basement;
- PCB-containing light ballasts were reported throughout the site building;

APEC	CoPC	RISK	RECOMMENDATION
Building interior	Hazardous materials	Moderate	<ul style="list-style-type: none">A hazardous building materials management and/or abatement plan should be completed prior to any demolition or renovations

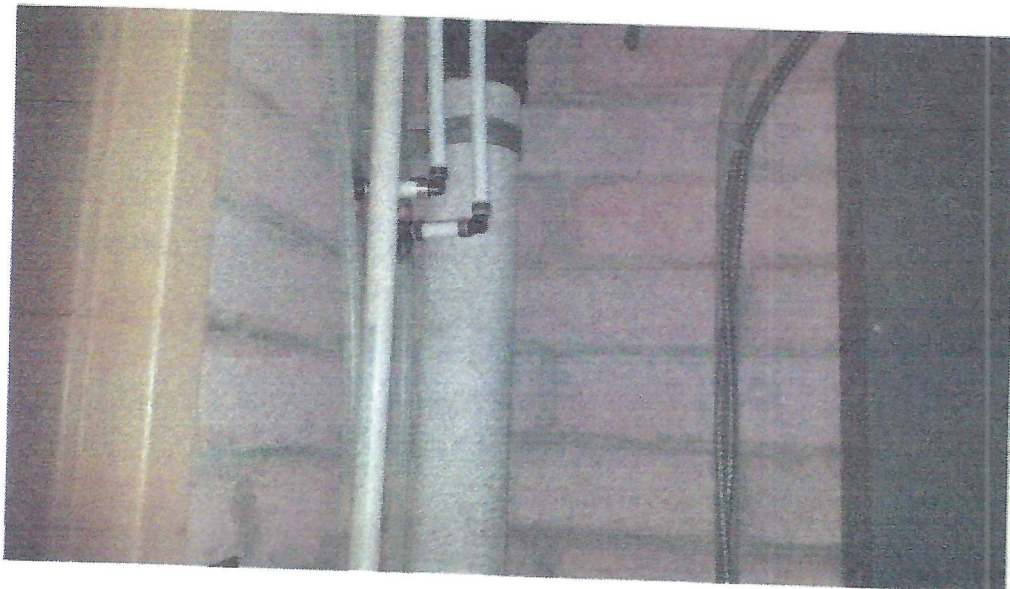
View: Pipe insulation located in the furnace room on the north side of the site building

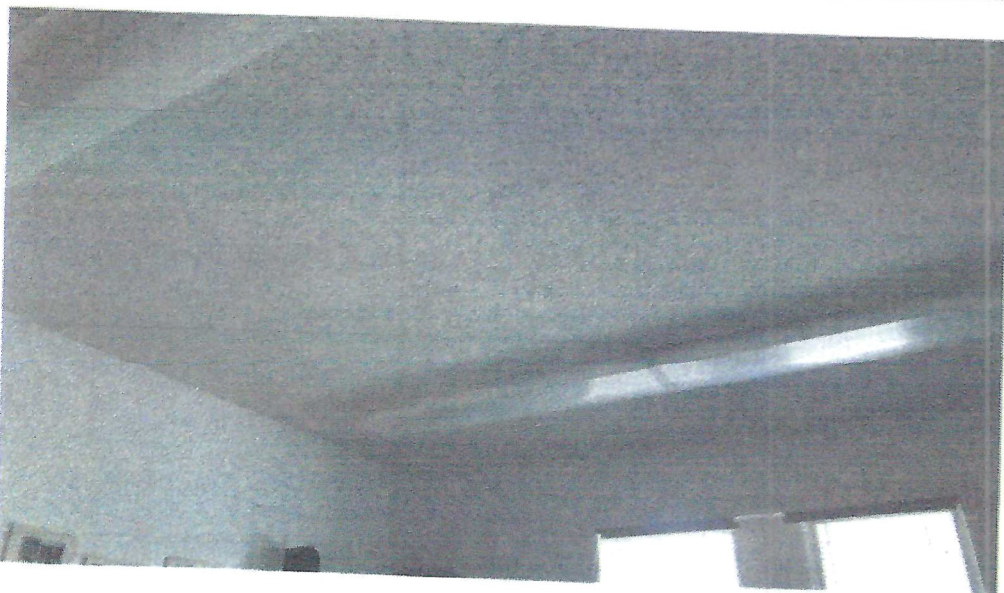
View: Typical ceiling tile located throughout the ground floor

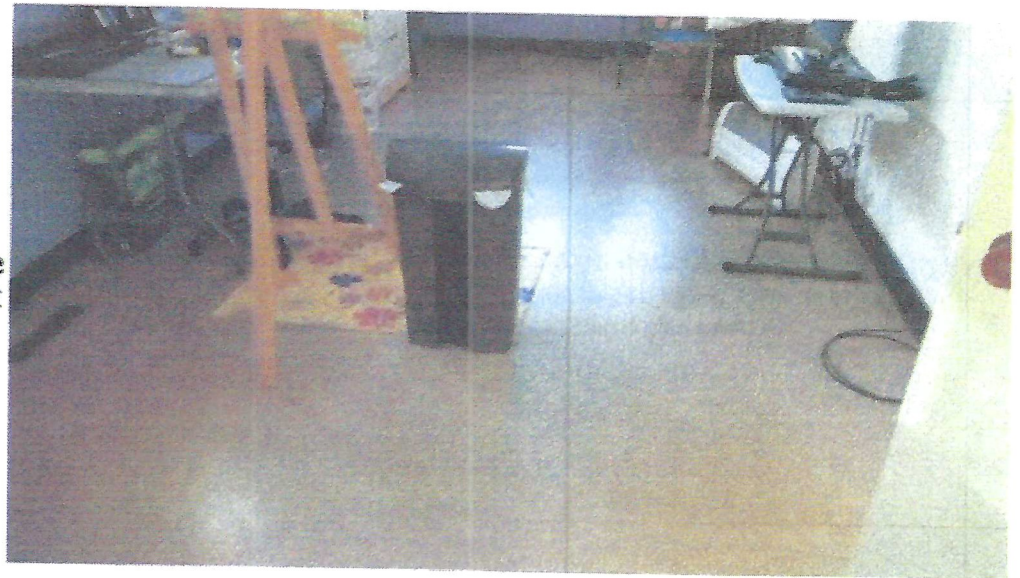
View: Typical tile located in the basement

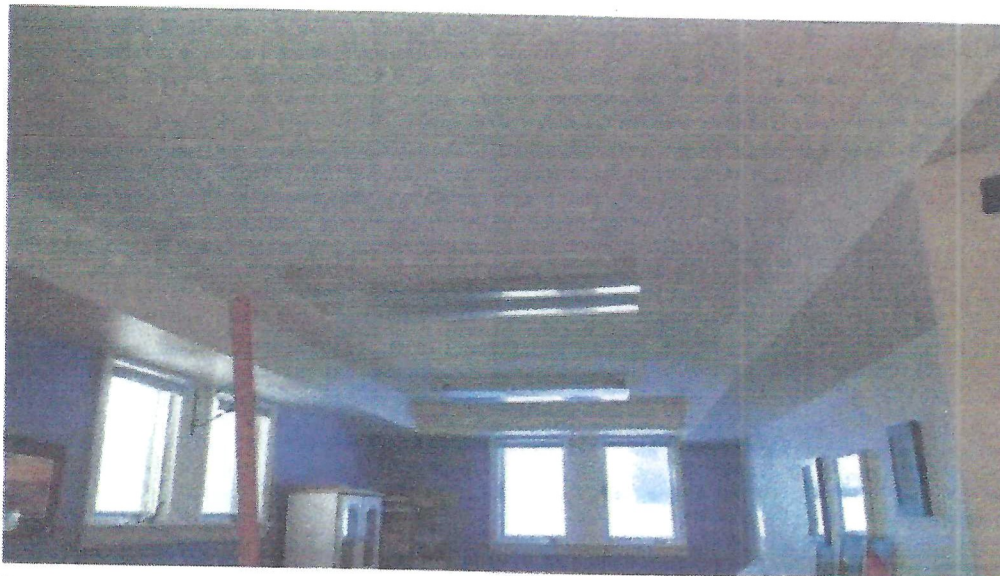
View: Typical ceiling tile located in the ground floor

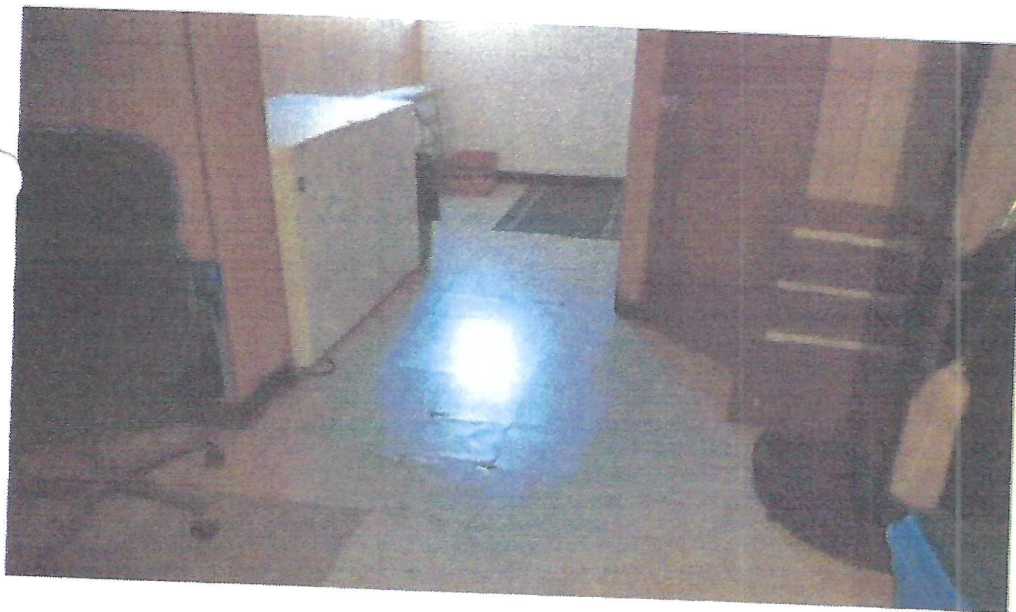
- There were no other recommendations in the 2004 Phase I ESA;
- A Hazardous Building Material Survey, completed by PHH ARC in 2004, was also reviewed;
- Asbestos-containing floor tiles were identified on both floors of the site building;

View: Broken floor tiles located in the central portion of the basement

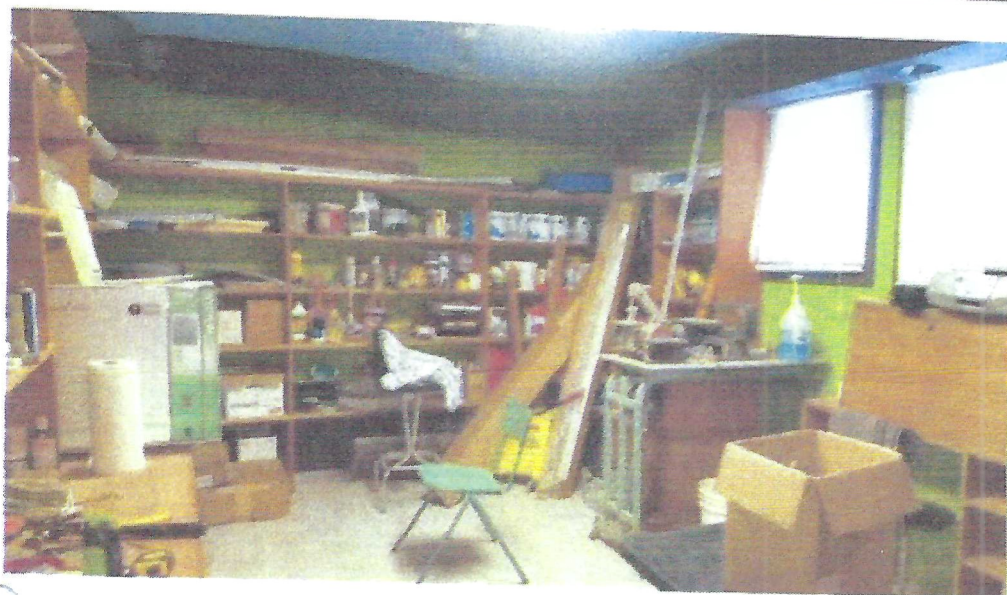
View: Maintenance room and associated chemical storage
