SITE ASSESSMENT
5123 – 5TH STREET EAST
CLARESHOLM, AB

Project No. 18076

March 28, 2018

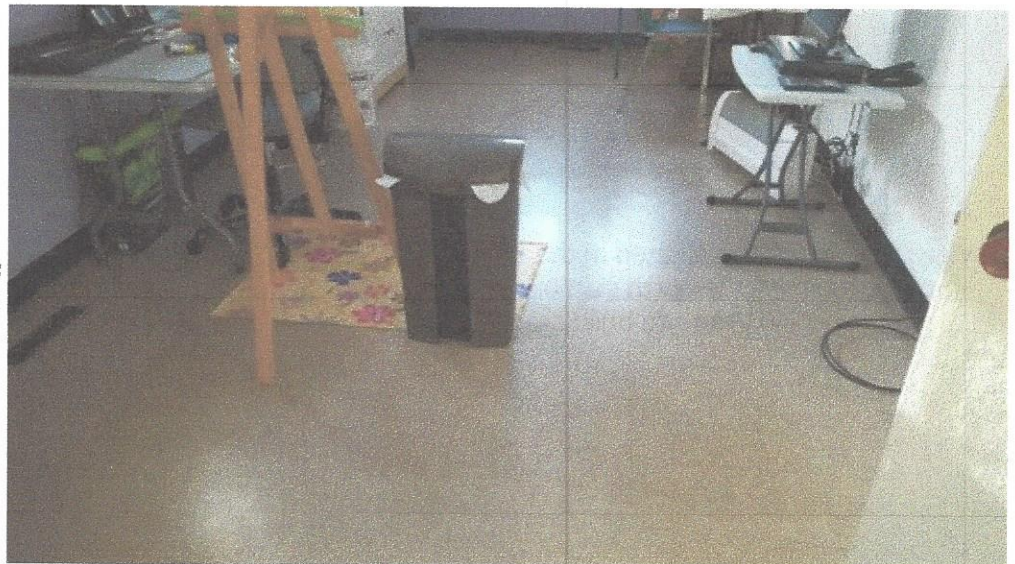
- Floor tile
- Drywall joint compound
- Ceiling tile
- Parging cement
- Vermiculite

View: Typical tile located in the basement

APEC	CoPC	RISK	RECOMMENDATION
Building interior	Hazardous materials	Moderate	▪ A hazardous building materials management and/or abatement plan should be completed prior to any demolition or renovations

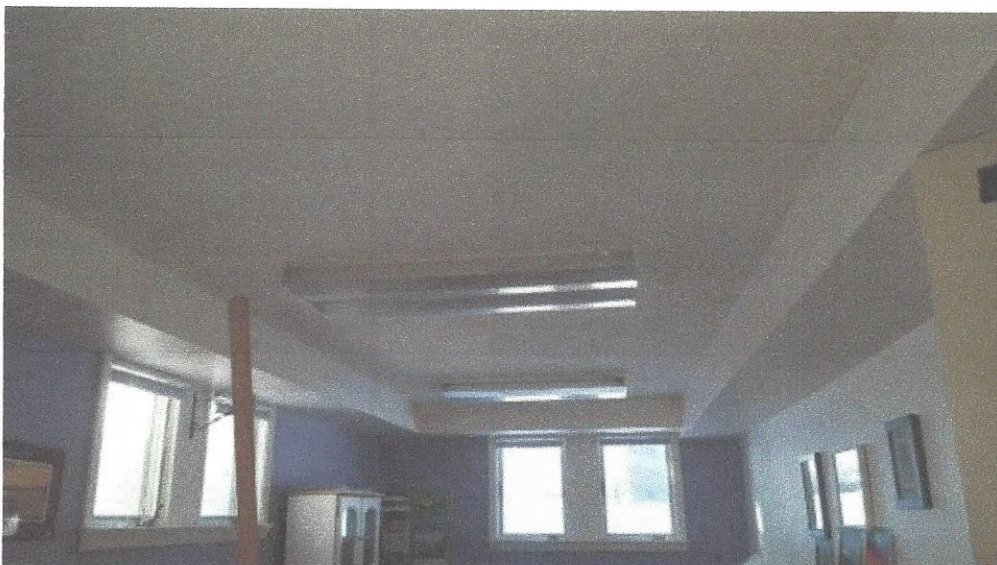
View: Typical ceiling tile located in the ground floor

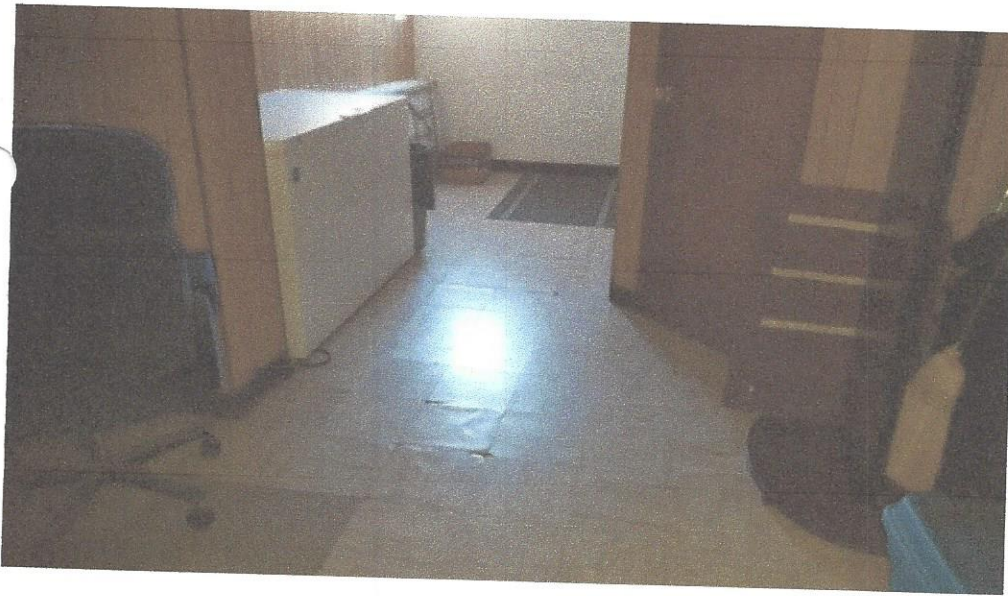
View: Broken floor tiles located in the central portion of the basement

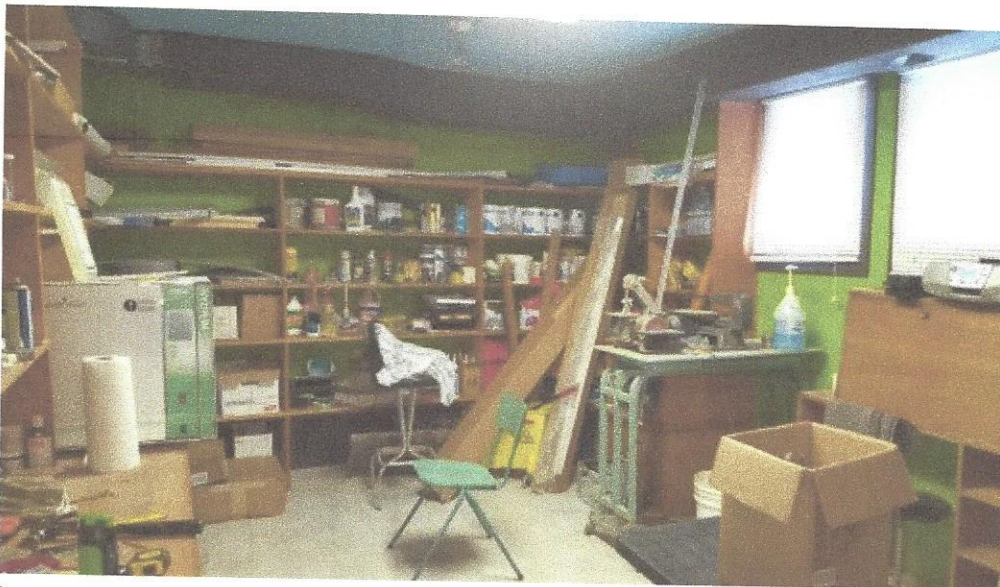
No fuel or chemical storage was observed on-site with the exception of common household chemicals such as cleaners, and paints and lubricants used for the general maintenance of the site building.

View: Maintenance room and associated chemical storage
