Home Inspection Report

PROPERTY INSPECTED:
5123 5 Street East
Claresholm, AB T0L 0T0

Date of Inspection: 09/06/2022

Inspection No. 1158-1-1475

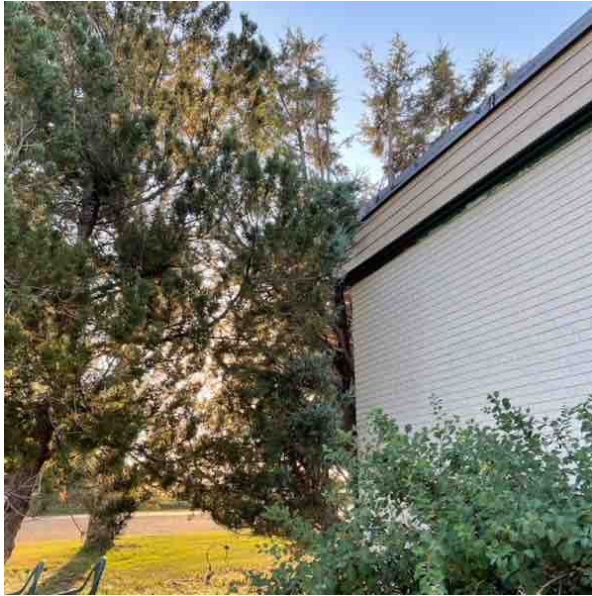
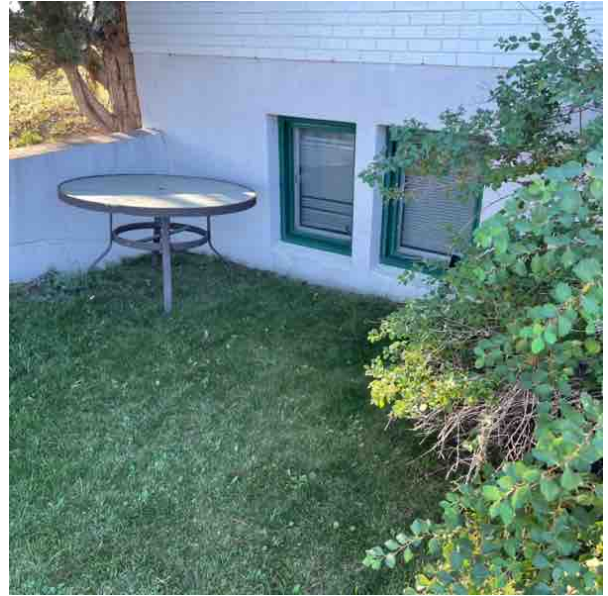
2.2.1 Recommend more slope away from the building, appears to be typical settlement. Soils could be added to achieve proper drainage away from the home

Trees and shrubs around the building are in need of trimming

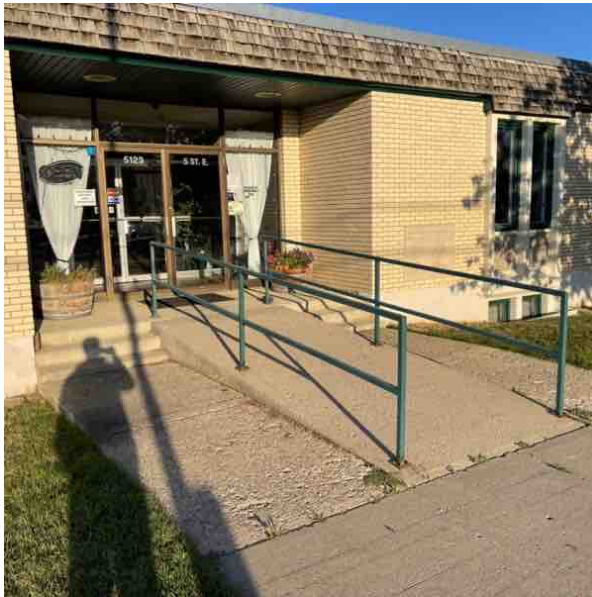
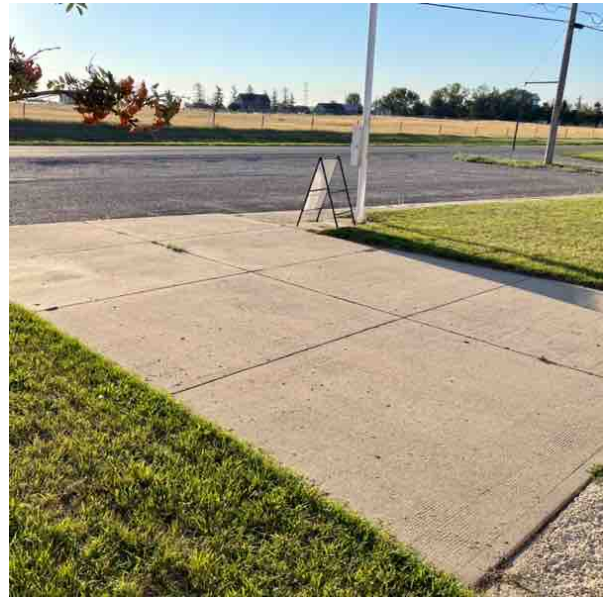
2.3.2 Some age typical wear

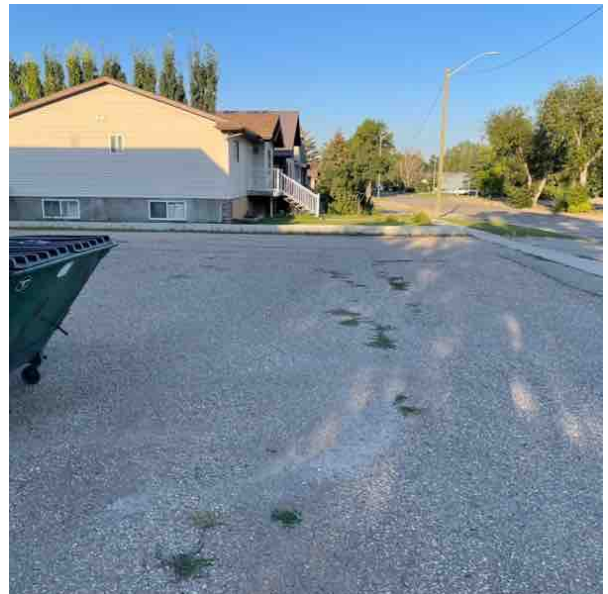
2.4.2 Worn/deteriorated

2.4.3 Some age typical wear

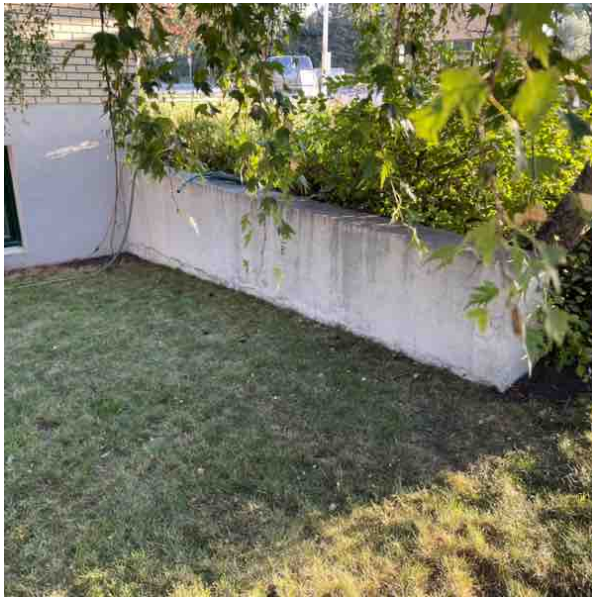
2.5.1 No visible damage

2.5.2 No major signs of settlement at the time of the inspection

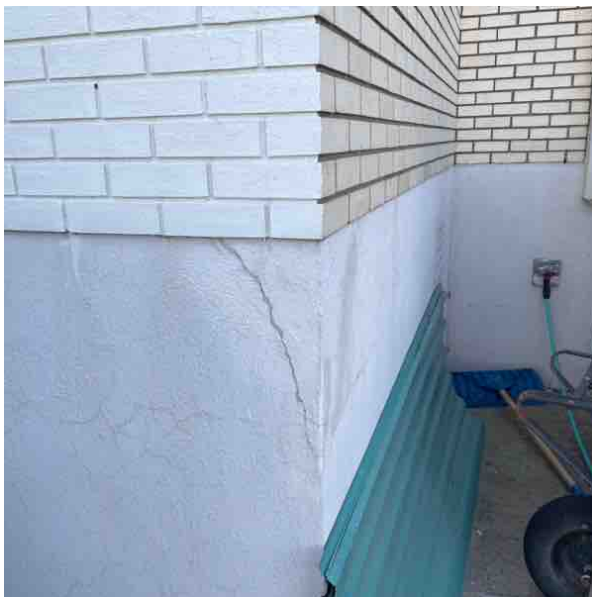
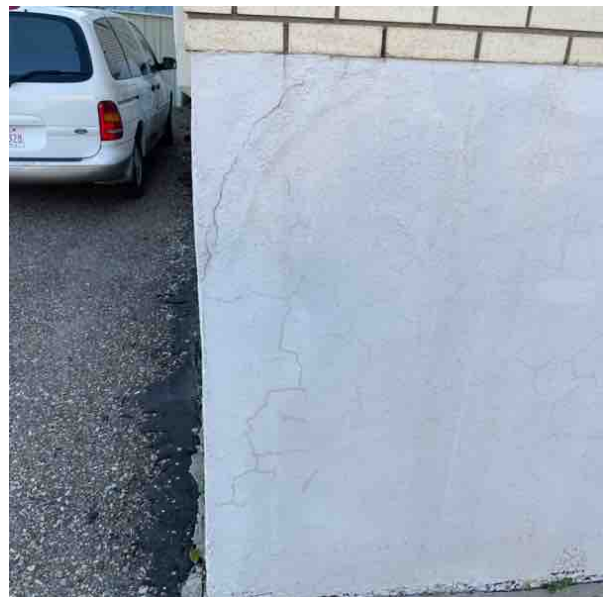
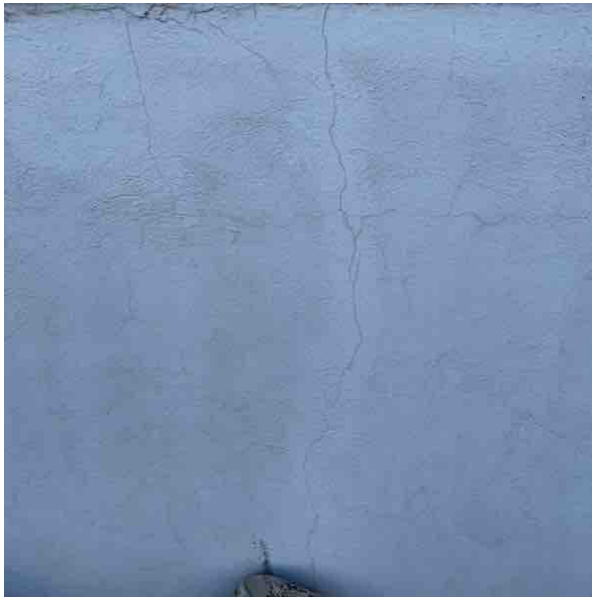
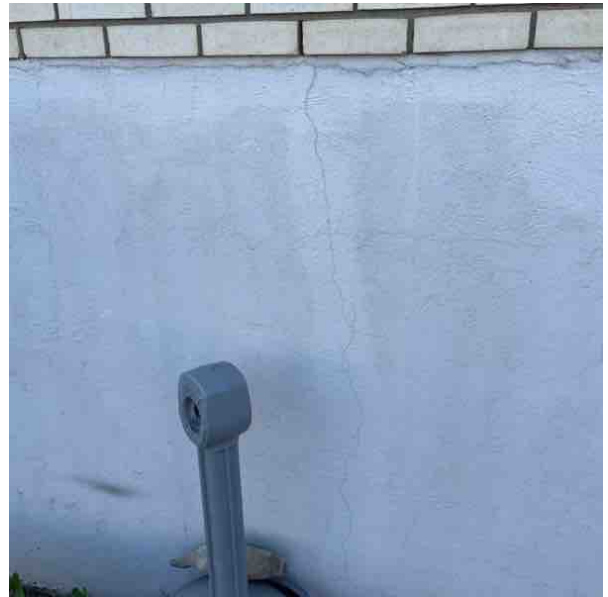
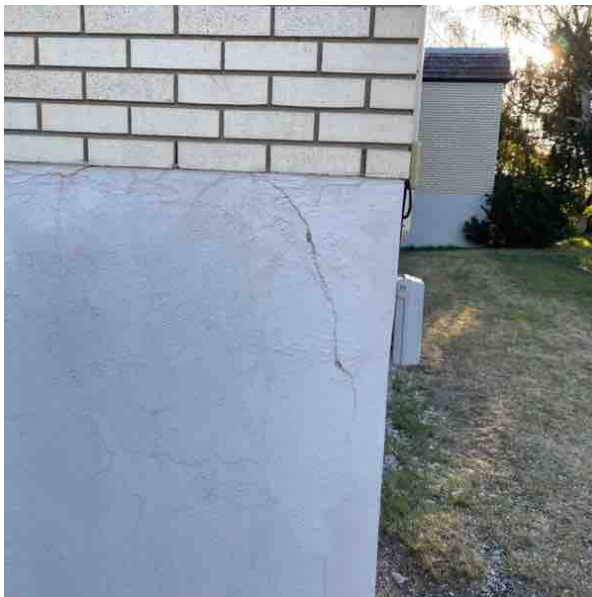
3.2.3 **Some age typical cracks, recommend monitoring and repair as needed. No major structural cracks were visible**

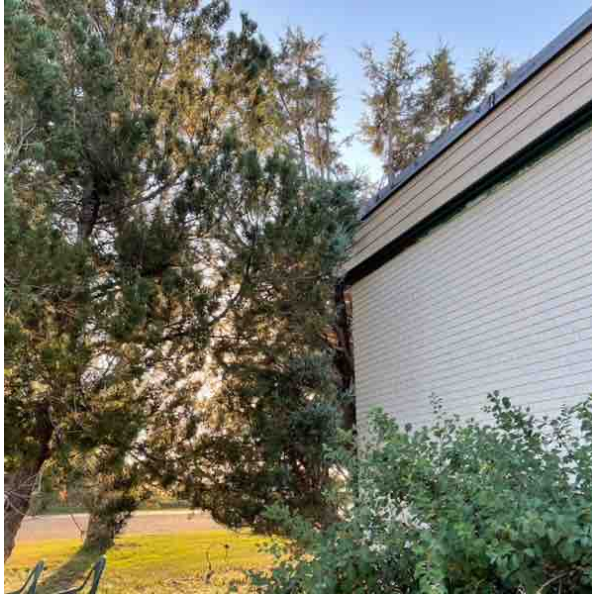
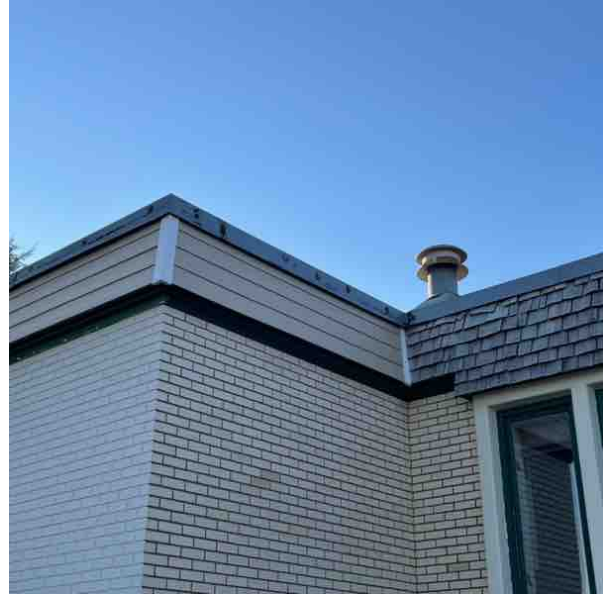
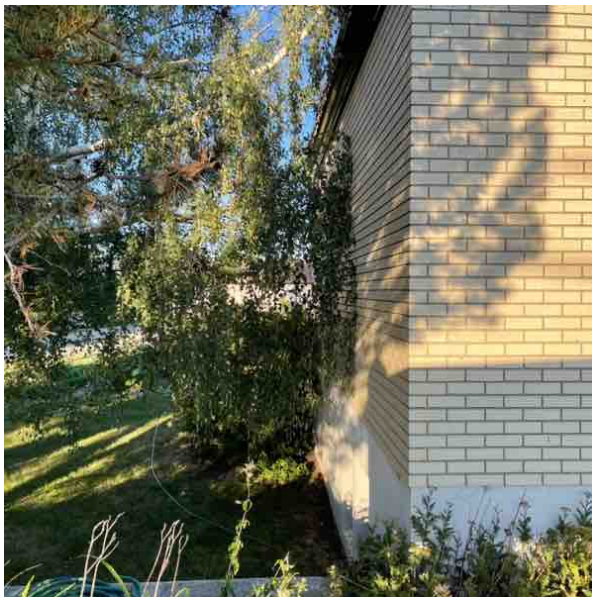
3.3.3 Building owner informed me that there was past repairs at North East corner. No current visible issues at the time of the inspection

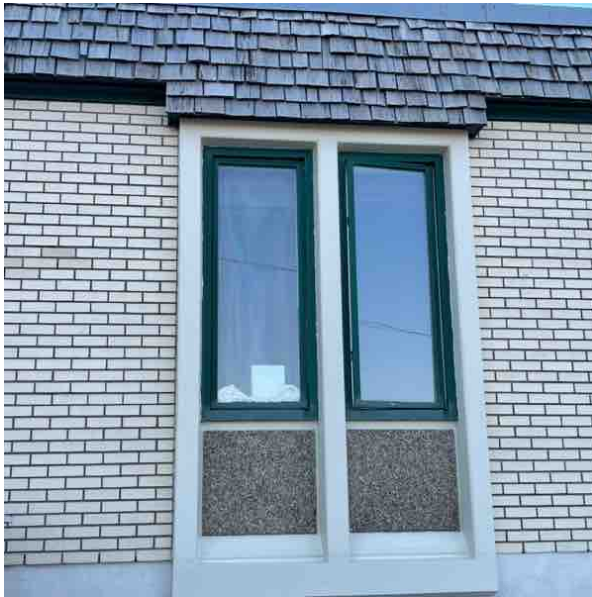
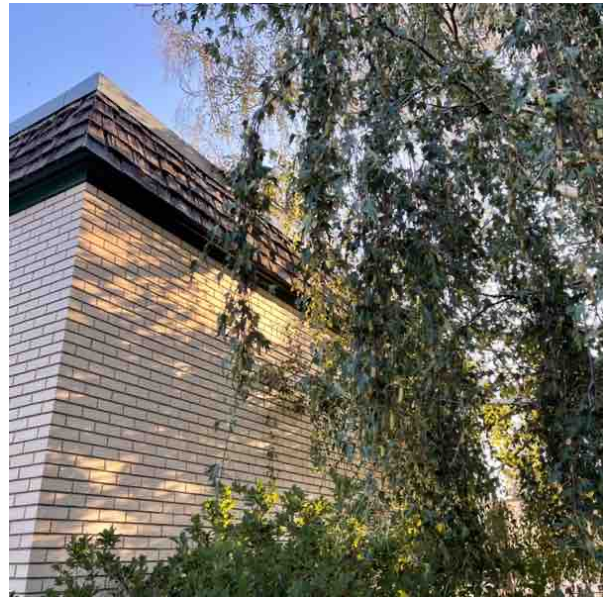
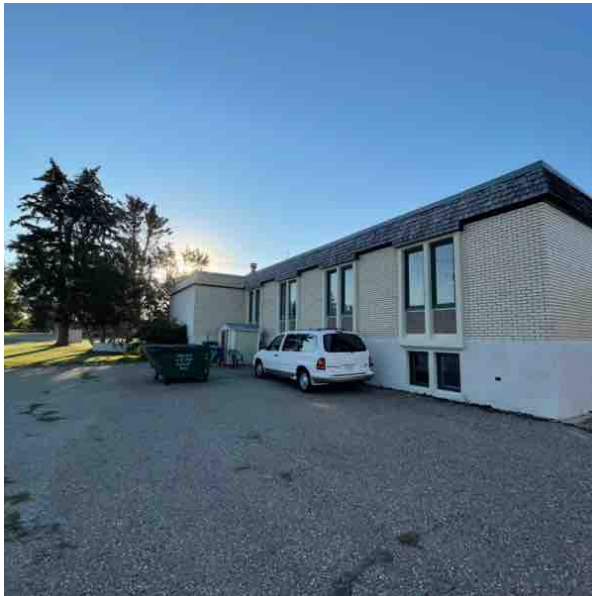
3.3.4 Some age typical wear on wood shake areas, recommend monitoring and repair as needed

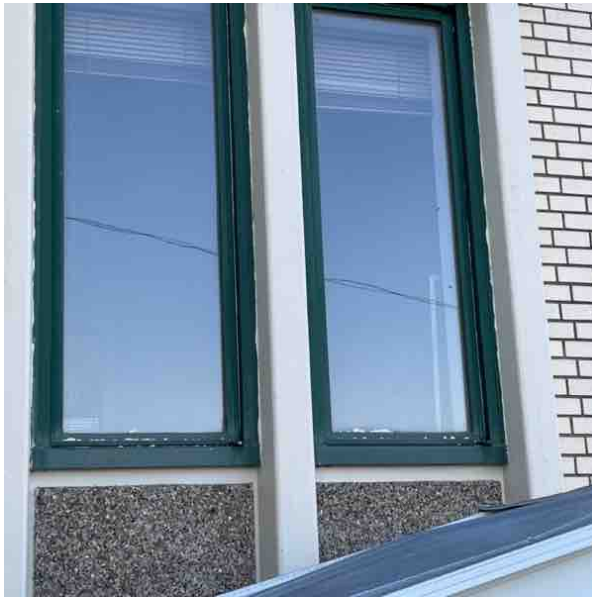
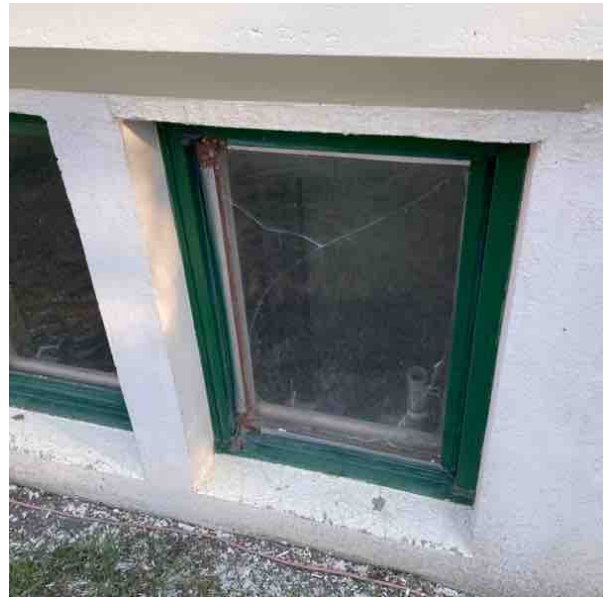
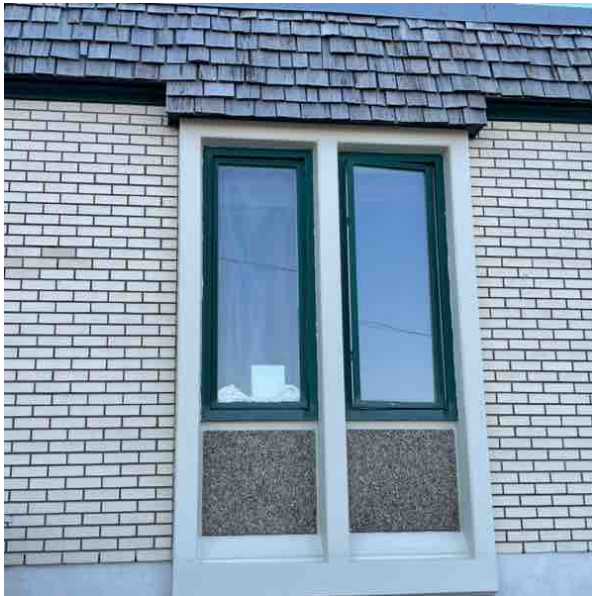
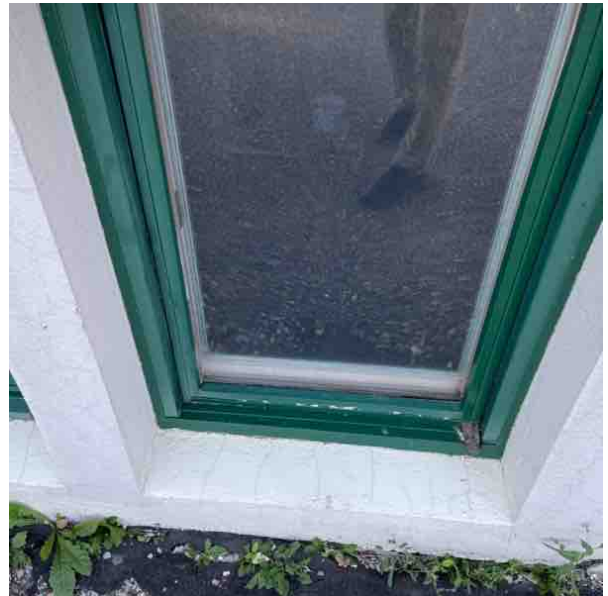
3.4.3 Low maintenance windows, some limited wear and cracked panes in areas

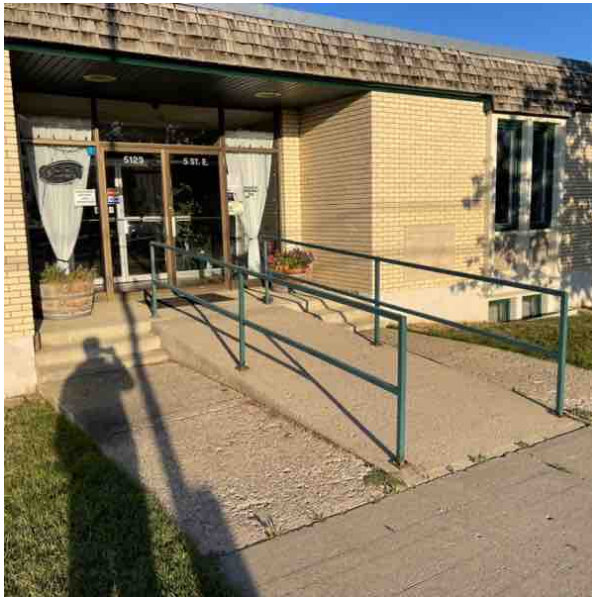
3.5.2 Worn/deterioration

3.5.3 Aluminum commercial doors

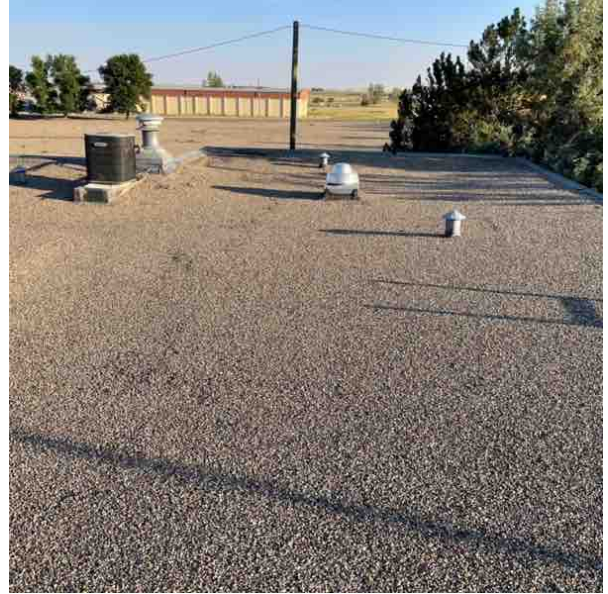
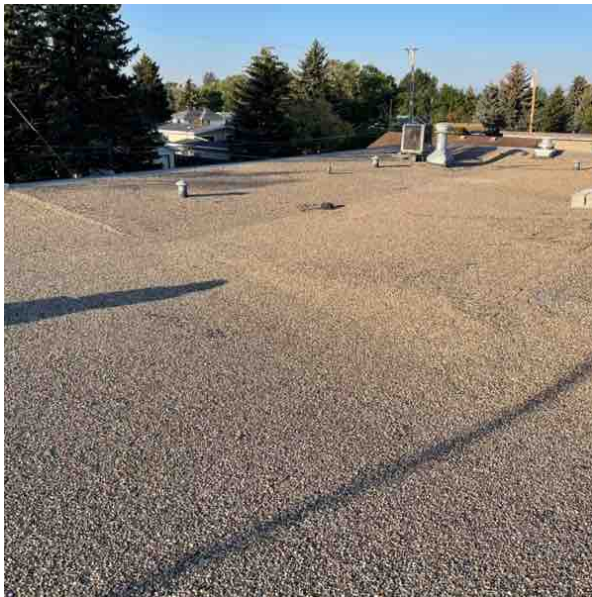
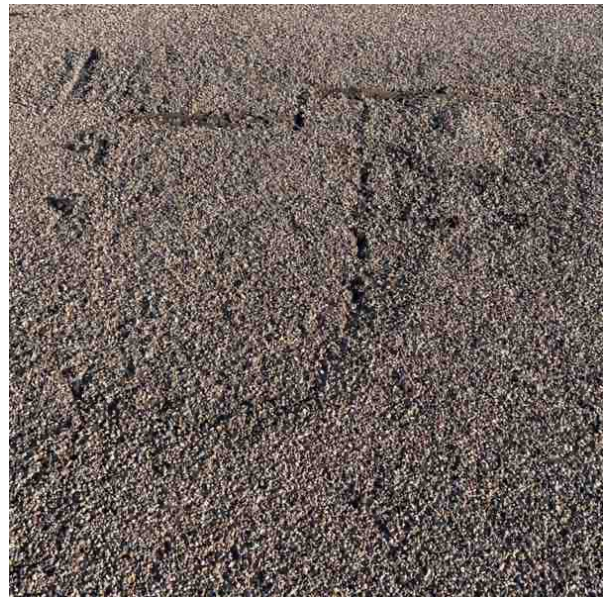
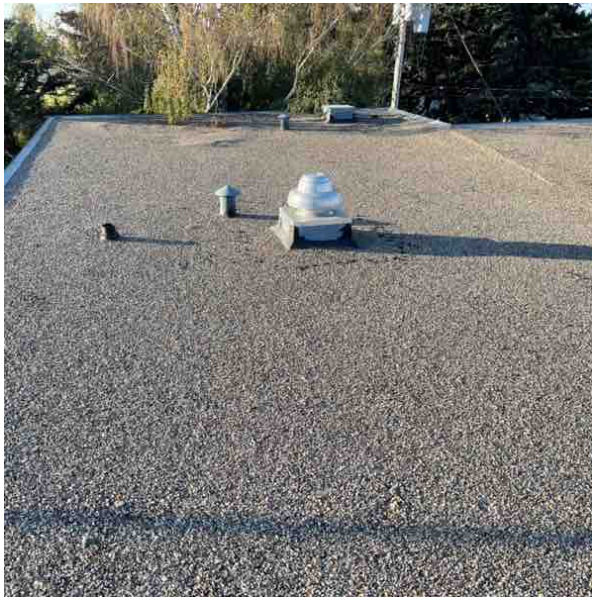
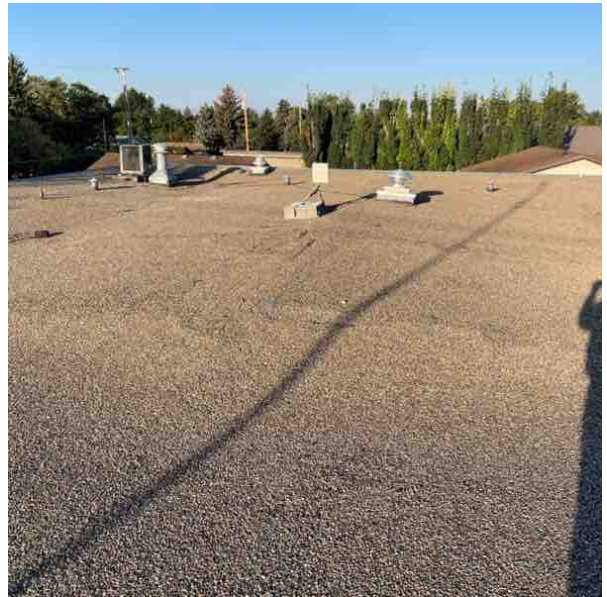
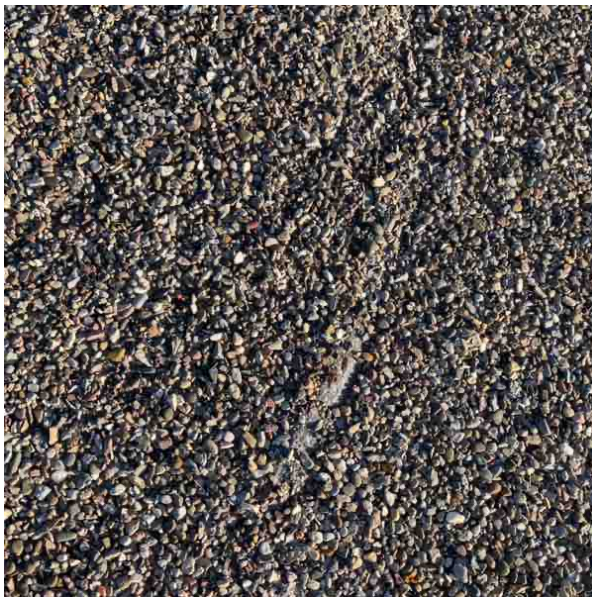
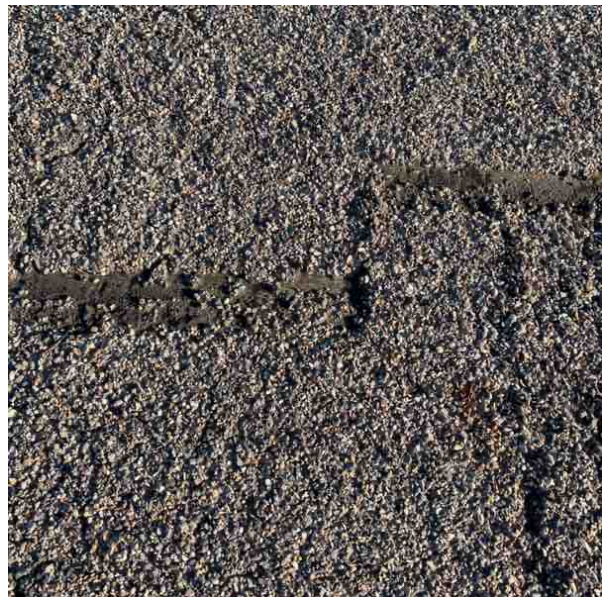
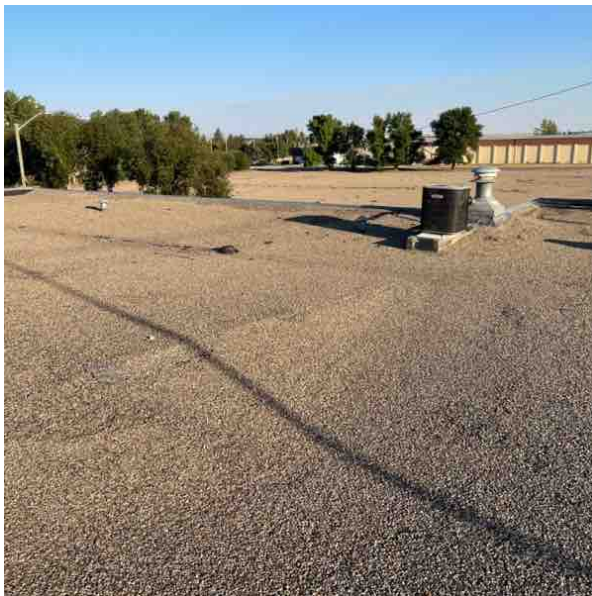
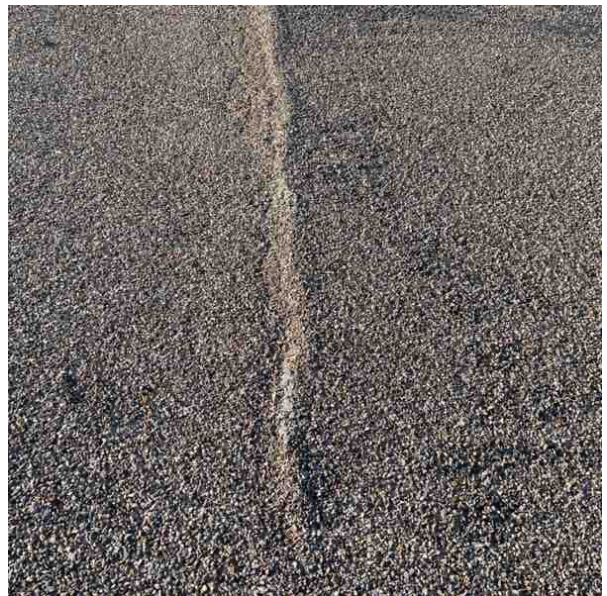
4.3.3 Estimated age of roof coverings is 15+ yrs old

Tar and gravel roof on building

Some visible wear and patched areas. New building owner should budget for repairs, maintenance to roof. Recommend consulting with a qualified contractor as to costs

No visible current leaks at that the time of the inspection. There are some visible stains on main floor ceiling but all were found to be dry at the time of the inspection with the use of a moisture meter

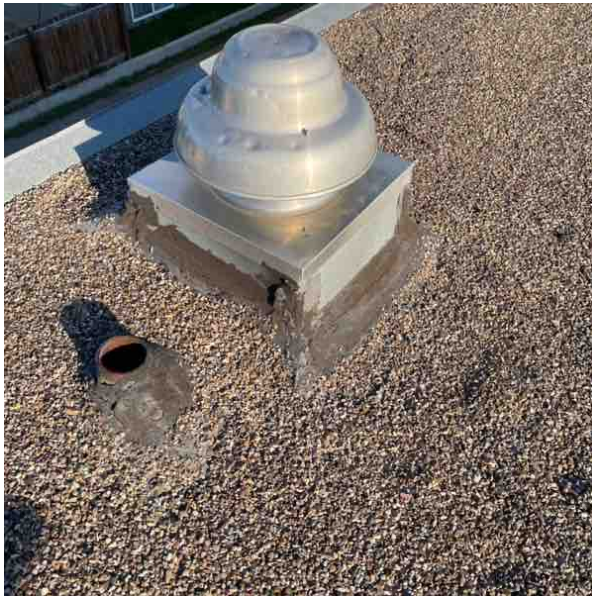
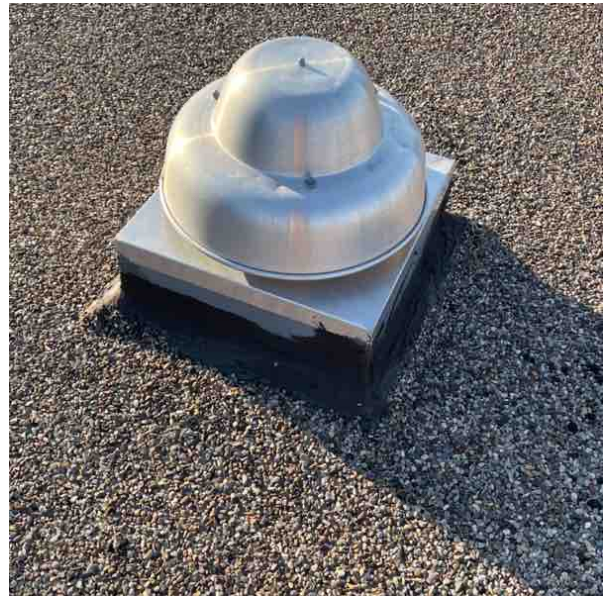
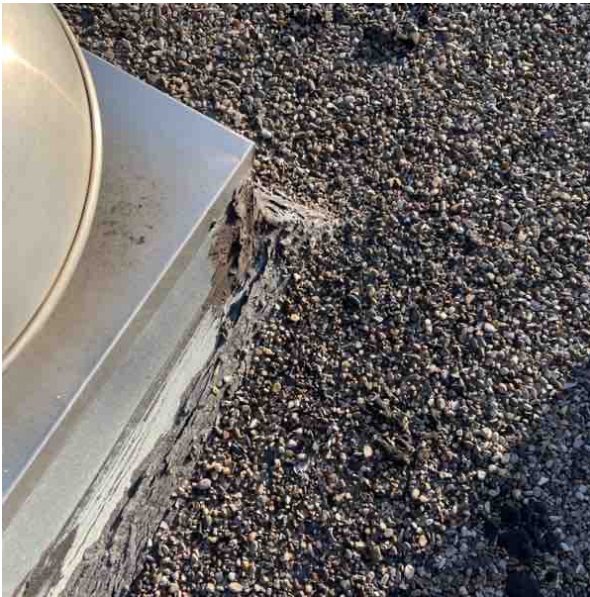
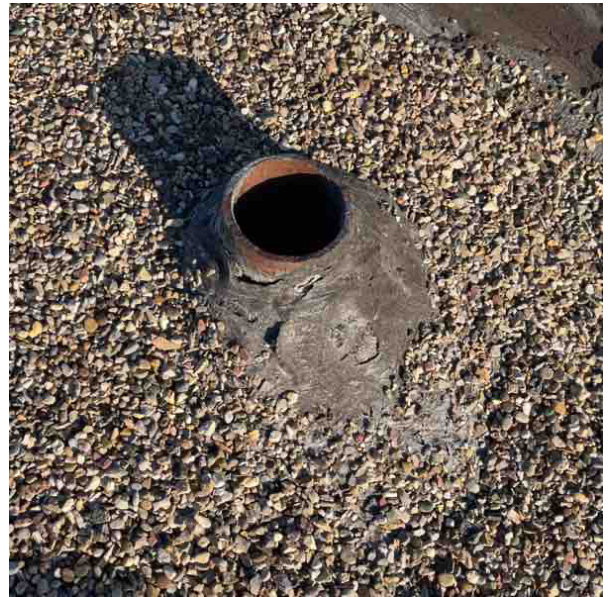
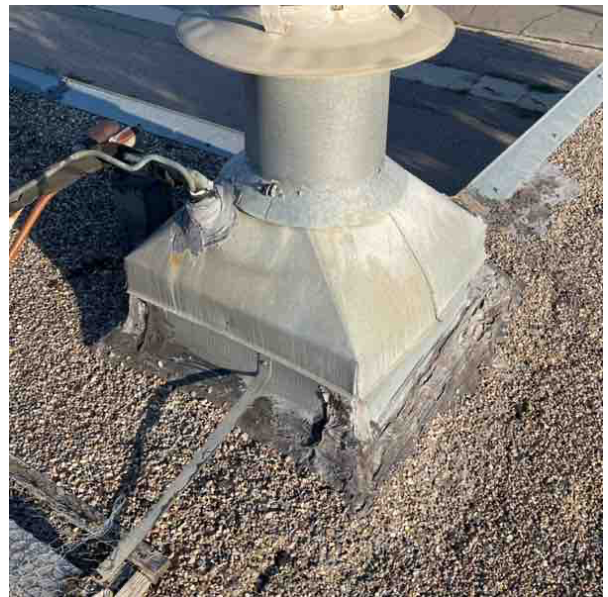
Some visible worn areas, recommend repairs as needed

4.4.2 **Recommend annual caulking to insure water proof seal**

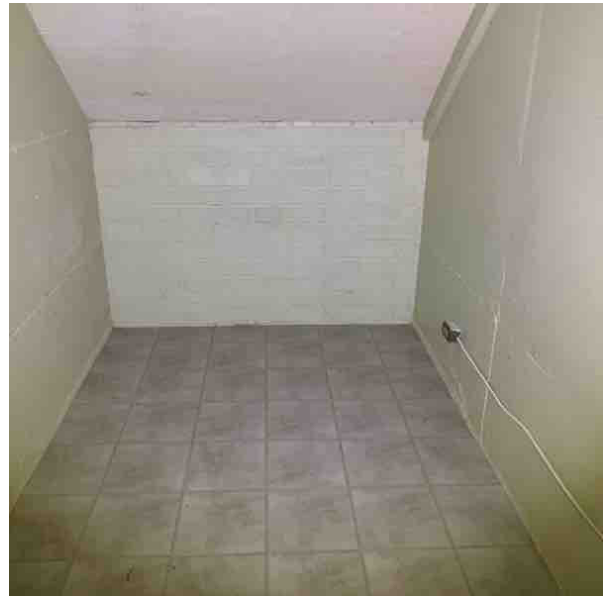
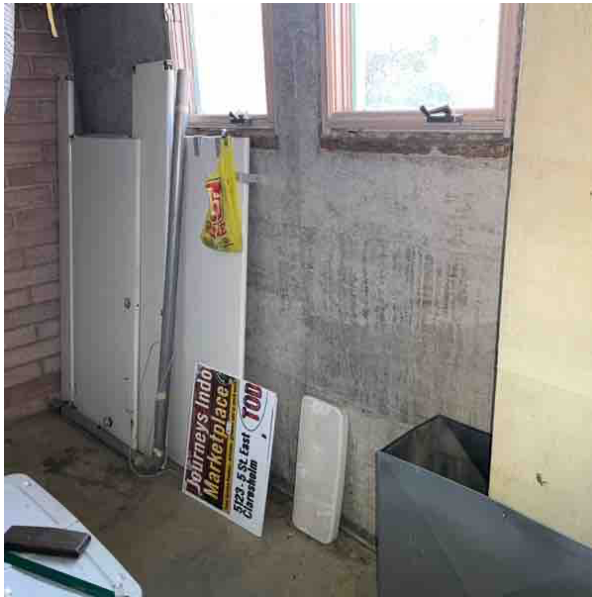
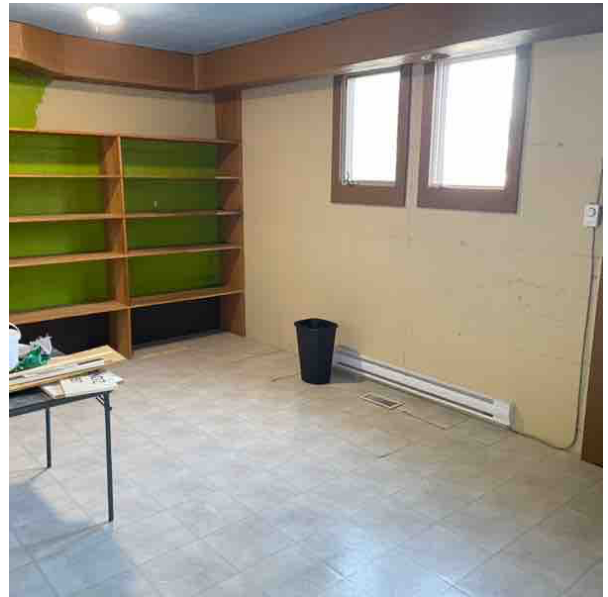
6.3.3 **Where foundation was visible there were no major cracks or signs of settlement or structural issues**

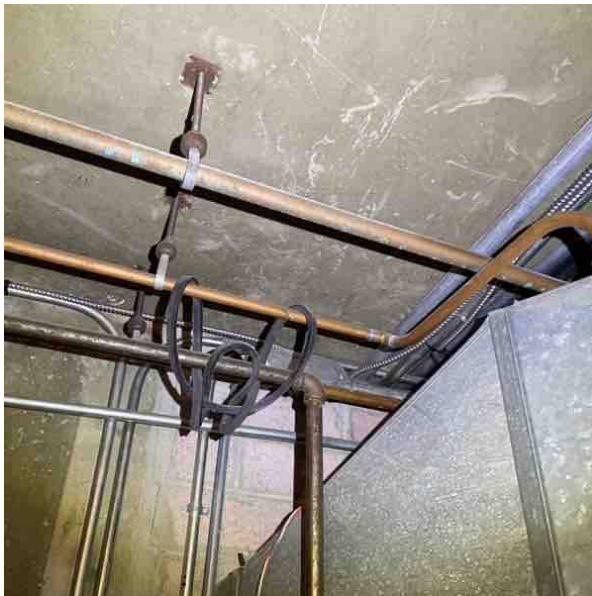
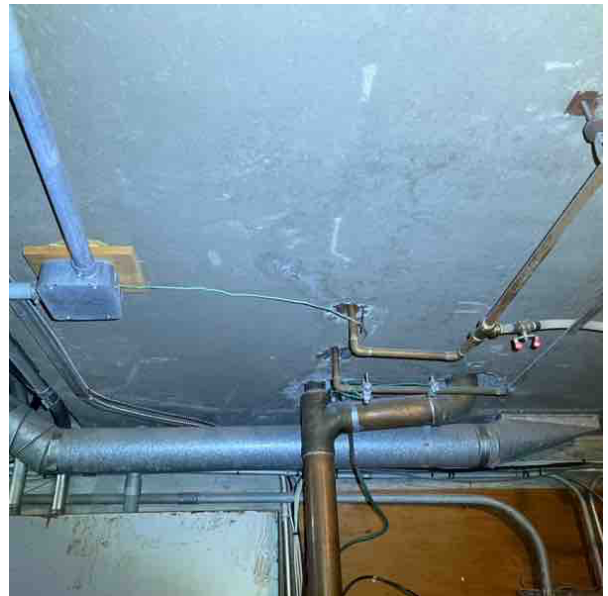
6.4.2 **Building is a complete concrete structure. Concrete foundation with concrete main floor.**

No visible current structural issues with the building at the time of the inspection

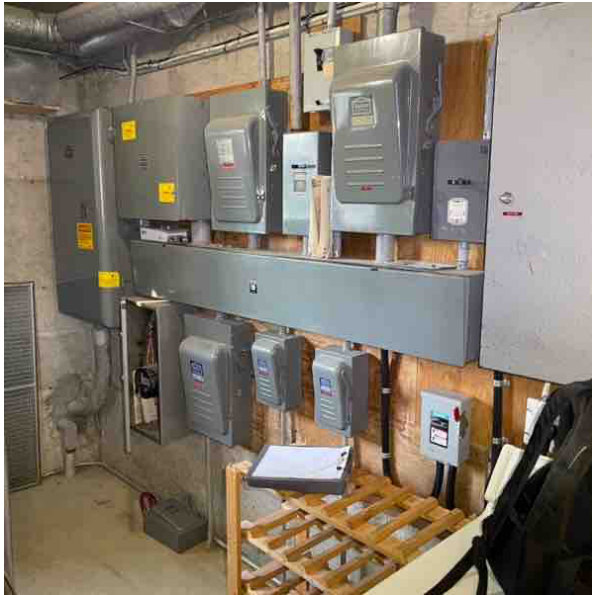
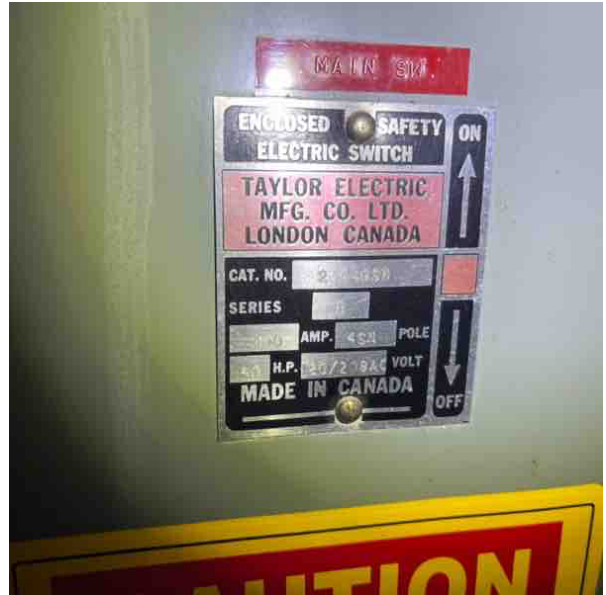
7.4.1 400 amp service to building

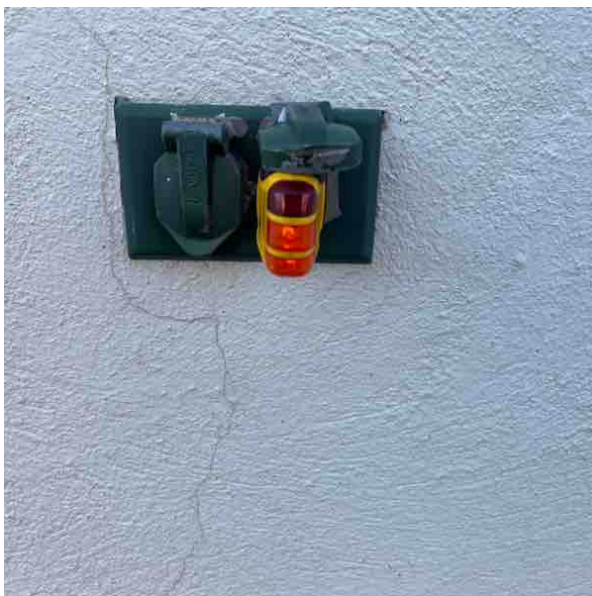
7.9.1 Recommend added Gfci protection on exteriors areas to insure proper coverage

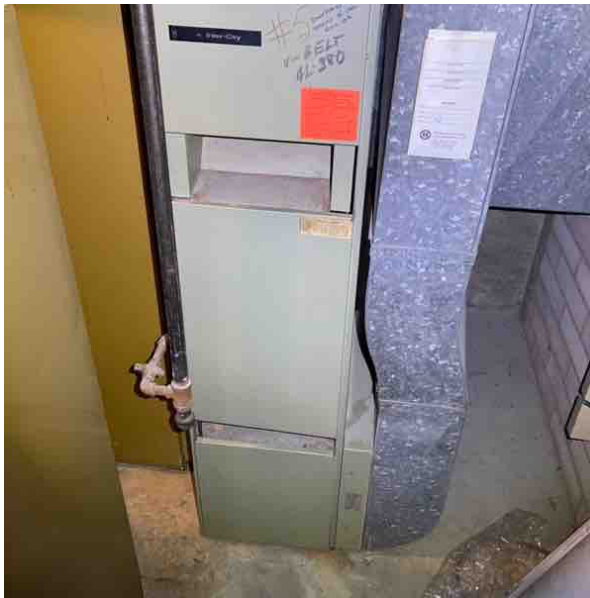
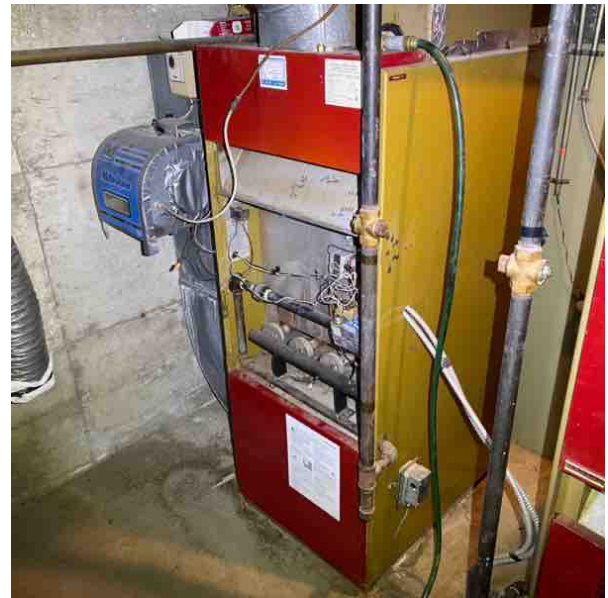
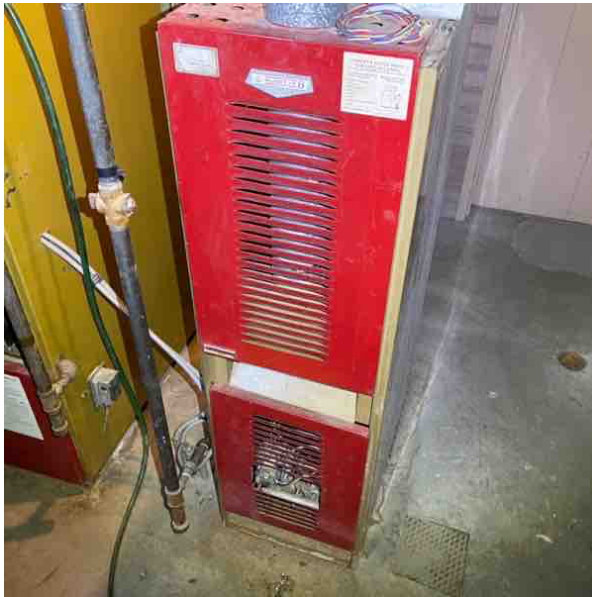
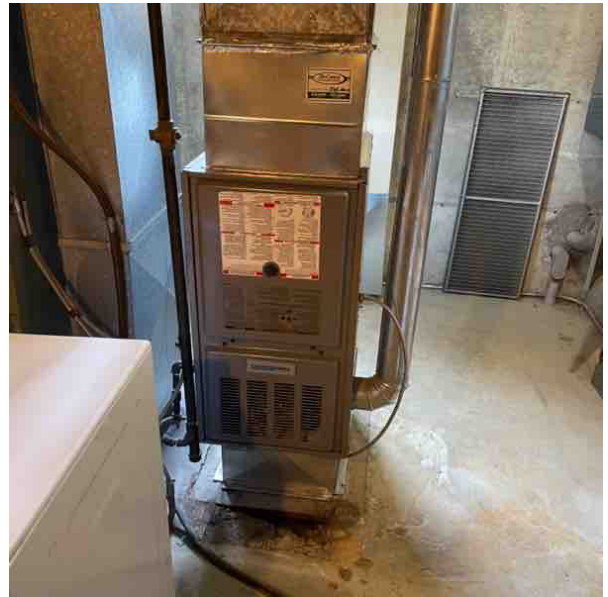
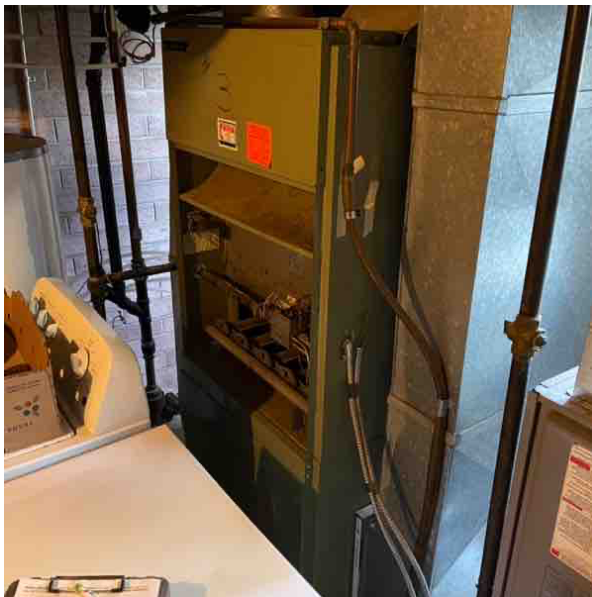
8.1.1 5 separate furnaces in the building

Bulloch furnaces are 50 + yrs old
Intercity green furnace is 56 yrs old
Comfort maker furnace is 12 yrs old

New building owner should budget for repairs and or replacement of all older furnaces

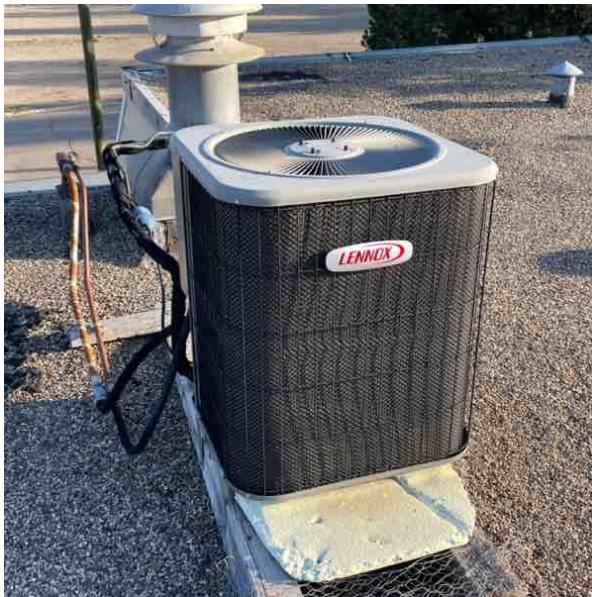
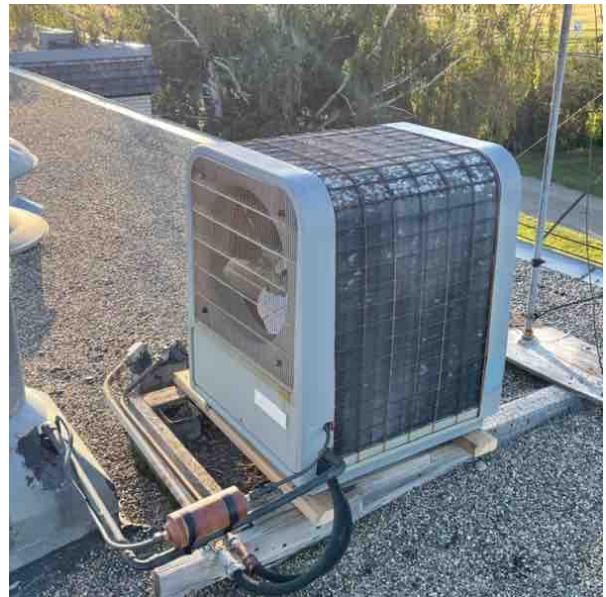
8.2.2 **2 roof top ac units**

1 Lennox that is under 10 yrs old, 1 York unit that is 20+ yr old

New building owner should budget for maintenance and repairs to older unit

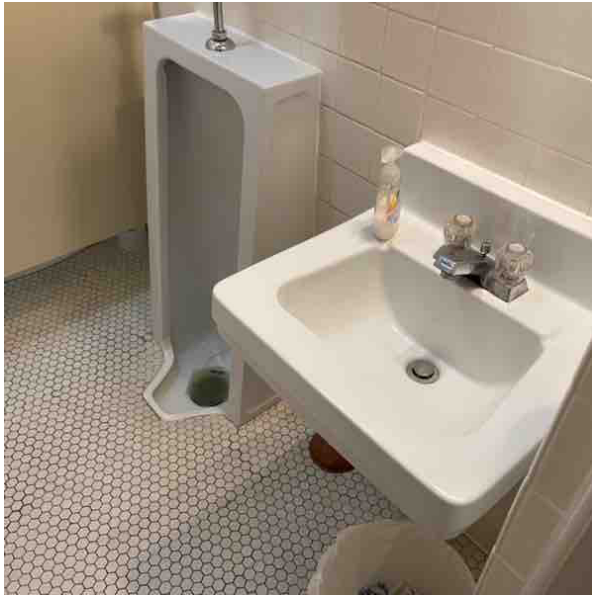
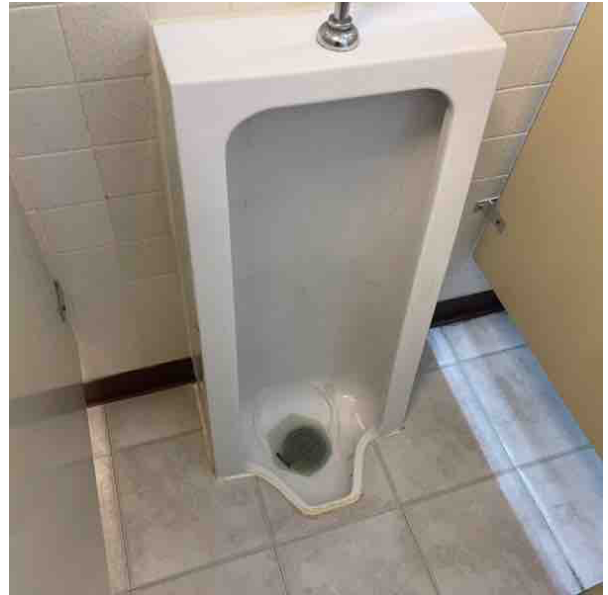
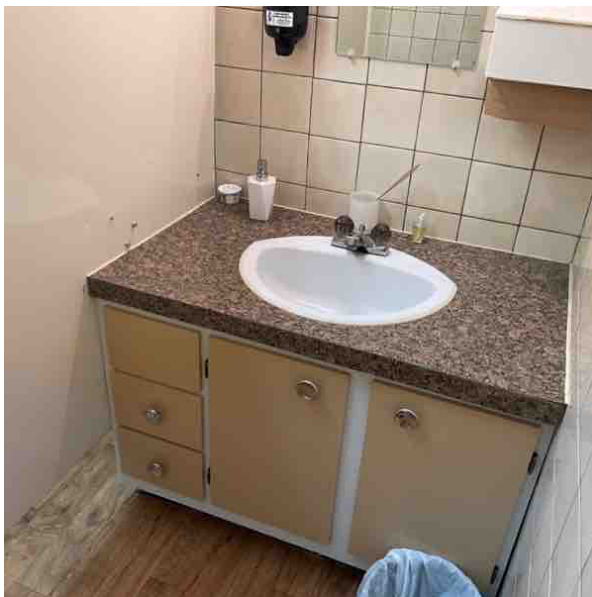
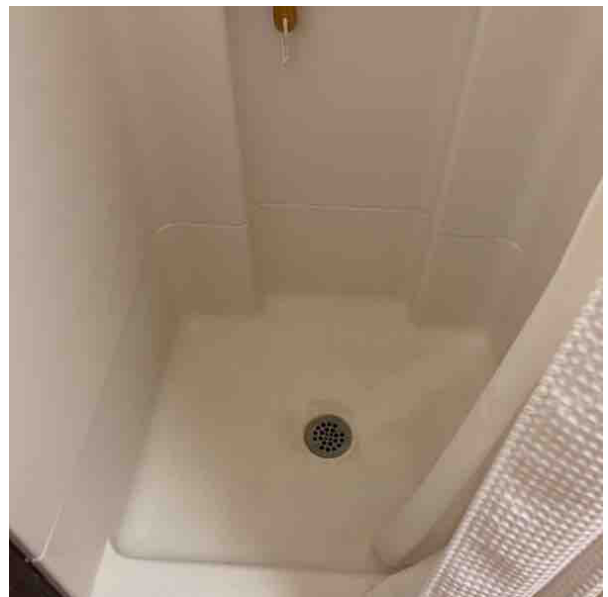
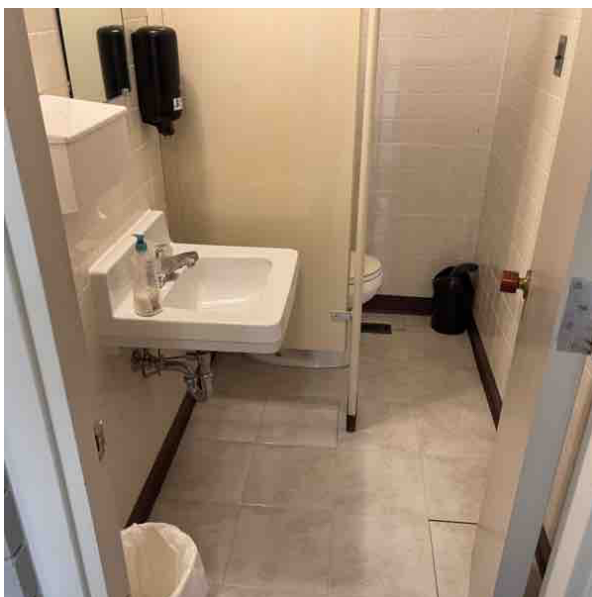
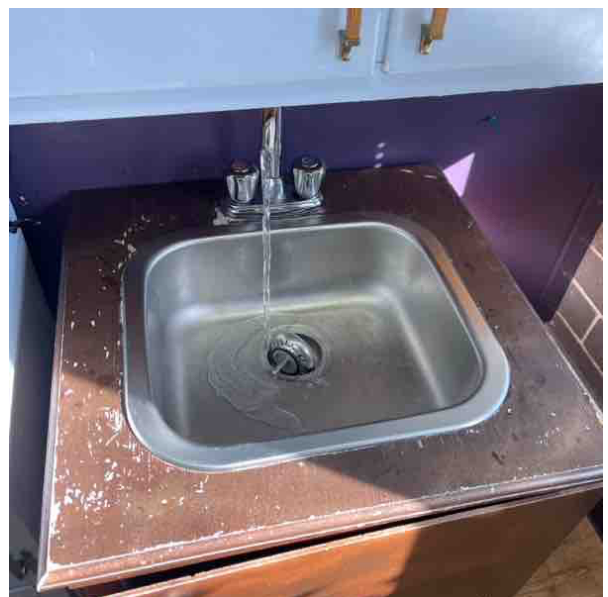
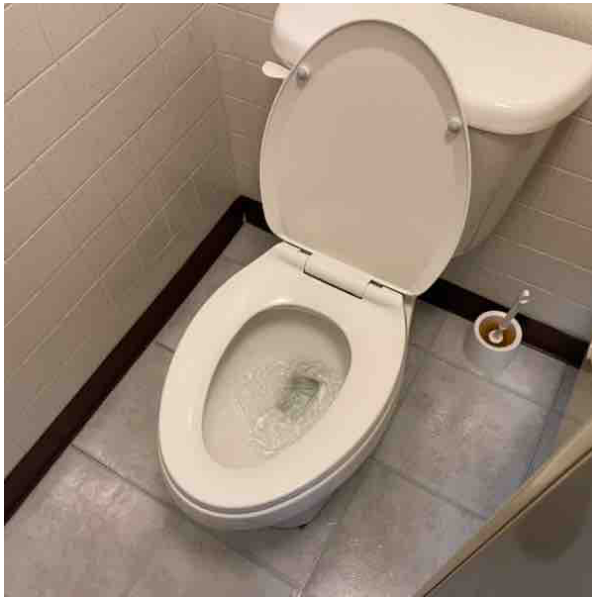
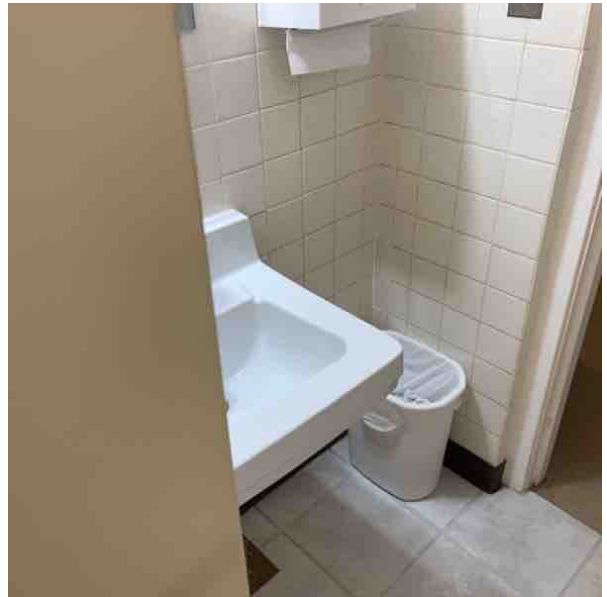
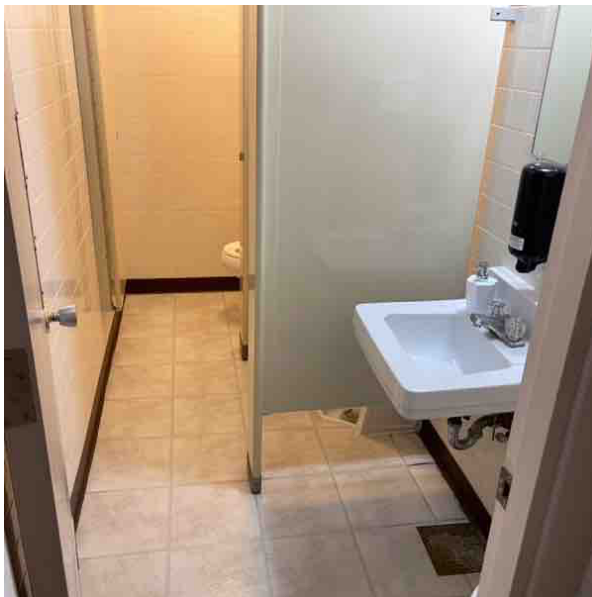
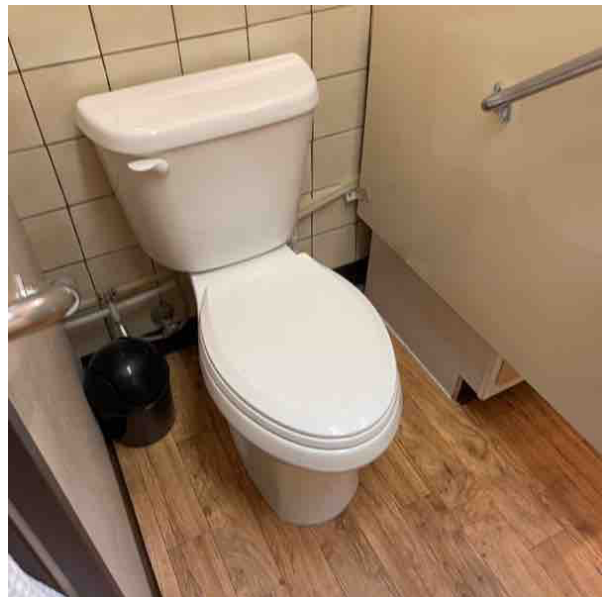
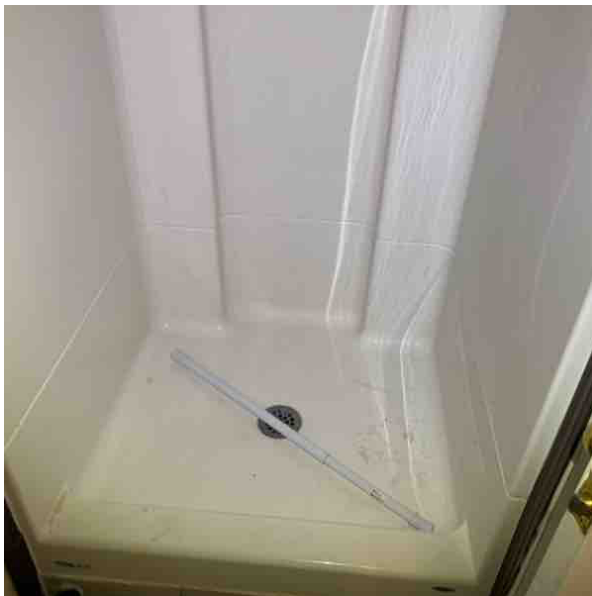
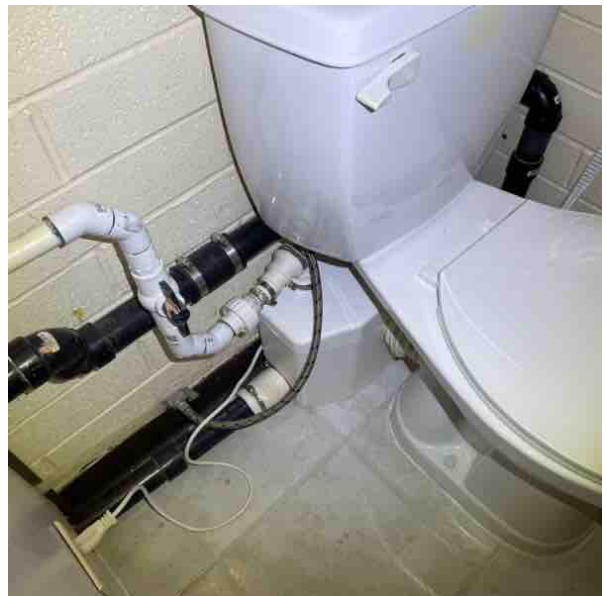
9.2.1 No visible leaks at any sinks, toilets and or showers at the time of the inspection
