Home Inspection Report

PROPERTY INSPECTED:
5123 5 Street East
Claresholm, AB T0L 0T0

Date of Inspection: 09/06/2022

Inspection No. 1158-1-1475

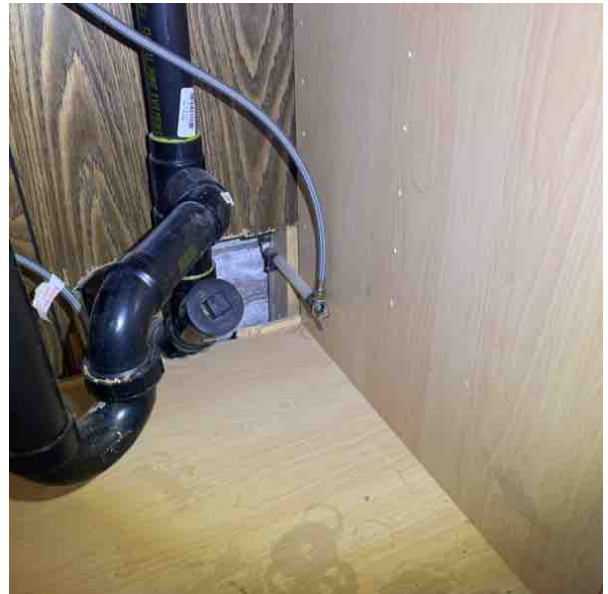
9.3.2 Where piping was visible it was found to be copper and pex piping

No visible current leaks at time of the inspection

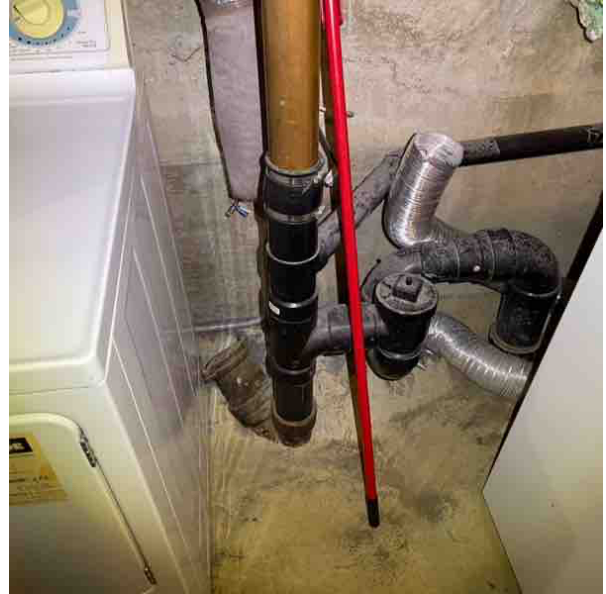
9.4.2 **Where piping was visible it was found to be Abs and copper piping**

No visible current leaks at the time of the inspection

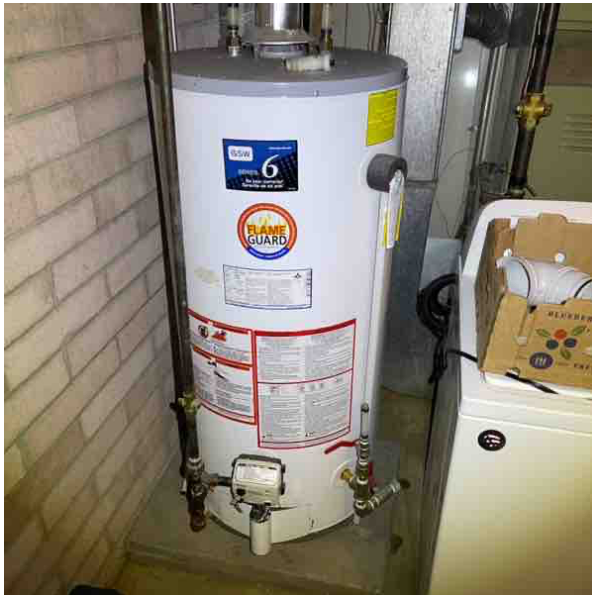
9.5.3 **1 hot water tank, 10 yrs old. No current leaks**
