Your Inspection Report

5008 54 Avenue
Eckville, AB T0M 0X0

INSPECTION DATE:
Thursday, August 25, 2022

Report No. 2950, v.0
certapropertyinspections.com

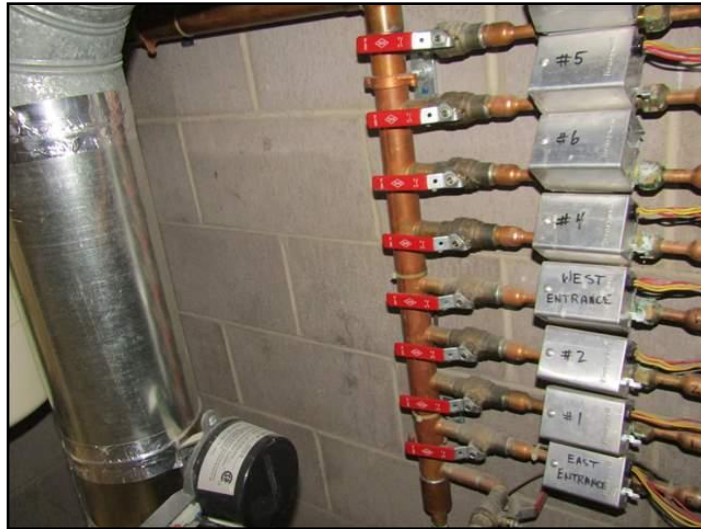
Condition: • The inspector was unable to get heat in units two and five. It appears that both have zone valves that need replacing as they would not function open even after switching from auto to manual.

valves for units 2 and 5 should be replaced

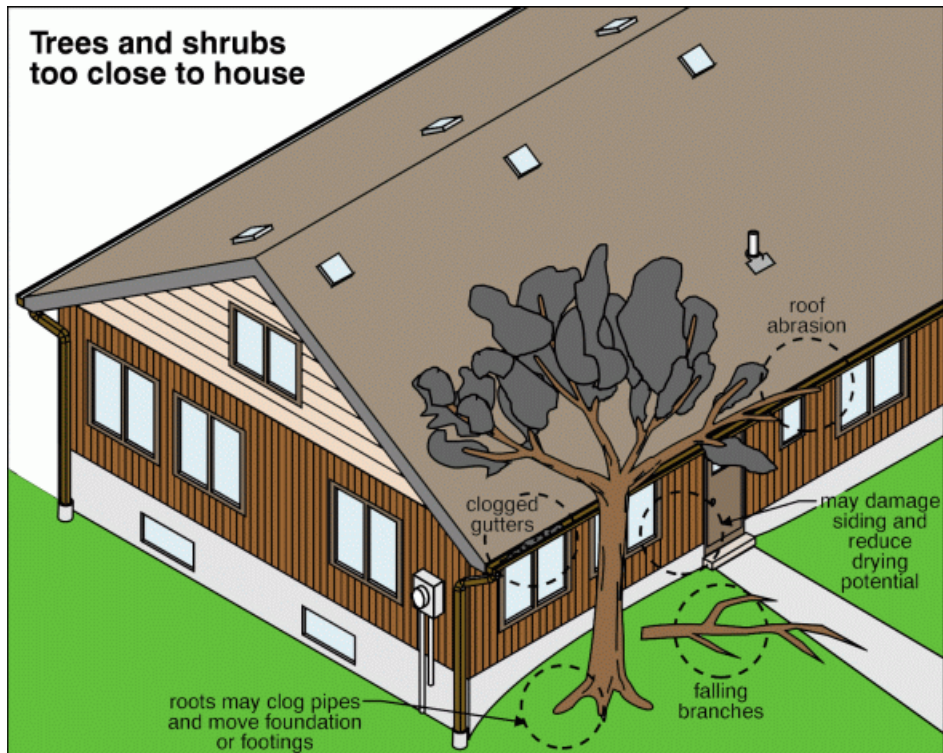
1. Condition: • Tree branches touching roof

Trees and shrubs should be kept away from structures as they can damage them. In addition, vegetation gives off lots of moisture and often harbours critters.

Implication(s): Shortened life expectancy of material

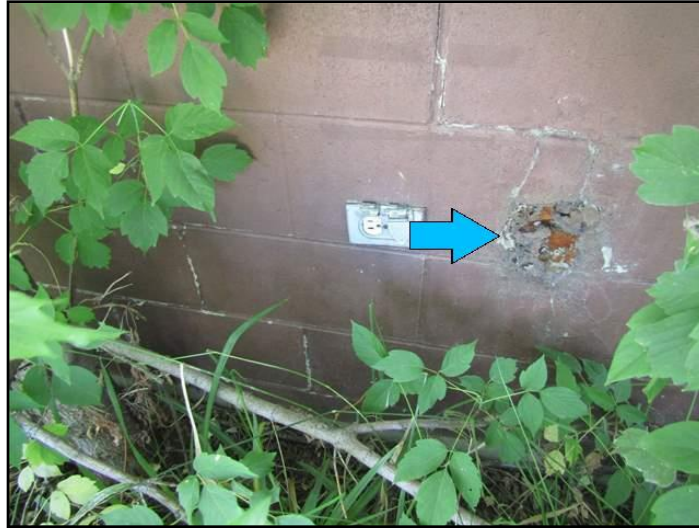
Seal openings

It is recommended to seal all openings and cracks on the cement block foundation walls.

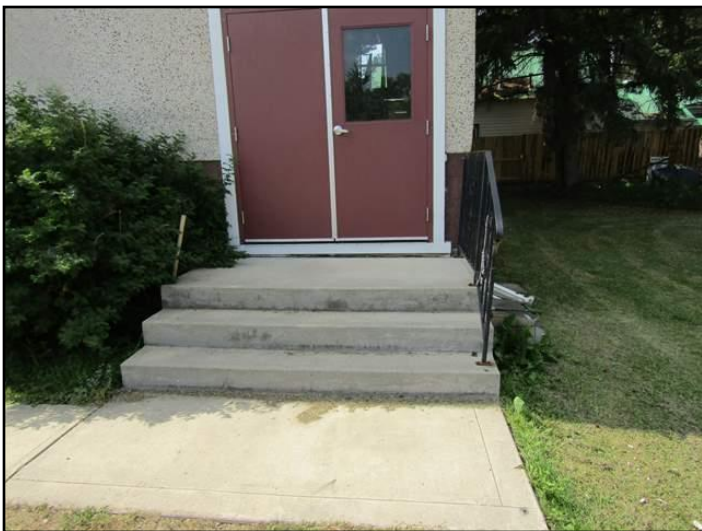
Concrete

Typical cracks and spalling were noted on the concrete steps. It is recommended to seal these areas to prevent further deterioration.

It is recommended to resurface the cracks and deteriorated concrete on the side to prevent further deterioration.

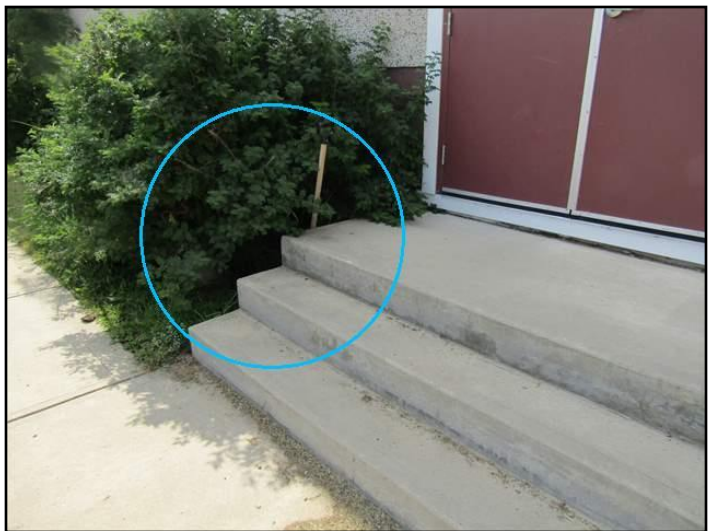
Handrail recommended

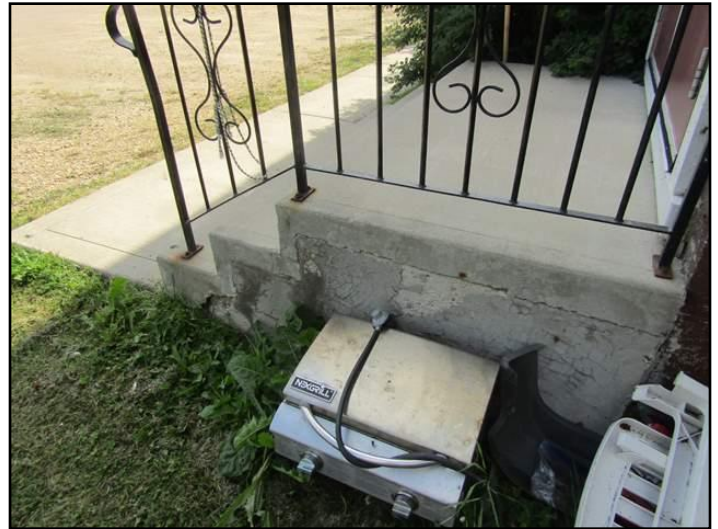
The handrail was noted to be loose and should be secured for safety measures.

Loose

Recommended to resurface

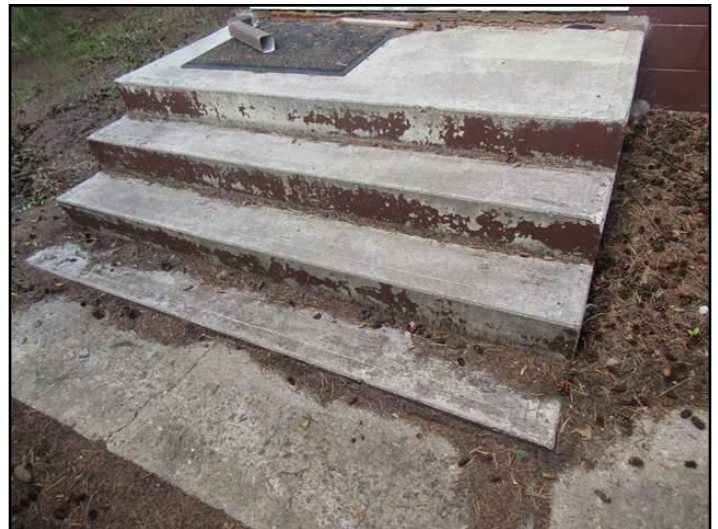
The stairs were noted to have shifted and are currently slanted. This is likely from the freezing and thawing weather cycles. As this is a possible tripping hazard, it is recommended to have this corrected.

Handrails recommended

Uneven riser heights

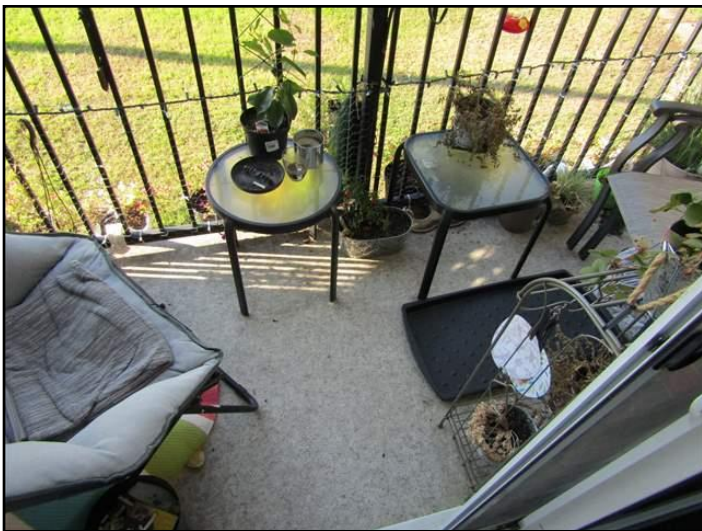
Unit 4

The balconies were inspected and appear to be well built and structurally sound. It should be noted that the inspector is unable to tell what the building material under the waterproof membrane looks like.

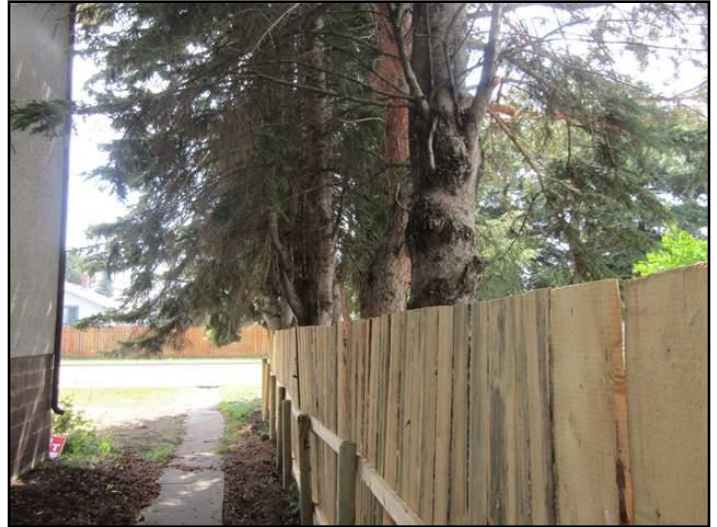
Keep vegetation away

It is recommended to keep vegetation away from the fence line as they may damage it or cause it to lean.

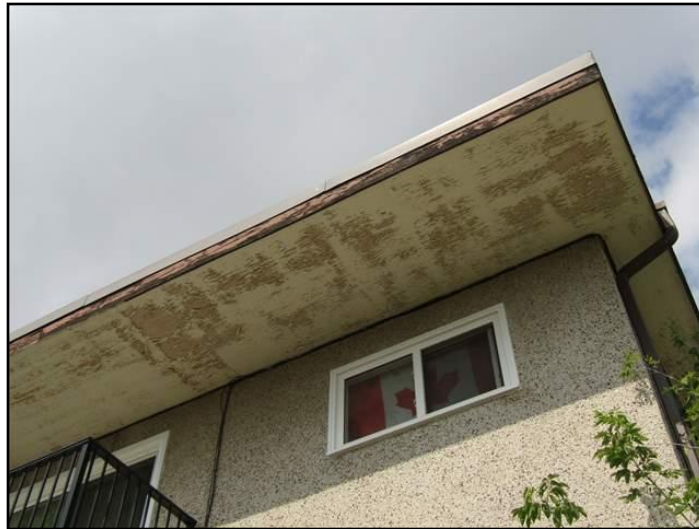
Exterior Wood Products

3. Condition: • It is recommended to maintain exterior wood products on a regular basis; this consists of removing old and damaged paint / stain, priming and reapplying new products. This will prolong the lifespan of the wood product.

Implication(s): Wood decay / Rot / Fungus Growth

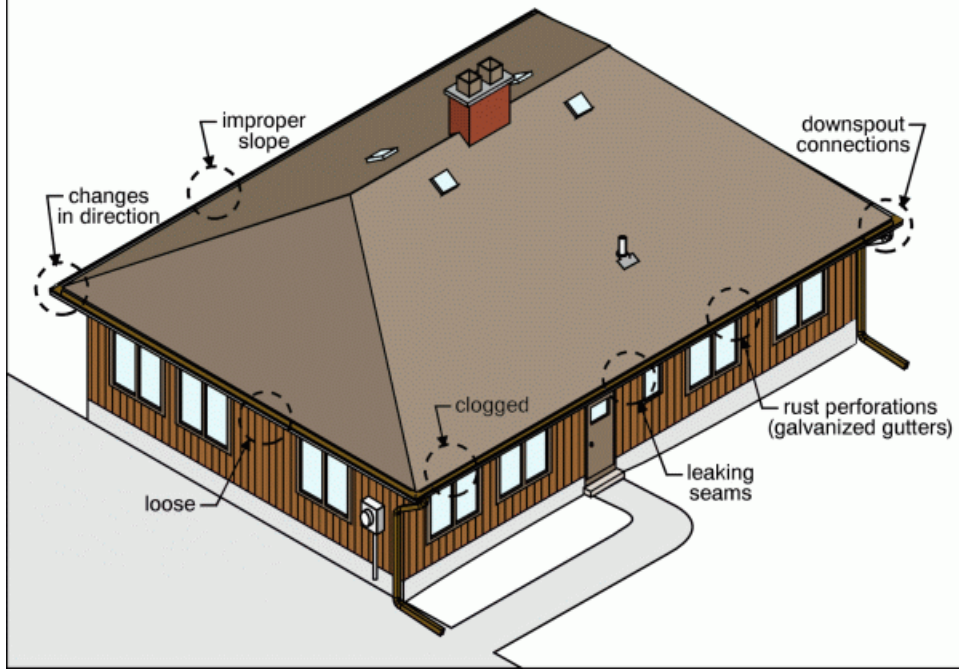
4. Condition: • Clogged

The scuppers on the roof were all found to be full of debris and vegetation. This is a likely cause for the ponding on the roof.

Implication(s): Chance of water damage to structure, finishes and contents

Clogged

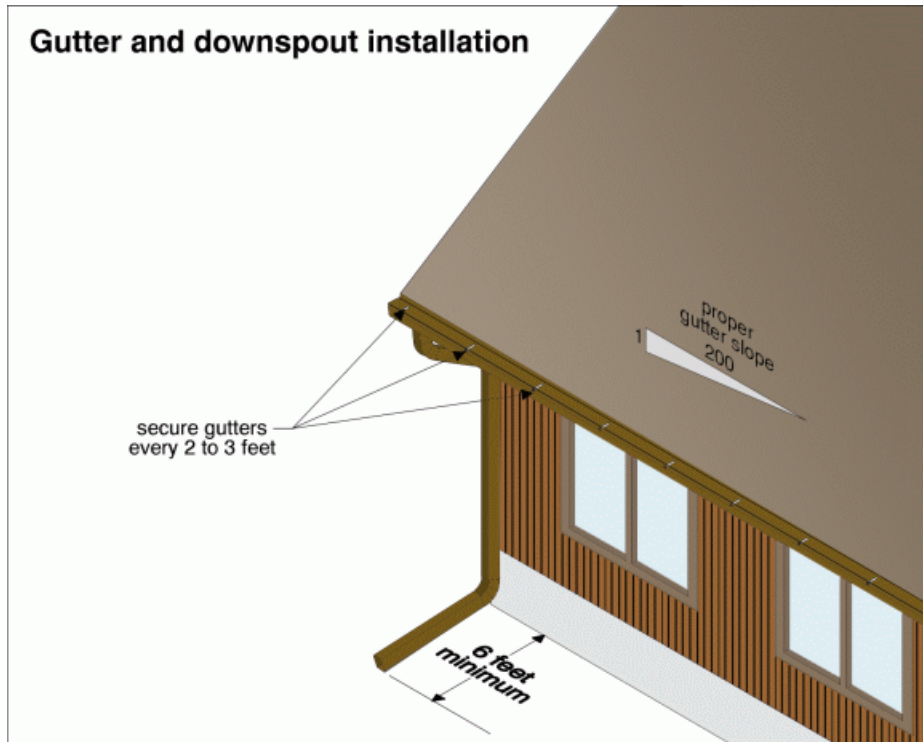
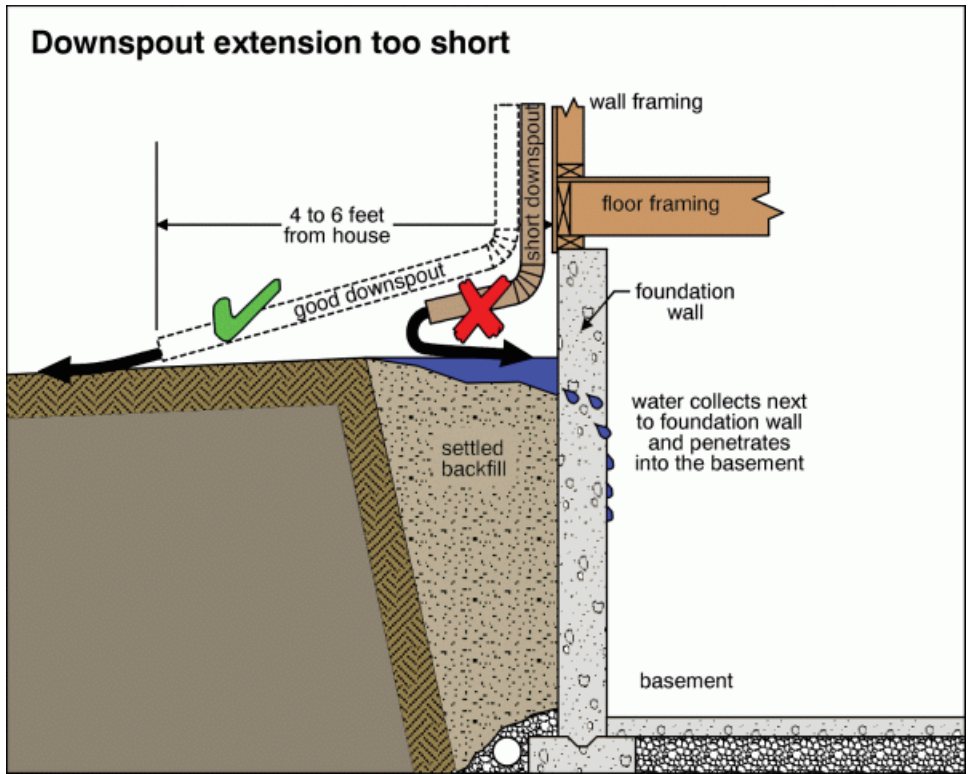
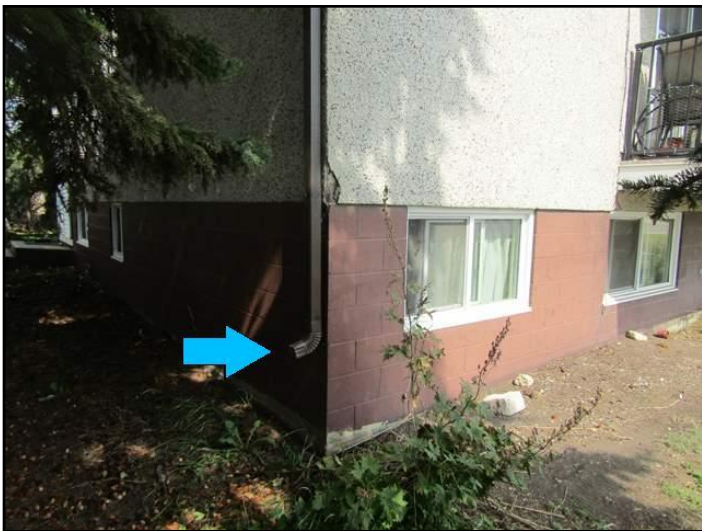
5. Condition: • Should discharge 6 feet from building

Downspout extensions should be secured to downspouts and positioned 6 feet away from the structure. This helps to prevent water migrating into the foundation and potentially causing structural issues. In addition, the downspout extensions should be checked that the run off does not make its way back towards the foundation of the structure.

Implication(s): Chance of water damage to structure, finishes and contents

Should discharge 6 feet from building

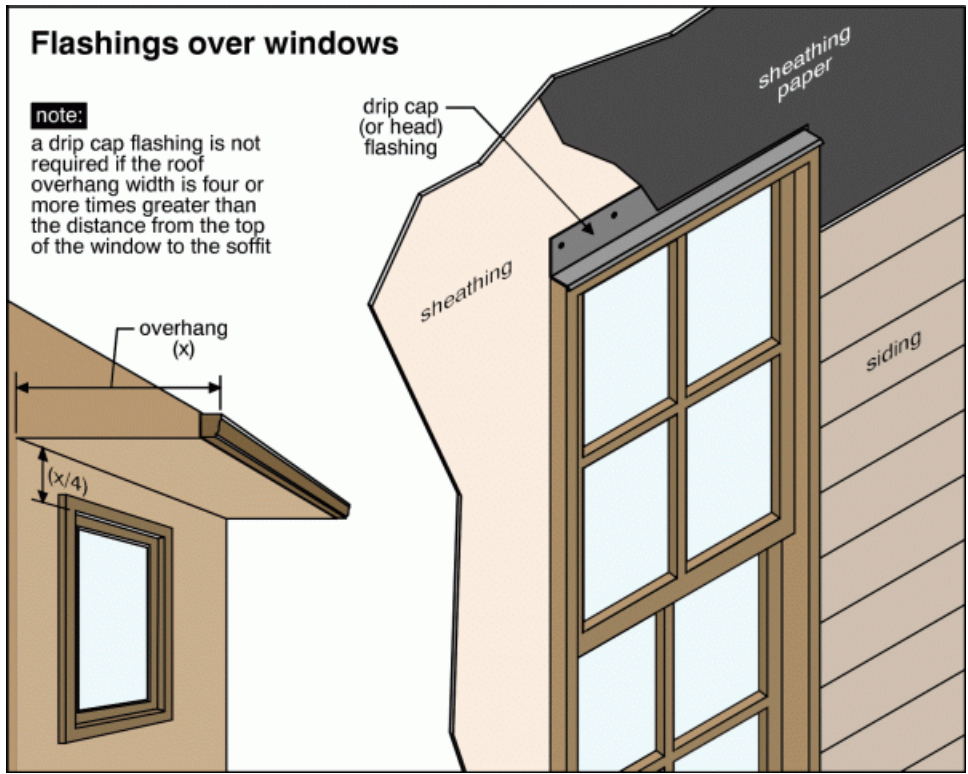
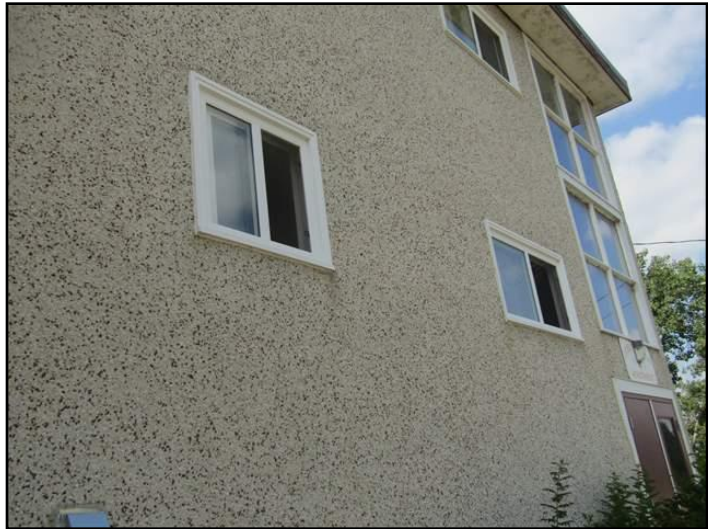
7. Condition: • Missing

All window and door trim should have a drip edge. These help prevent water penetration into the building and the framing around the structure. It is recommended to seal the areas with caulking to prevent water intrusion.

Implication(s): Chance of water damage to structure, finishes and contents

Missing

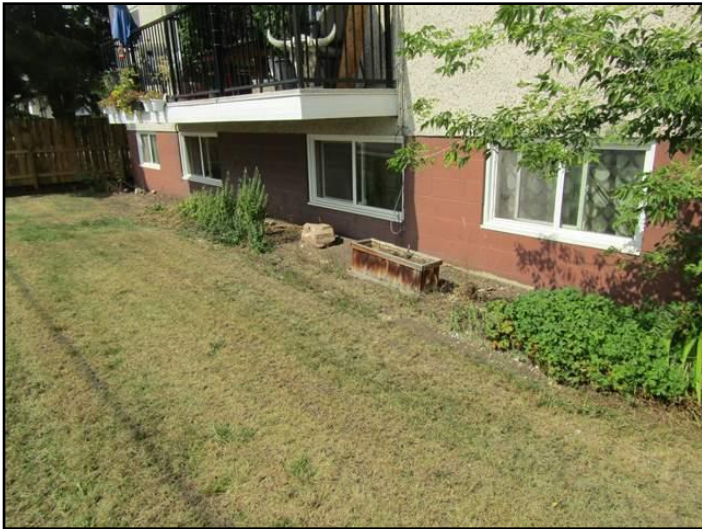
9. Condition: • Improper slope or drainage

Improper slope or drainage

It is recommended that the grading around the structure be positive; meaning that it should slope away. This helps prevent water penetration into the structure. Fill areas that have settled next to the structure with clay-not topsoil- with a positive slope away from the structure (10 per cent is recommended).

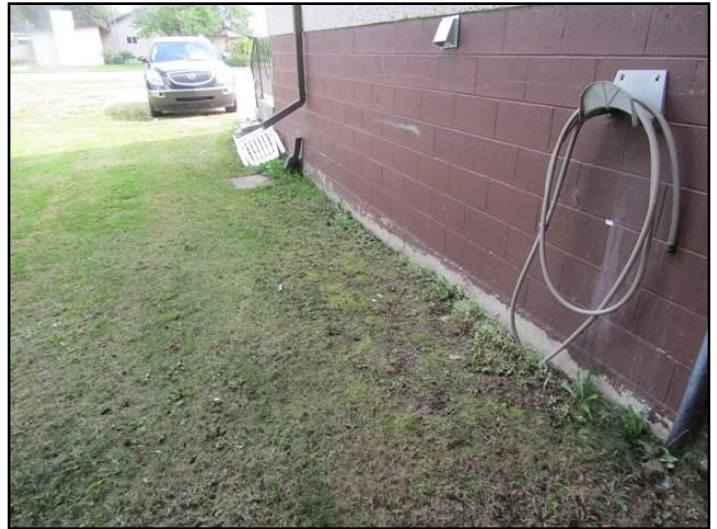
Improper slope or drainage

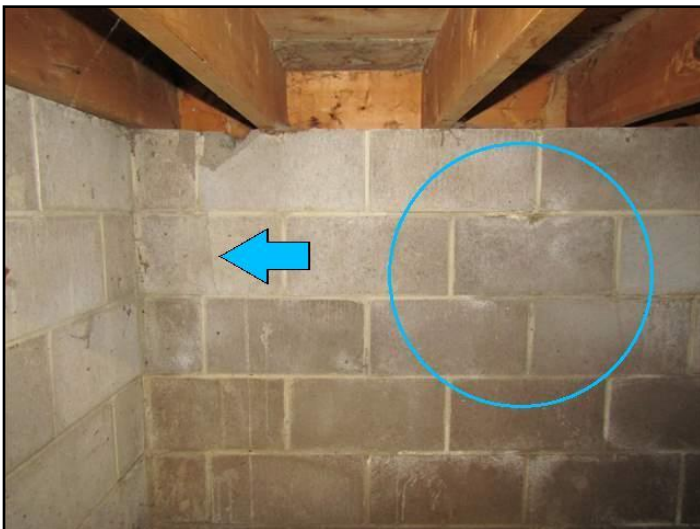
10. Condition: • Some step cracks were noted on the concrete block foundation. There are any number of causes for a concrete block foundation to crack: water, shifting in the ground, tree roots deteriorating. It is recommended to have these cracks along the mortar sealed or re-mortared by a professional for structural integrity and to help aid in the prevention of water intrusion.

Crack on block as well as Step crack

It is recommended to have the crack on the block (Where the arrow in the picture is pointing to) sealed with a cement sealant to prevent water intrusion.

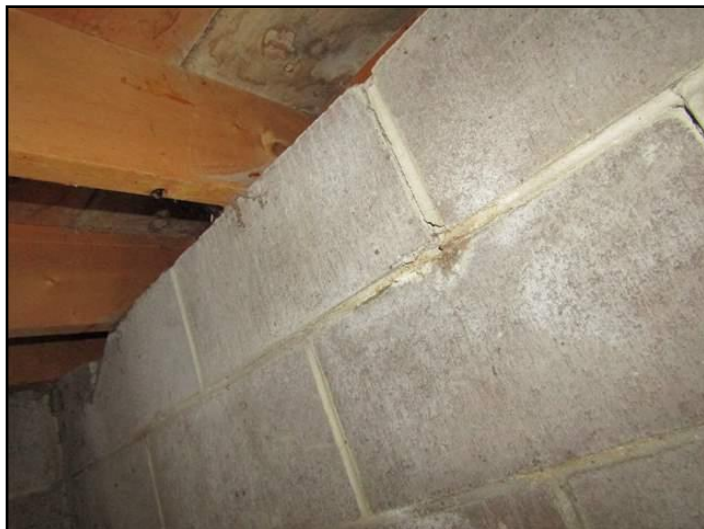
Step crack

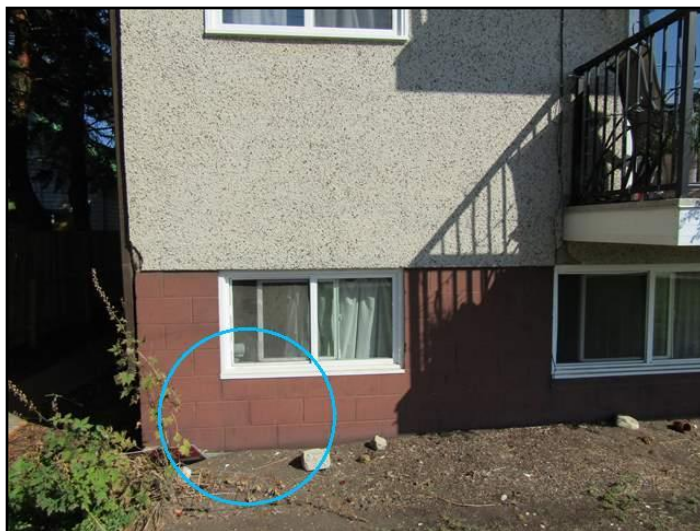
Step Crack

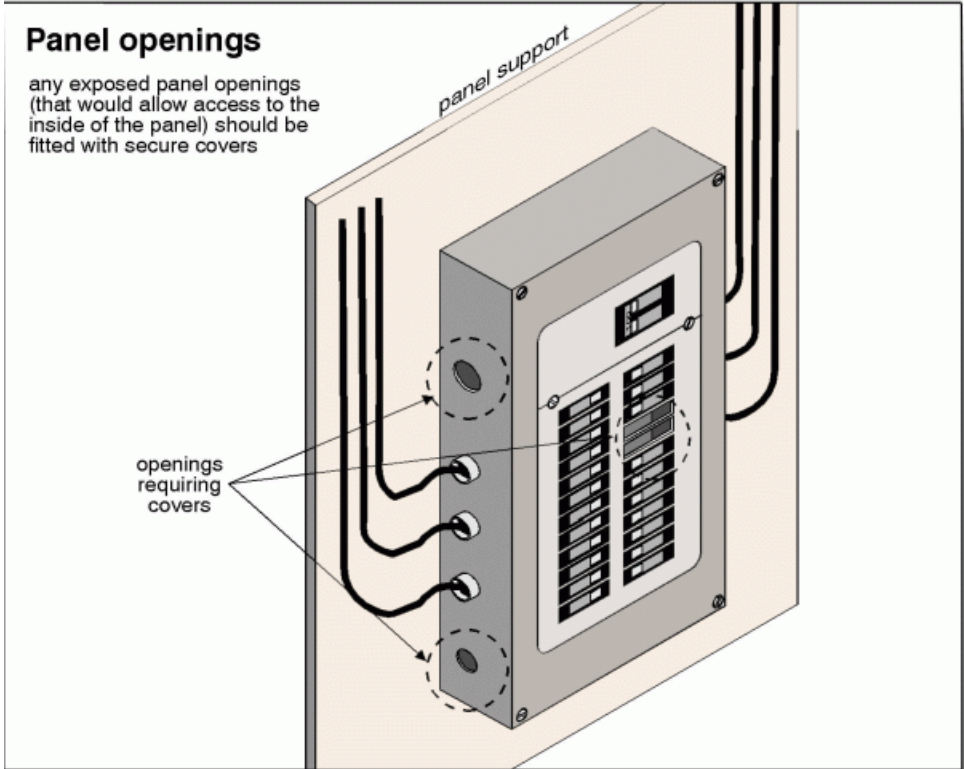
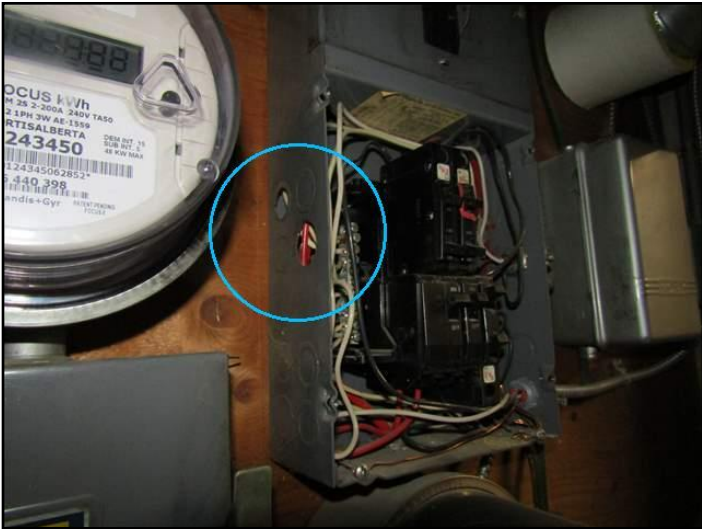
Mechanical room

11. Condition: • Openings in panel

All openings to the panel should be closed off.

Implication(s): Electric shock | Fire hazard

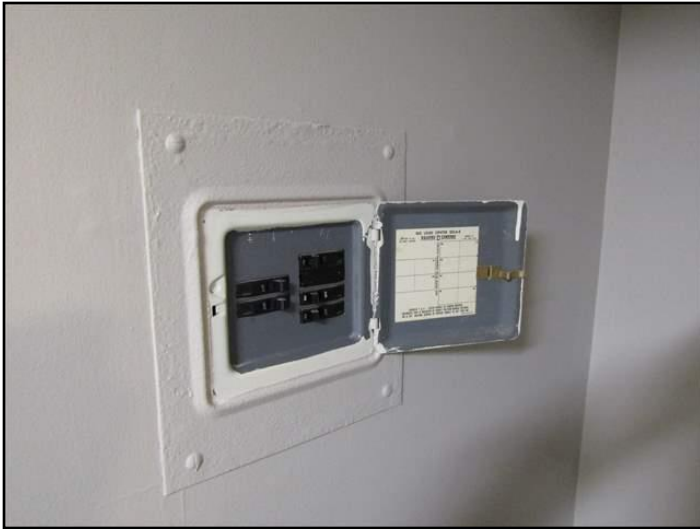
Unit 5

12. Condition: • Circuits not labeled

Some of the breakers in the units were not labelled, all breakers should be labelled. It is recommended to have this done by a qualified person.

Implication(s): Nuisance

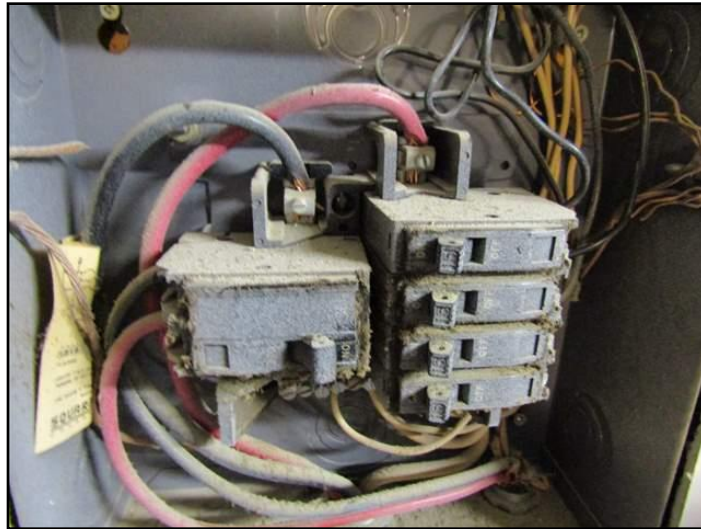
Unit 4

13. Condition: • It is recommended to clean the dust out of the following breaker panel. Dust may damage the breakers to the point where they will not "trip" when needed.

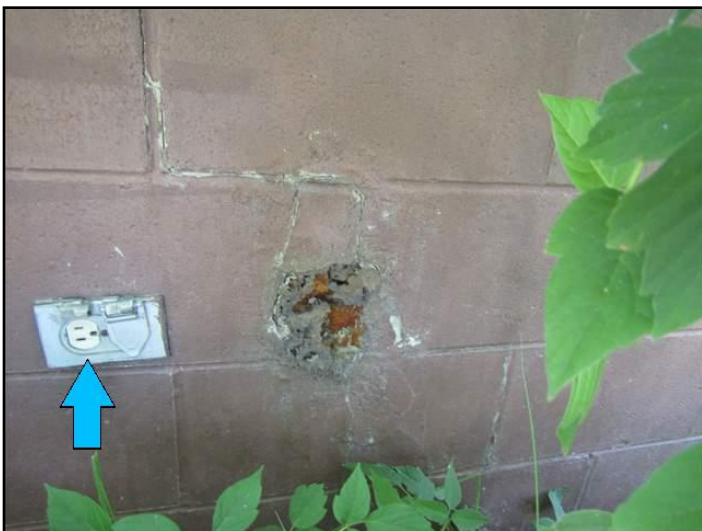
16. Condition: • Not suitable for outdoor (exterior) use
- A proper weather rated cover should be installed for the following outdoor receptacles.
Implication(s): Shock hazard or interruption of electrical service

Not suitable for outdoor (exterior) use

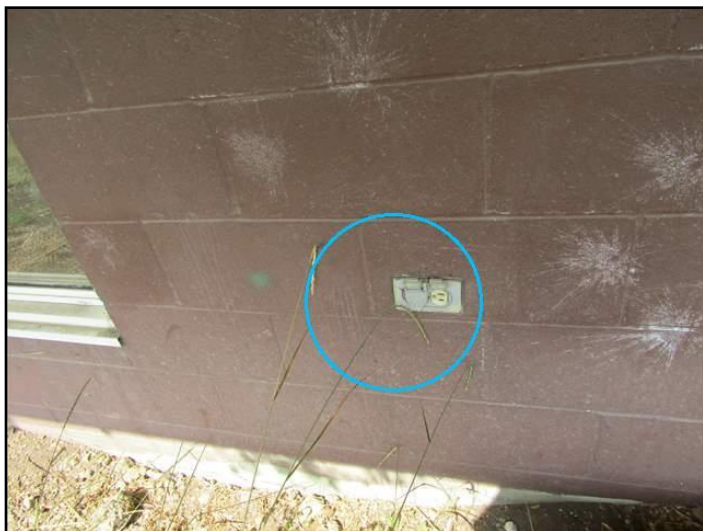
Not suitable for outdoor (exterior) use

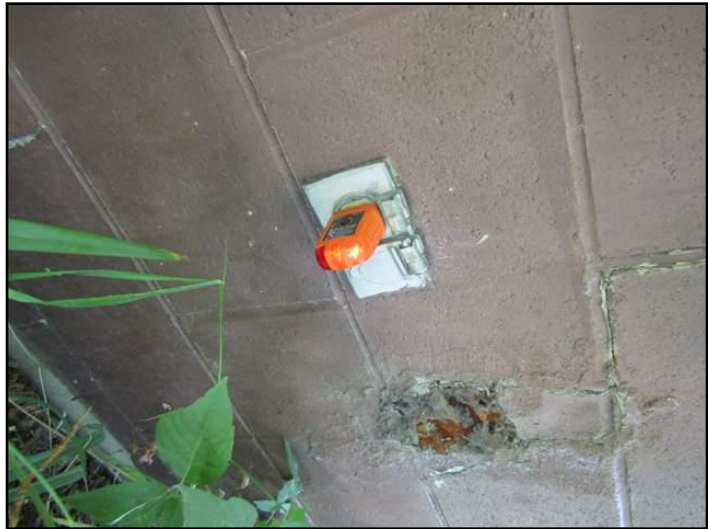
17. Condition: • Outdoors
Though it was not in the building code when the house was built, it is recommended to have GFCI protection for outdoor receptacles.

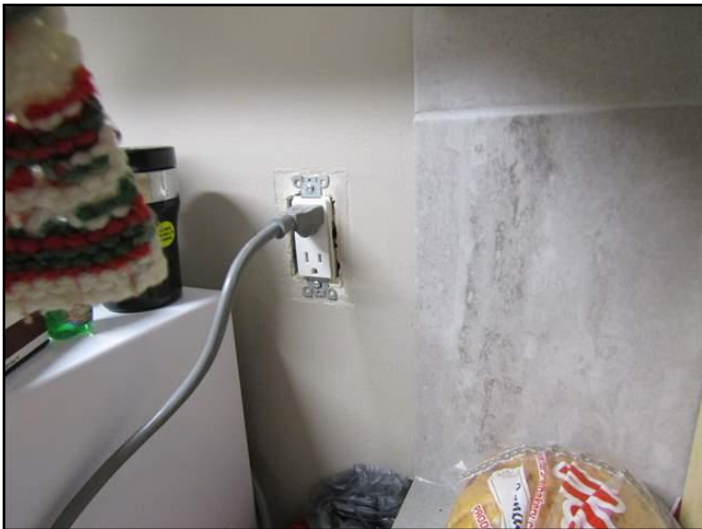
Unit 3

18. Condition: • Missing

It is recommended to have cover plates on junction boxes, switches, and outlets.

Implication(s): Electric shock

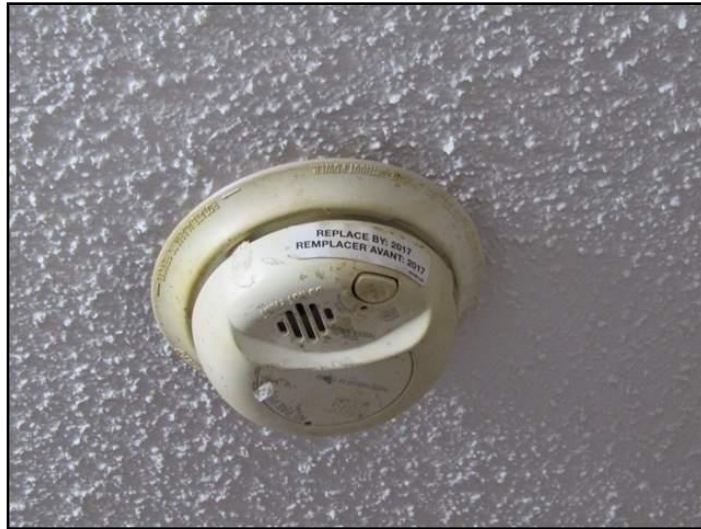
Unit 2

21. Condition: • More than 10 years old

All the smoke detectors in the structure should be checked to ensure that they are not older than 10 years; as this is the typical life span of the units. The radioactive element in ionization smoke alarms will decay beyond usability within 10 years.

Implication(s): Life safety hazard

These units should be tested on a monthly basis with a canister of smoke to ensure they are functioning properly. Batteries should be changed annually at the least.

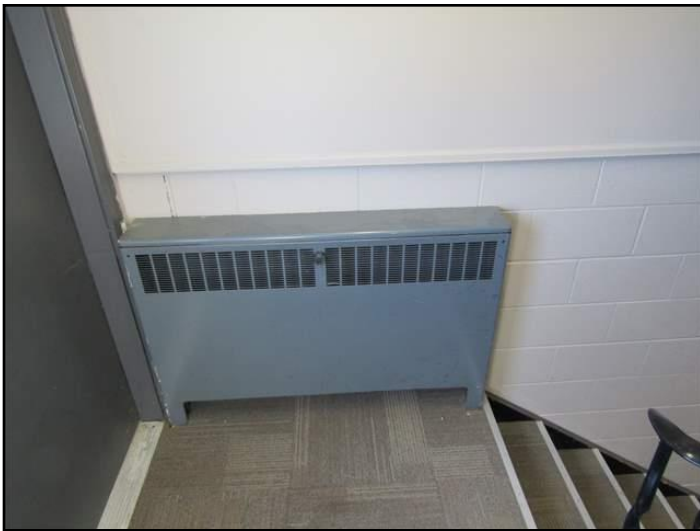
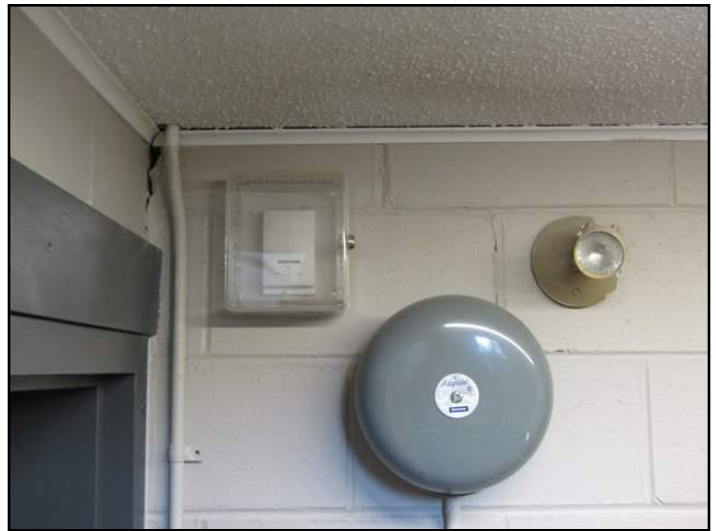
Auxiliary heat: • The two stairwell/hallway heaters appeared to be in good working order but could not be tested at the time of the inspection as the thermostats were locked up.

Thermostat locked

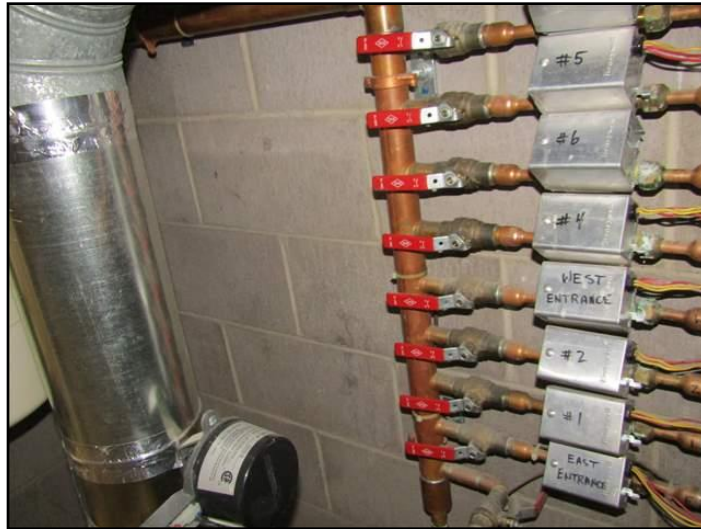
25. Condition: • The inspector was unable to get heat in units two and five. It appears that both have zone valves that need replacing as they would not function open even after switching from auto to manual.

valves for units 2 and 5 should be replaced

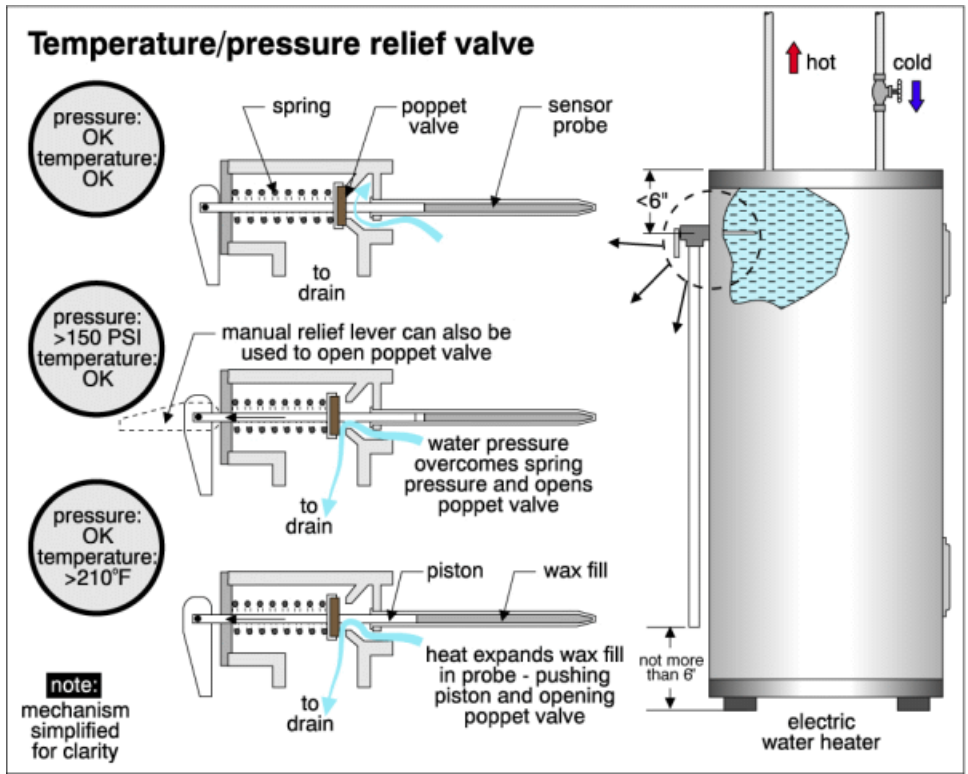
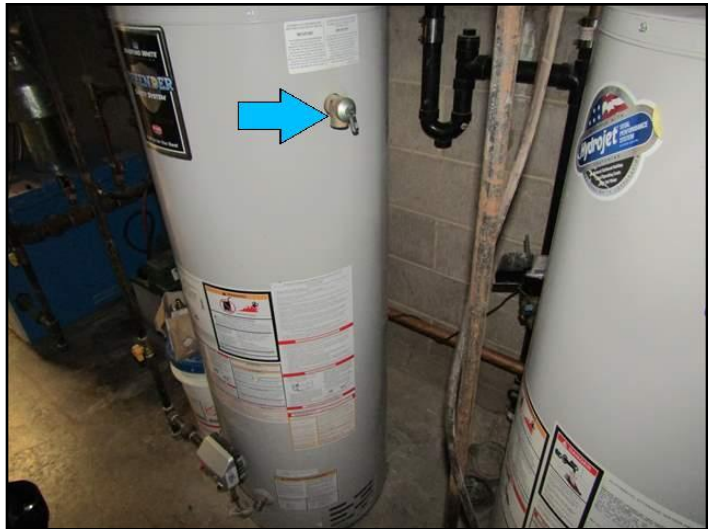
26. Condition: • Discharge tube missing

Implication(s): Scalding

Discharge tube missing

It is recommended to install discharge tubes for the temperature pressure relief valves.

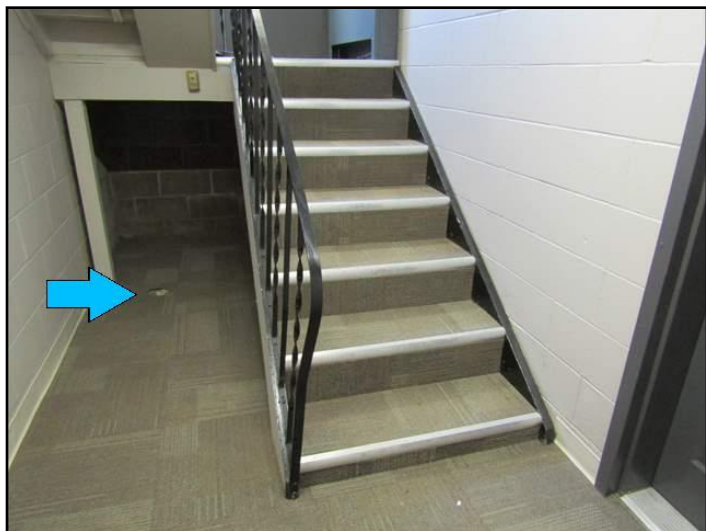
27. Condition: • Grate missing, rusted or obstructed
Floor drains should have grates to prevent debris from falling in.

Implication(s): Chance of water damage to structure, finishes and contents | Trip or fall hazard

Grate missing

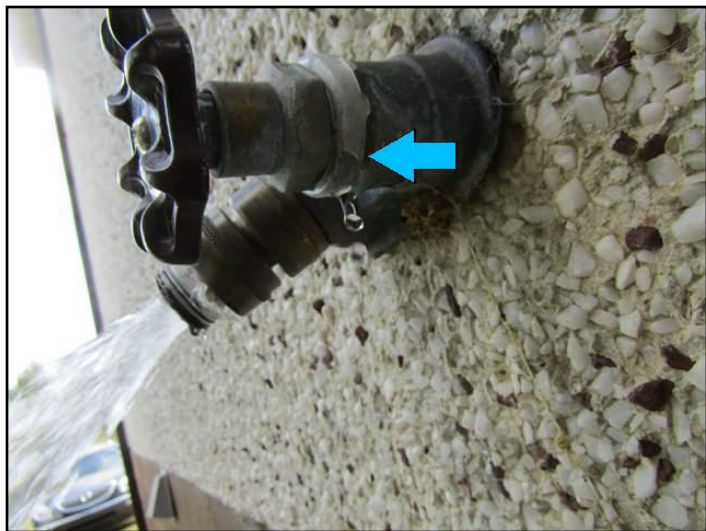
28. Condition: • Leak or drip

The exterior hose bib leaks and should be replaced by a qualified plumber.

Implication(s): Chance of water damage to structure, finishes and contents

Leak or drip

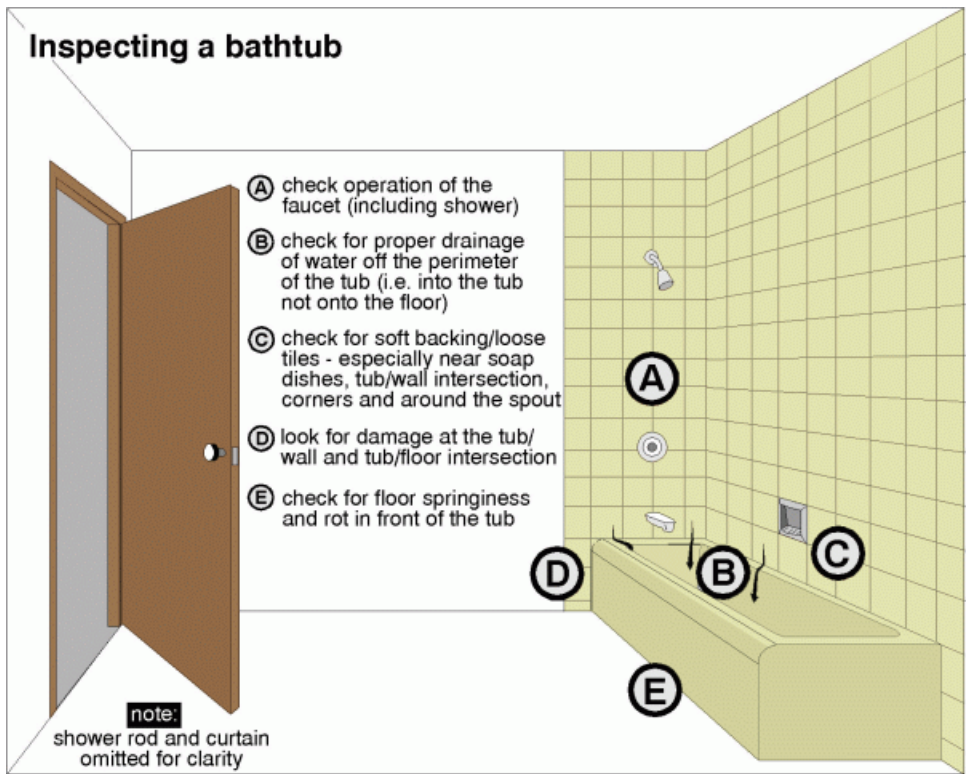
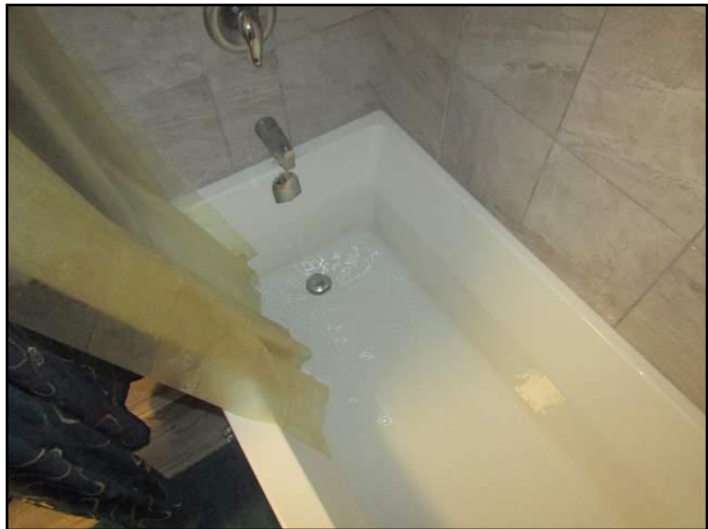
Unit 6

29. Condition: • Slow drain

The following bathtub had a slow drain. This may be remedied by using a plastic snake, or pouring vinegar down the drain.

Implication(s): Chance of water damage to structure, finishes and contents

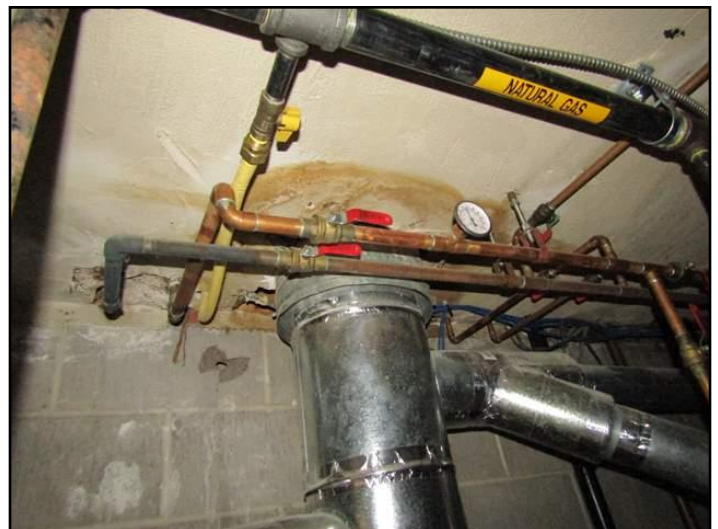
31. Condition: • Water damage

The following area in the mechanical room was found to have excess amounts of water damage but no current moisture. It was unclear what caused this but it may be condensation from the heat in winter. It is recommended to have a professional evaluate this further and to have the affected materials replaced.

Implication(s): Chance of movement | Rot | Leakage

Water damage

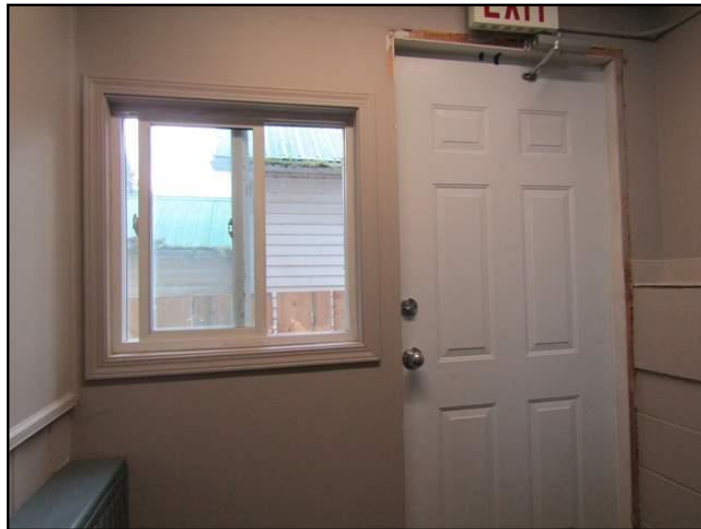
Building rear entrance

32. Condition: • Torn

Some screens in the dwelling were found to be damaged.

Implication(s): Chance of pests entering building

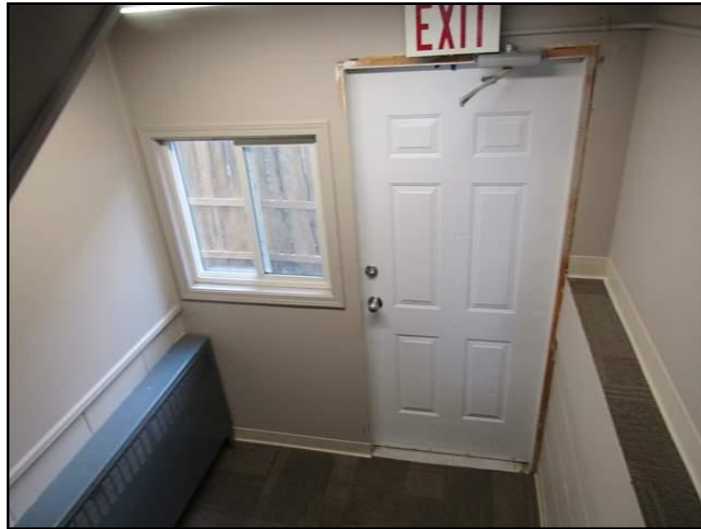
33. Condition: • The following notes were made regarding doors at the property;

Rear entrance door/mechanical damage

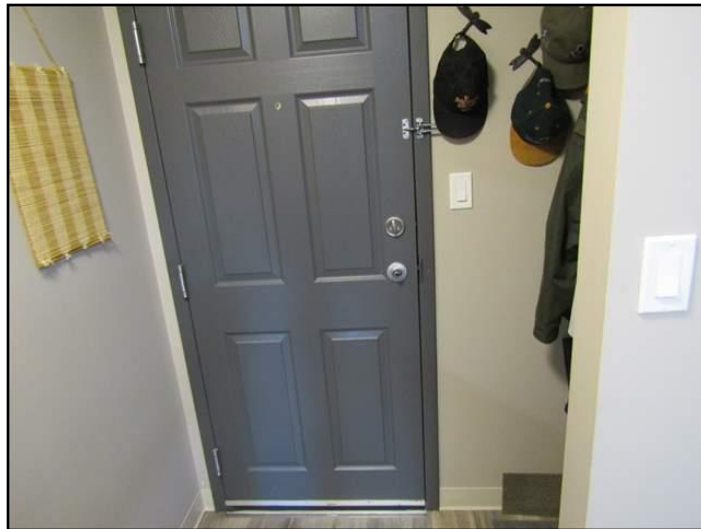
Unit 6

34. Condition: • Broken

The following handle is damaged and should be repaired or replaced.

Implication(s): System inoperative or difficult to operate

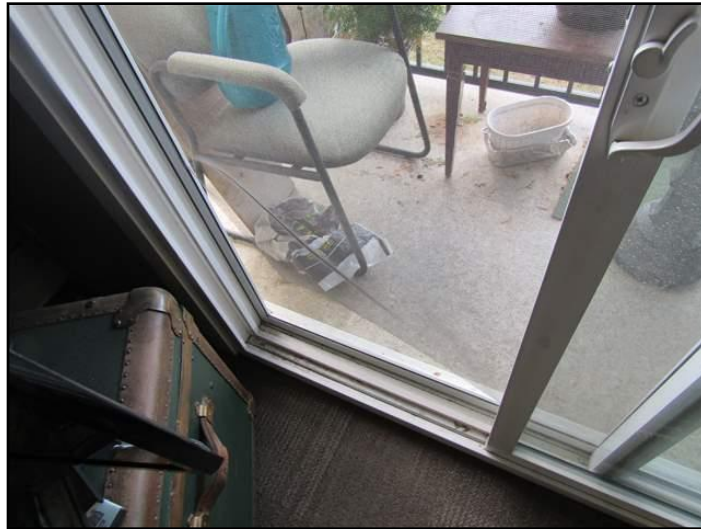
Unit 3

35. Condition: • Torn

The storm screen was found to be torn and should be repaired or replaced.

Implication(s): Chance of pests entering building

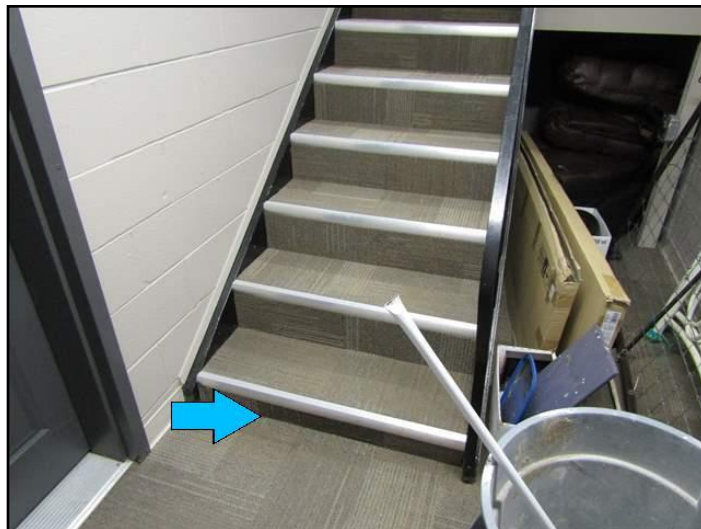
36. Condition: • Riser height should be within 3/8" on all steps to prevent tripping accidents.

Uneven riser heights

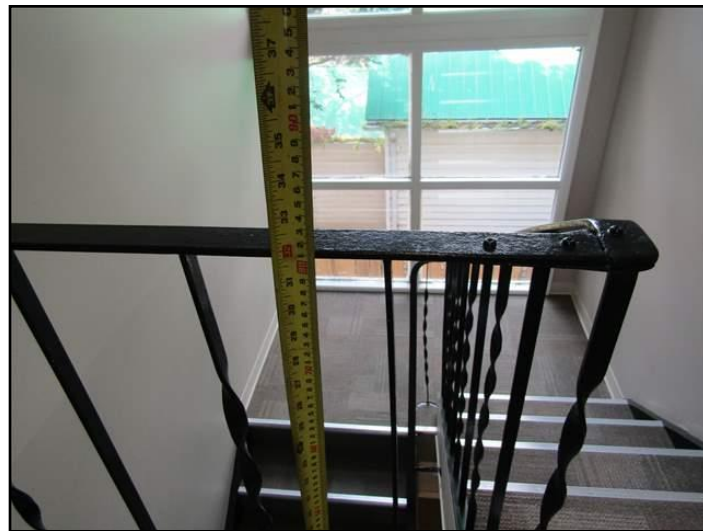
37. Condition: • Too low

In addition, when the distance from the floor to ground is less than 6' handrails be a minimum of 36" in height. It is recommended to raise these.

Implication(s): Fall hazard

32" stairwell handrails

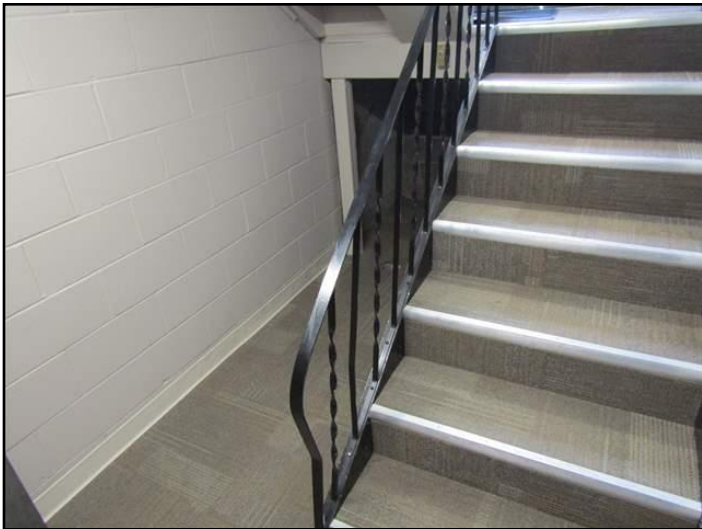
38. Condition: • Loose

Some of the handrails were loose and should be tightened.

Implication(s): Fall hazard

Loose

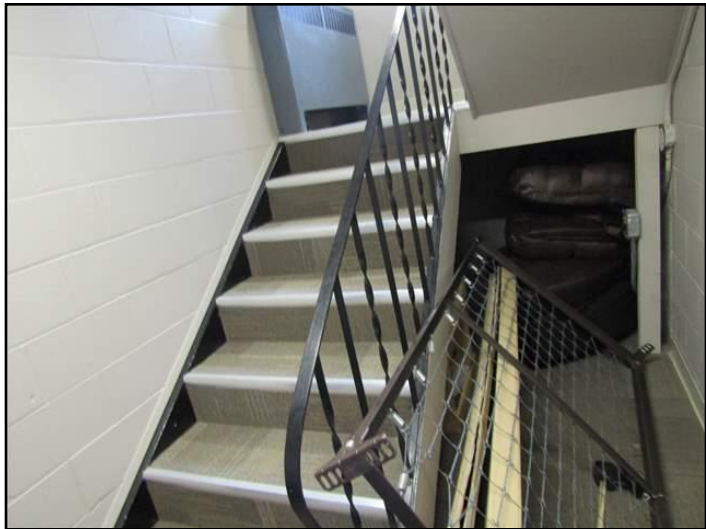
Loose
