Your Inspection Report

5008 54 Avenue
Eckville, AB T0M 0X0

INSPECTION DATE:
Thursday, August 25, 2022

Report No. 2950, v.0
certapropertyinspections.com

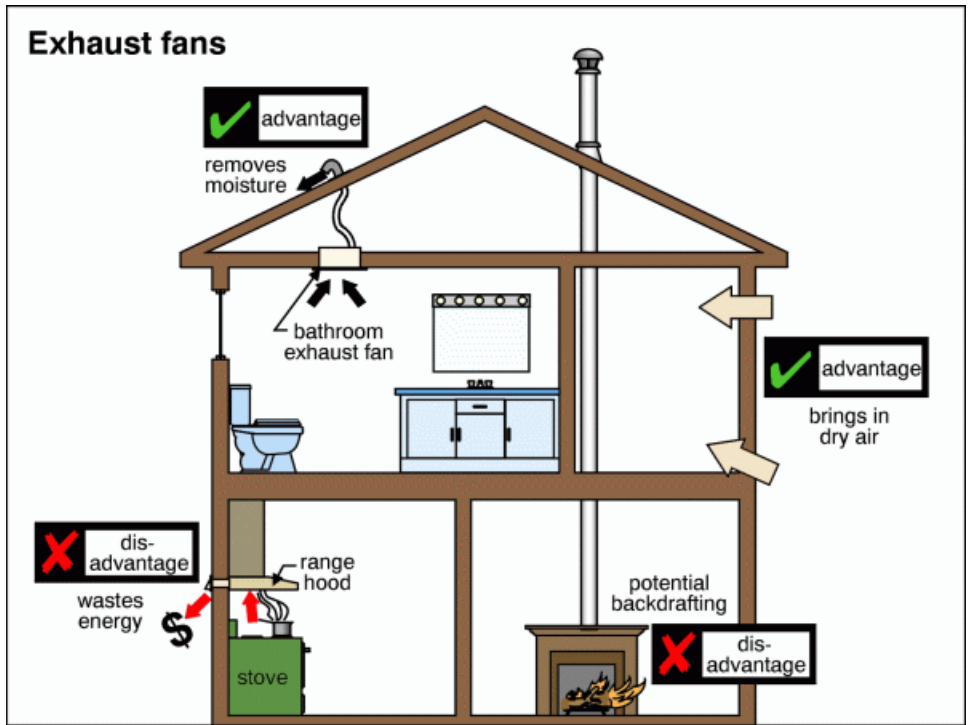
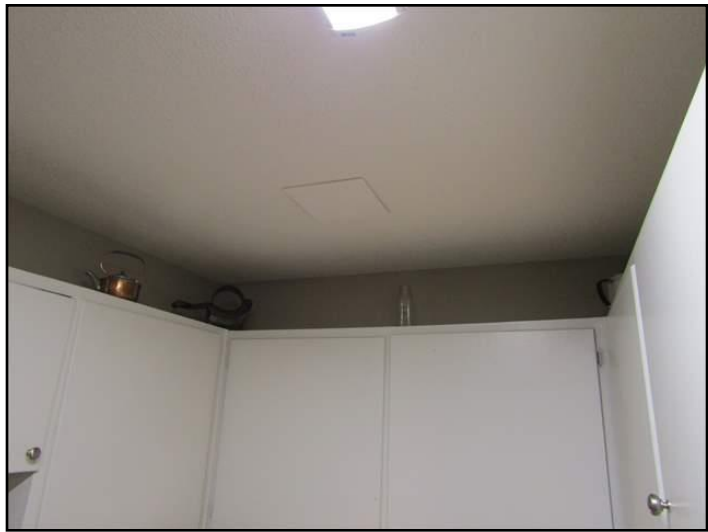
Unit 6

39. Condition: • Missing

It is recommended to install an exhaust fan in the following kitchen.

Implication(s): Chance of condensation damage to finishes and/or structure

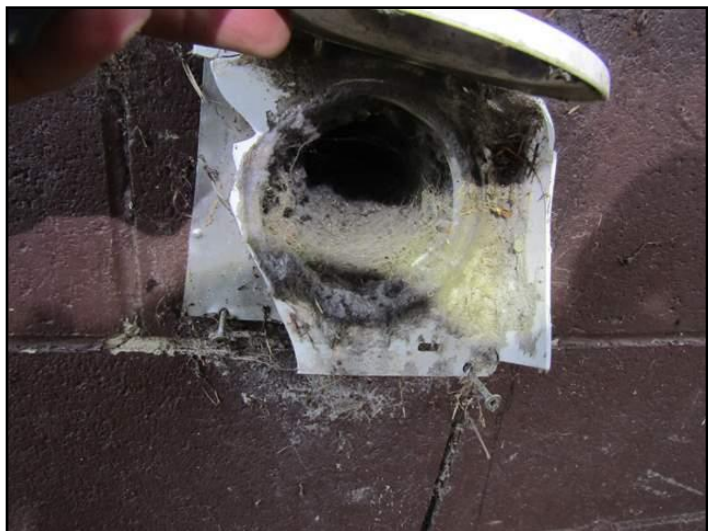
40. Condition: • Dryer vent obstructed

It should be noted that a build up of lint can be a fire hazard.

Implication(s): Equipment ineffective | Fire hazard

Dryer vent obstructed

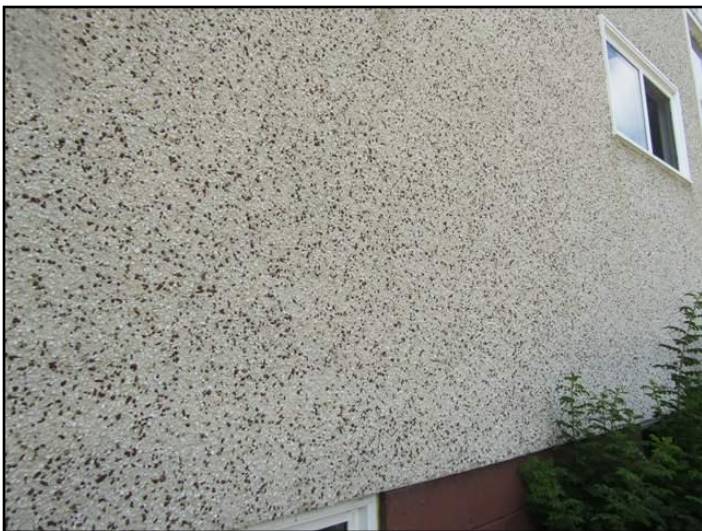
Stucco

41. Condition: • Possible asbestos containing materials

It should be noted that structures built pre 1990 may contain asbestos in a variety of building materials such as flooring, drywall mud compounds, insulation, paints, stipple, stucco, HVAC duct wrap, and others. To determine if asbestos is present, analysis must be done by a certified laboratory. Typically these materials are not harmful if not disturbed. Simply applying tin tape over top will also prevent interaction with product.

Implication(s): Health hazard
