TECHNICAL MEMO

To Jan Pedersen, Condominium Property Manager Peka Professional Property Management Ltd.	From Brian Bain, P.Eng Mechanical Engineer
Re Pointe of View Mechanical Review	Date February 14, 2020

The Pointe of View condominium building at 115 Elk Run Blvd has had several leak issues regarding their plumbing with increasing occurrence over the past few years. The Pointe of View condominium corporation through Peka Professional Property Management Ltd. (Peka) have retained McElhanney Ltd. to complete a mechanical review of the building to help determine potential root cause of the issues. The following report provides a review of McElhanney's inspection and recommendations.

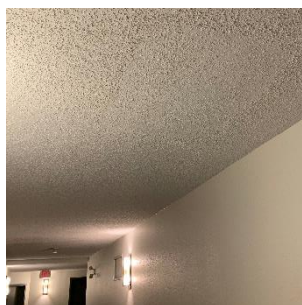
Figure 2 - 2nd Floor Leaks Location

There have been 12 water leak incidents since 2016. Bulk of leaks appear to be pin hole leaks in copper lines. A major leak occurred in 2018 in a section of larger piping in the crawl space. There have also been two leaks shown by drywall repairs in the ceiling of the second floor from the 3/4" recirculation line shown in Figure 2.

Most of the recirculation line leaks appear to be between the first risers and the hot water tanks. This would indicate that the first risers are receiving more flow than the rest likely due to no balancing of the system.

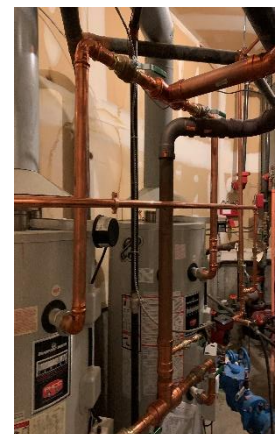
Figure 1 - DHW Tanks

The DHW system consists of two 65 gal hot water tanks located in the mechanical room as shown in Figure 1. The supply lines are then routed through the crawlspace and up through risers to a 3/4" recirculation line in the ceiling of the second-floor hallway.

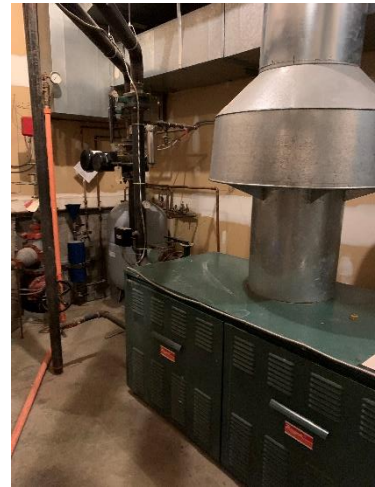
Figure 3 - Hydronic Boiler

All rooms in the building are heated by base board heaters. A water boiler system, shown in Figure 3, feeds piping to each units' heaters and zone valves are actuated to control flow based on the thermostat setting.

There are two pumps in the system for flow that are plumbed in parallel with only one running at time. They are fixed speed operated with no flow control for different levels of demand. Much of the system was not visible as mostly located in units. The system is heated by a 1188 MBH non-condensing boiler at a design temperature of 82°C (180°F) and is vented through a common 18" vent to the roof.

Majority of the leaks in the hydronic system have been at zone valves. Since the pumps for the system run at a single speed and are continuous this can result in large flow to the valves depending on how much demand there is in the system. Honeywell also indicated that the existing pumps were starting to leak and were due for a service during the summer of 2018, there was no indication if this was completed.

The boiler is the original and is 25 years old now which is pushing the expected life span. However, the boiler is still operating and there was no indication on the provided documentation that heating of units is a problem. Thus, there is no reason why it can't remain in service with regular maintenance. The risk of waiting for a replacement is that it could fail at an inopportune time when the outside temperature is below zero. This would result in a more expensive replacement, and potential repairs to other components in the system, and increased stress for all parties involved.

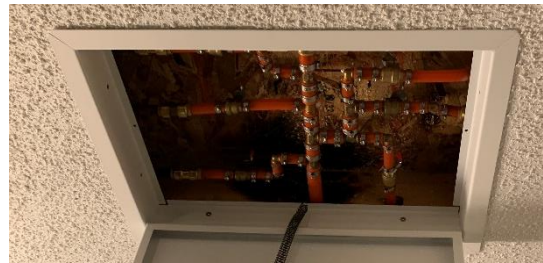
Figure 4 - 2nd Floor Ceiling

All lines in the crawl space and the visible areas of the recirculation line in the ceiling of the second floor are not insulated. There does not appear to be any balancing valves for each of the risers to ensure equal recirculation flow to all. Much of the copper piping is type M while some of the repaired lines in the second-floor ceiling have been replaced by PEX as shown in Figure 4.

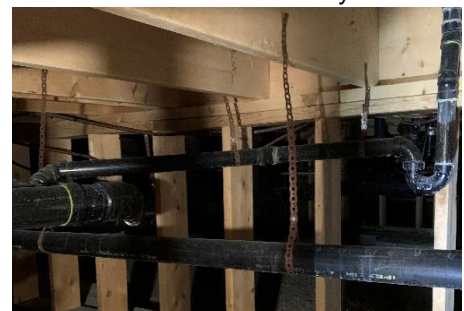
Figure 5 - Sanitary Drainage

The only visible drainage is in the crawl space. Visual inspection showed many of the drains having slope issues and pipe supports missing.

No matter how much effort is put in to ensuring proper drain slopes and pipe supports all drainage systems are reliant on minimal grease and hair being put down drains. The number one solution to drainage blockages will be tenant education to ensure compliance.

To limit the effect of grease, ensuring that all piping has proper slope and support is the next best solution. If water is not able to sit and build grease on the walls it is less likely to accumulate blockages.

Blockages can still develop even if increased education, proper pipe slopes and supports are implemented. It is recommended that a periodic maintenance plan to clean drainage piping should be implemented to reduce surprise blockages.

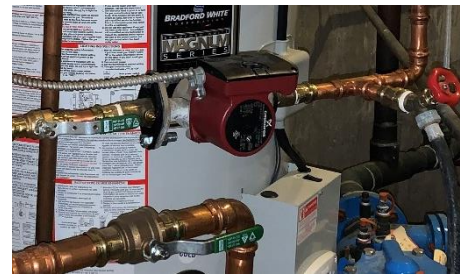
Figure 6 - DHW Recirculation Pump

The drawings while hard to read indicate the pump to be a Grundfos UP 15-18 SBU pump with 0.5 L/s flow at 1 m of head. The actual pump installed is a UPS 15-58 FC and was set on the low setting as shown in Figure 6 and the pump curve can be found in appendix C. To confirm the flow rate in the piping a rough estimate was complete as no flow measurements have been completed. The farthest riser from the hot water tank is roughly ~60 m and the closest is ~5 m with the second-floor ceiling being about ~5 m up. Depending on if the system is balanced with equal flow to the farthest riser or being short circuited through the closest riser flows could range from 0.26 to 0.32 L/s (4.1 to 5.1 GPM) which results in 0.84 m/s to 1.02 m/s (2.8 to 3.3 ft/s) flow velocities in a ¾" cooper pipe. It is recommended to keep the maximum flow velocity of hot water in copper piping between 0.6 and 0.9 m/s (2 and 3 ft/s) which results in a flow rate of 0.19 to 0.29 L/s (3.0 to 4.6 GPM) in a ¾" line.
