**PHASE I ENVIRONMENTAL SITE ASSESSMENT
5202 - 51 AVENUE**

**LOTS 21 TO 24, BLOCK 14, PLAN 5868Z
CASTOR, ALBERTA**

PROJECT No.: RD5253

DATE: APRIL 2, 2015

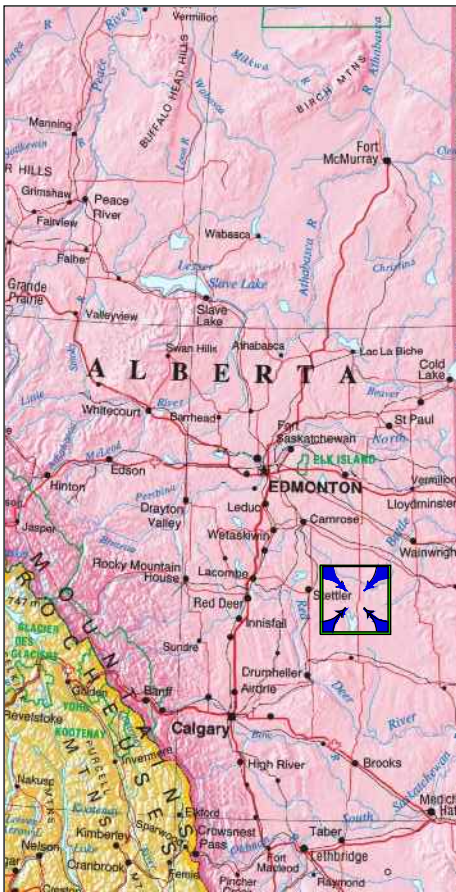
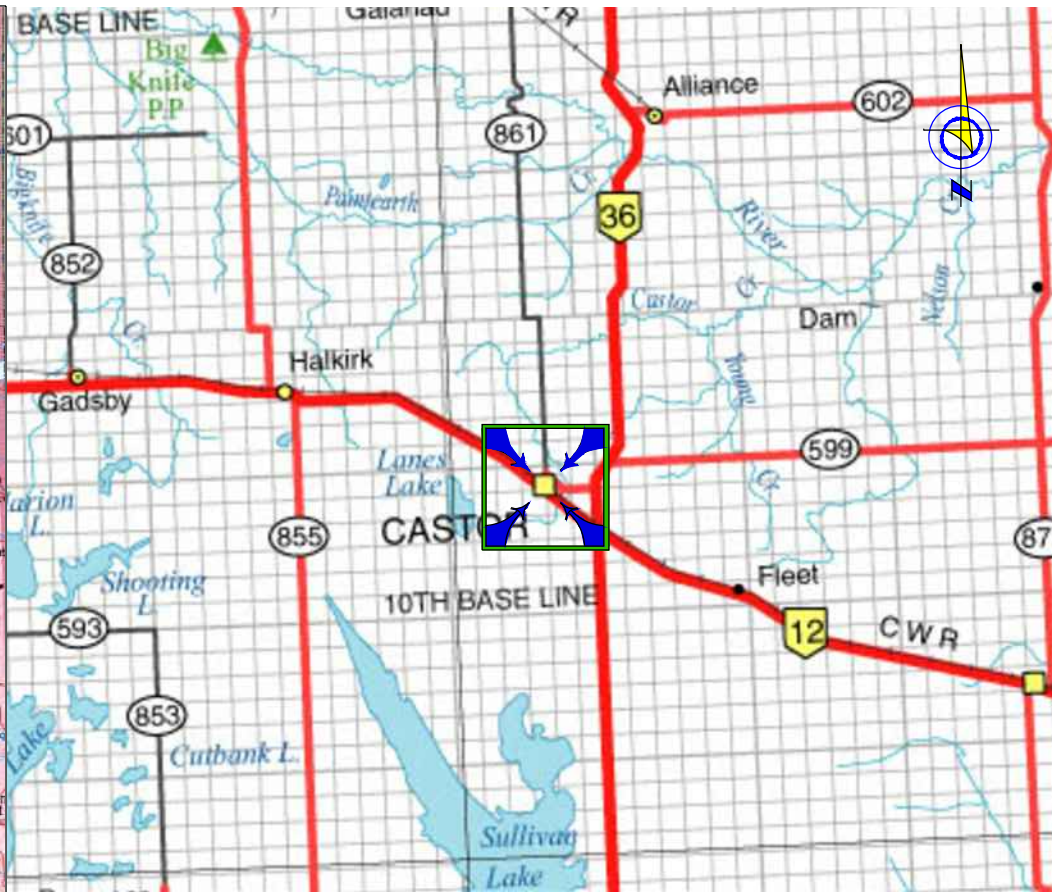
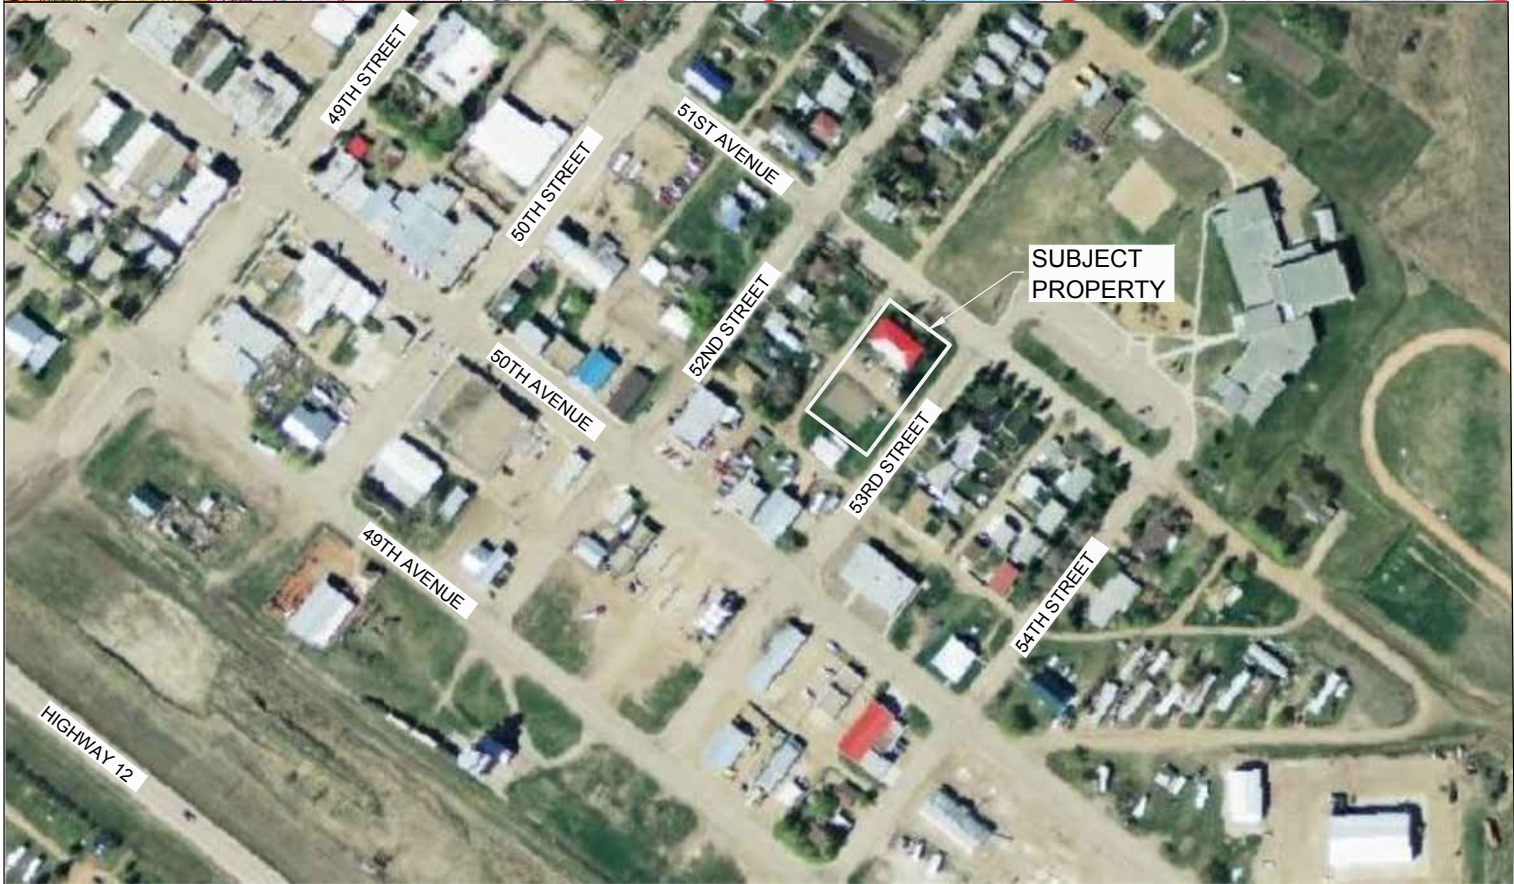
CLIENT:	KEY PLAN		
	REALTY EXECUTIVES RED DEER	PHASE I ENVIRONMENTAL SITE ASSESSMENT 5202 - 51ST AVENUE, CASTOR, ALBERTA		
		DRAWN: MG	CHK'D.: MMc	REV #: 1
		SCALE: NTS	JOB NO. RD5253	DRAWING NO. FIGURE 1

The property is referred to in this report as the “Property”, “Subject Property” or “Site” as shown on Figure 1. The Property in relation to surrounding properties is shown on Figure 2.

The Property was located in a residential area on the east side of the Town of Castor, Alberta (Figure 1). The Property was developed with a two storey multi-unit residential building. A gravel surfaced parking area with electrical outlets was located southwest of the building. The remainder of the Property was grass surfaced which had snow cover at the time of the inspection (Photographs 1 to 3; Figure 3).

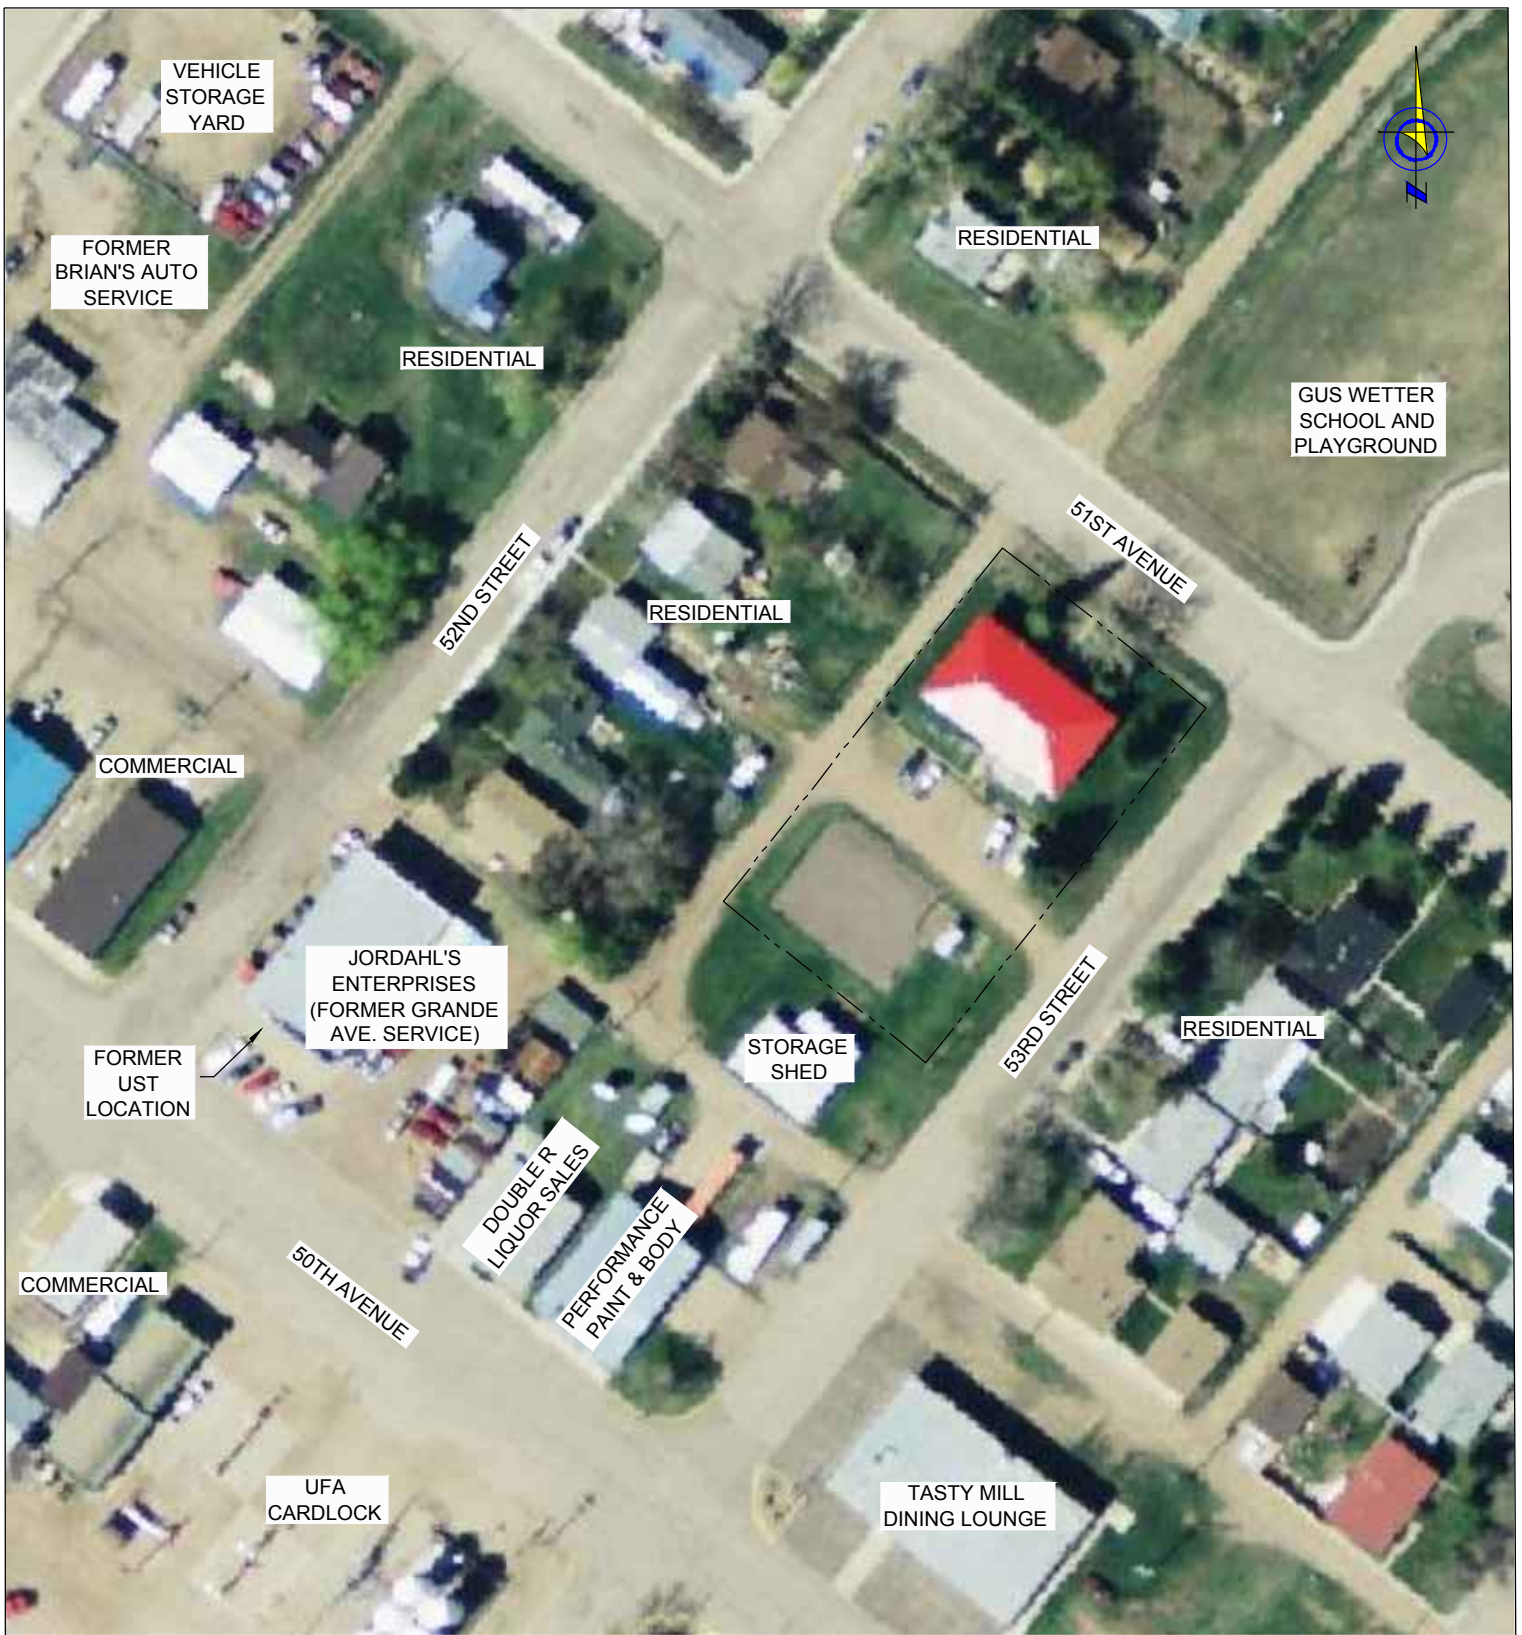
CLIENT:	AREA PLAN		
	REALTY EXECUTIVES RED DEER	PHASE I ENVIRONMENTAL SITE ASSESSMENT 5202 - 51ST AVENUE, CASTOR, ALBERTA		
		DRAWN: MG	CHK'D.: MMc	REV #: 1
		SCALE: 1:1000	JOB NO. RD5253	DRAWING NO. FIGURE 2

The Property was bound to the north by 51st Avenue, to the northwest by residential development and 52nd Street, to the southeast by 53rd Street and residential development, and to the south and southwest by commercial development (Figure 2).

The Property was surrounded by residential sites to the north, northwest and southeast, commercial development to the southwest and a school to the northeast. The Property was bound to the north by 51st Avenue and to the southeast by 53rd Street (Figure 2).

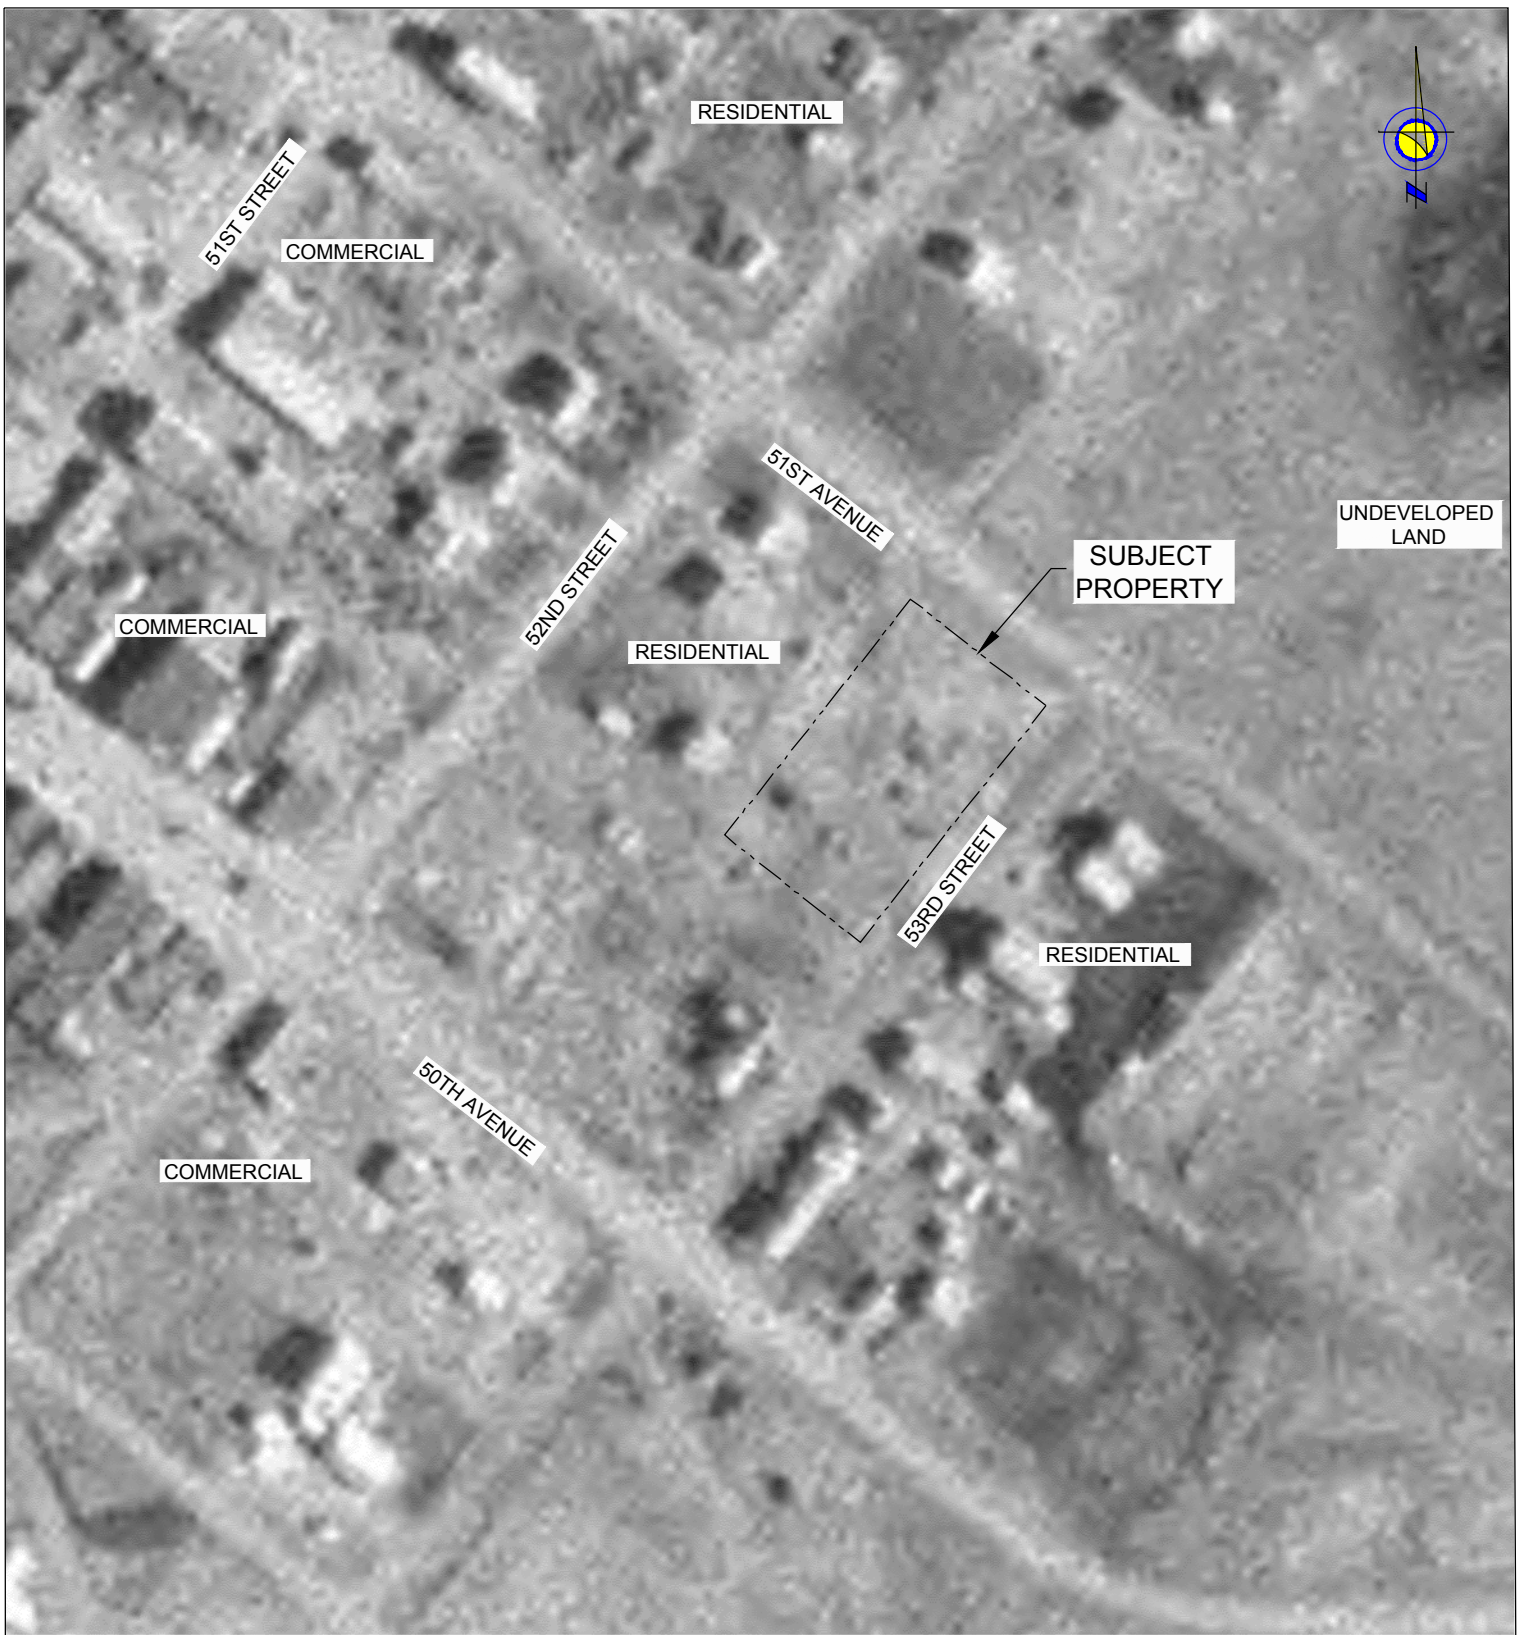
CLIENT:	1950 AERIAL PHOTOGRAPH		
	REALTY EXECUTIVES RED DEER	PHASE I ENVIRONMENTAL SITE ASSESSMENT 5202 - 51ST AVENUE, CASTOR, ALBERTA		
		DRAWN: MG	CHK'D.: MMc	REV #: 1
		SCALE: 1:1500	JOB NO. RD5253	DRAWING NO. FIGURE 4

Year	1950	<ul style="list-style-type: none"> The Property was undeveloped land and was bound to the north by 51st Avenue and to the southeast by 53rd Street. Residential development was present to the north, northwest, and southeast. 51st Street, 52nd Street and 50th Avenue were developed to the west and south. Commercial development was visible to the west and southwest.
Job	49-73D	
Roll	AS154	
Line	5204	
Photo #	129	
Year	1963	<ul style="list-style-type: none"> The Property was developed with a building and parking lot. Residential development to the southeast was no longer visible. A school was developed to the northeast. Commercial development expanded to the southwest. Residential development expanded to the north.
Job	63-73D	
Roll	AS868	
Line	5205	
Photo #	11

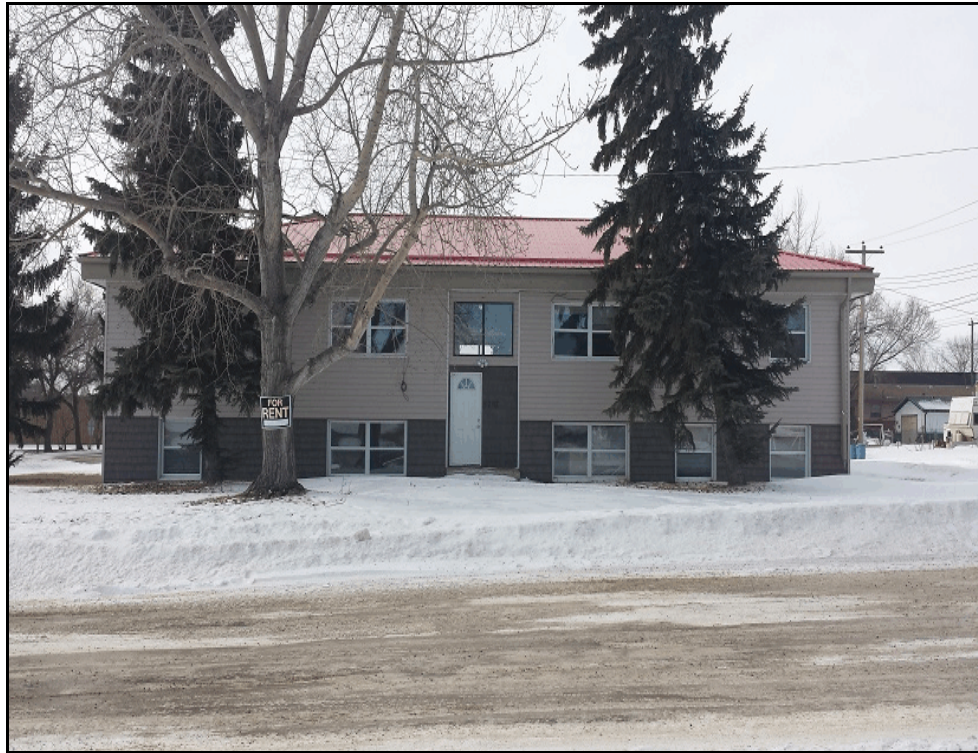
Photograph 1: Facing south from 51st Avenue at the Property, showing the exterior finishes of the apartment building with the back alley to the right (March 5, 2015).

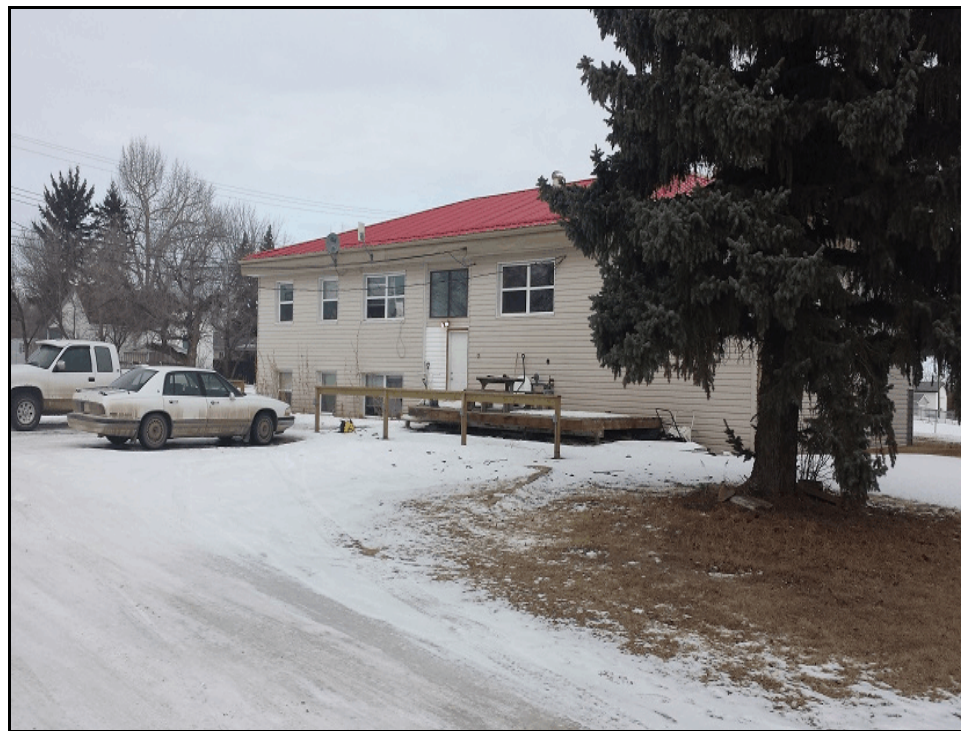
Photograph 2: Looking north at the back entrance of the apartment building and the parking stall area (March 5, 2015).

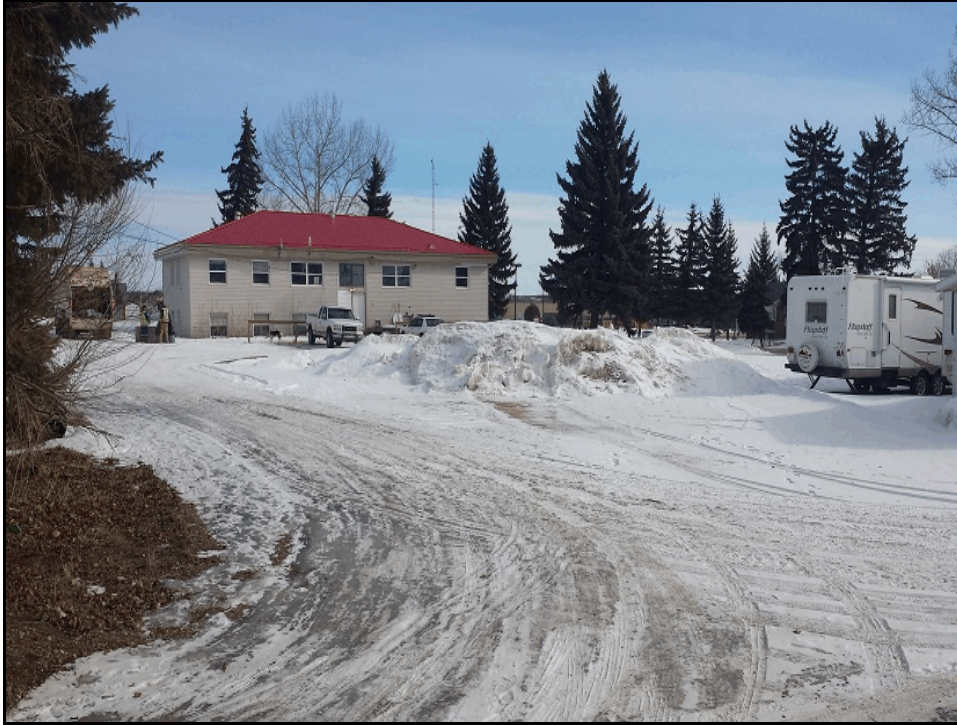
There were no liquid discharges observed from the Property other than storm water. All storm water flow was directed towards 53rd Street to the southeast (Photograph 3).

Photograph 3: Looking northeast across the back alley at the yard of the Property which featured a stockpile of cleared snow from the parking area at the time of the inspection (March 5, 2015).

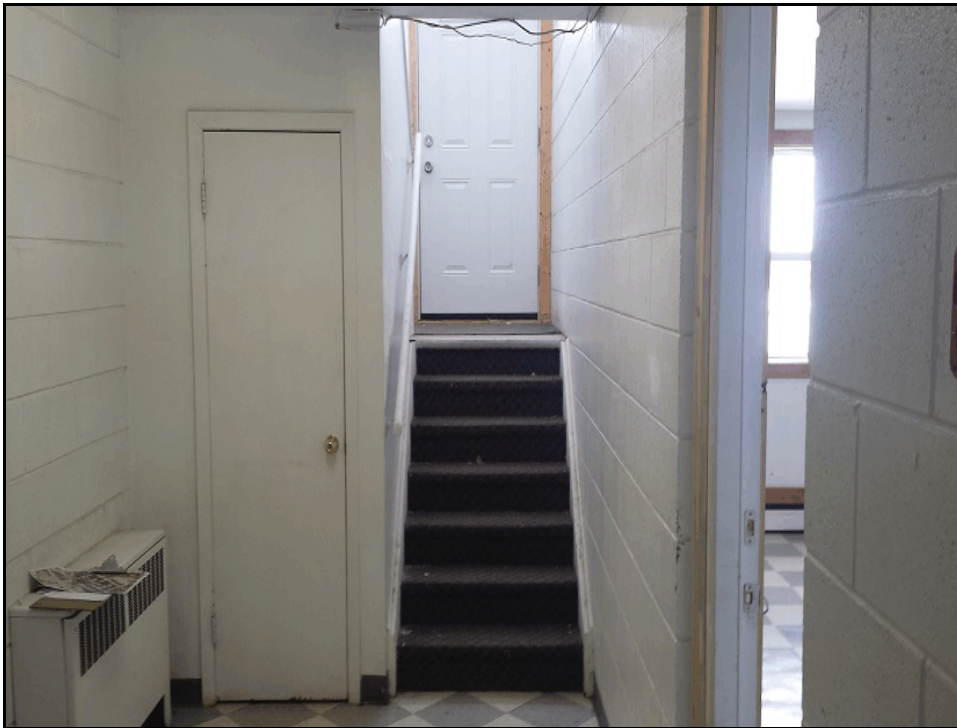
The two-storey building had vinyl and wood siding, a metal clad roof and consisted of seven residential units, a laundry room, storage room and utility room. The hallways and the two inspected units had painted concrete block and drywall finishes, with carpet, vinyl tile and wood laminate flooring, and fluorescent and incandescent lighting. Fire alarms and emergency lighting were noted in the hallways. The rental unit kitchens had wood cabinets, laminate counters and ceramic tiles. Baseboard heaters, mercury thermostats and electric panels were noted in both units (Photographs 4 to 8).

Photograph 4: Showing the lower level hallway of the building, with vinyl tile flooring, painted concrete block finishes and baseboard area heater (March 5, 2015).

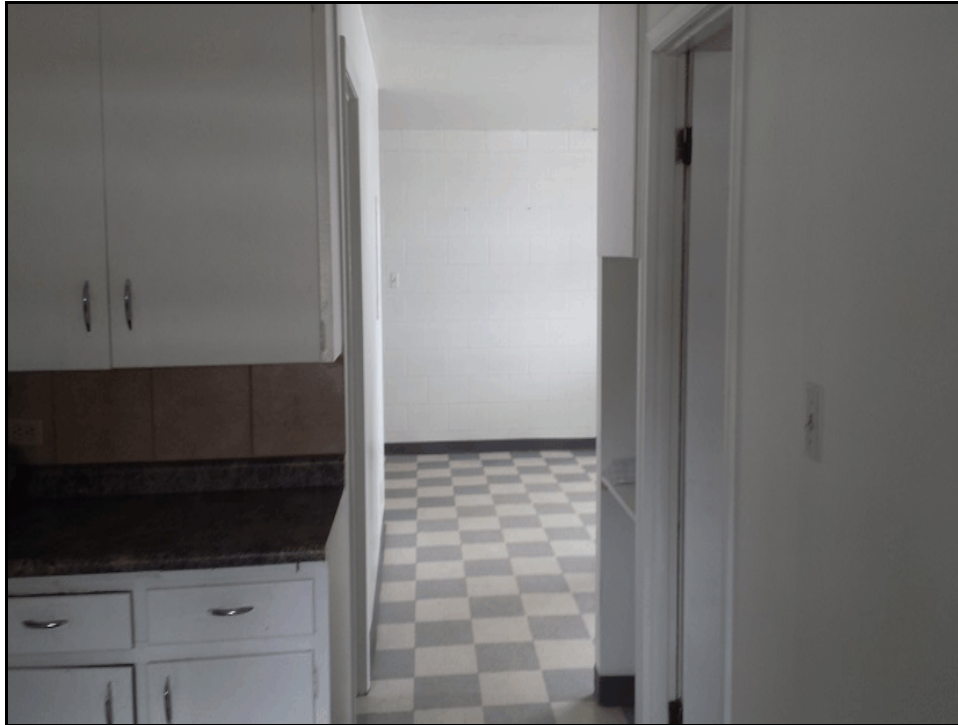
Photograph 5: Looking at the kitchen and living room of a rental unit in the building. Showing wood cabinets, laminate counter and ceramic tile finishes in the kitchen, and painted drywall and vinyl flooring throughout the rental unit (March 5, 2015).

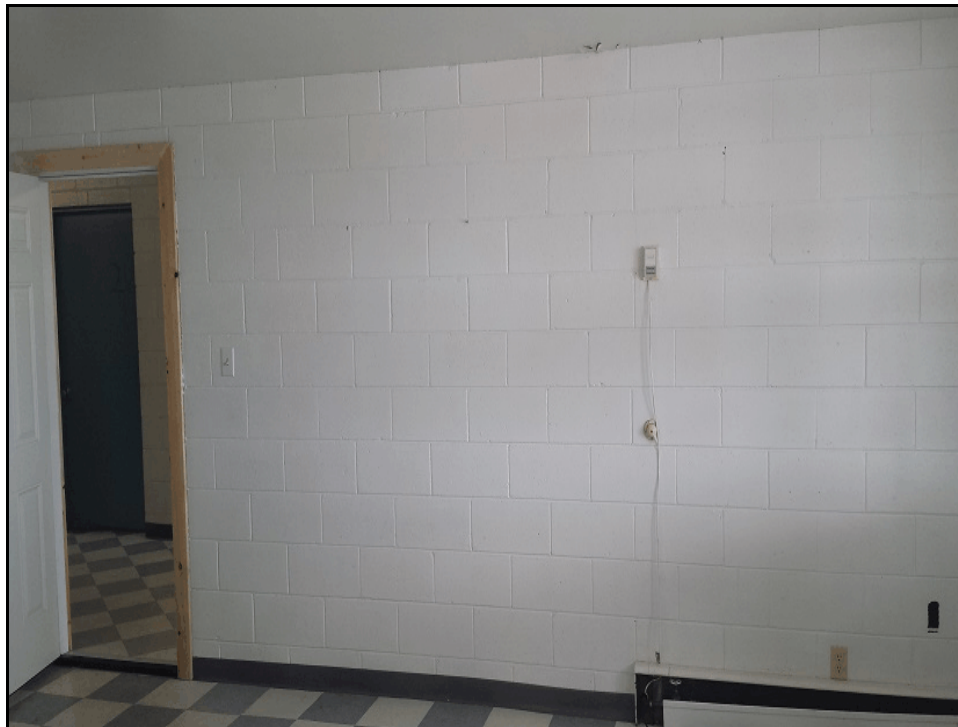
Mercury-containing thermostats were noted during the building inspection.

Photograph 6: Showing a mercury thermostat, baseboard heater and painted concrete block finishes in one of the rental units (March 5, 2015).

Due to the age of the building, asbestos containing materials (ACMs) and other hazardous building materials such as lead paint, fluorescent light ballasts containing PCBs and mercury thermostats may be present. Light ballasts and old mercury containing thermostats must be properly disposed of when replaced.

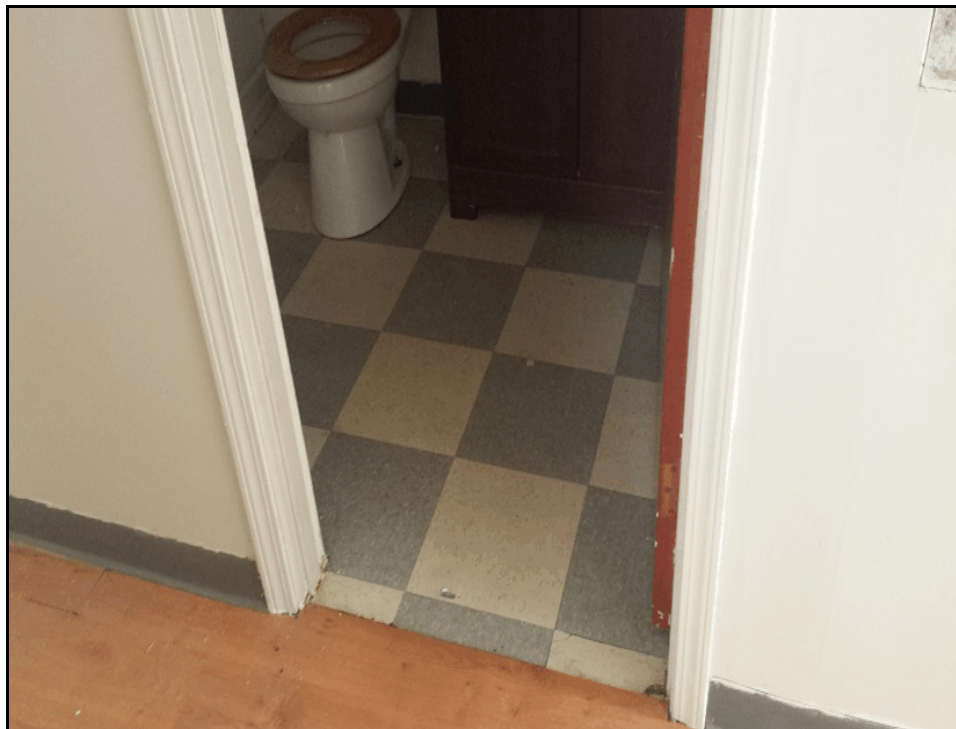
Photograph 7: Looking at the wood laminate flooring overlying vinyl tile noted in one of the renal units (March 5, 2015).

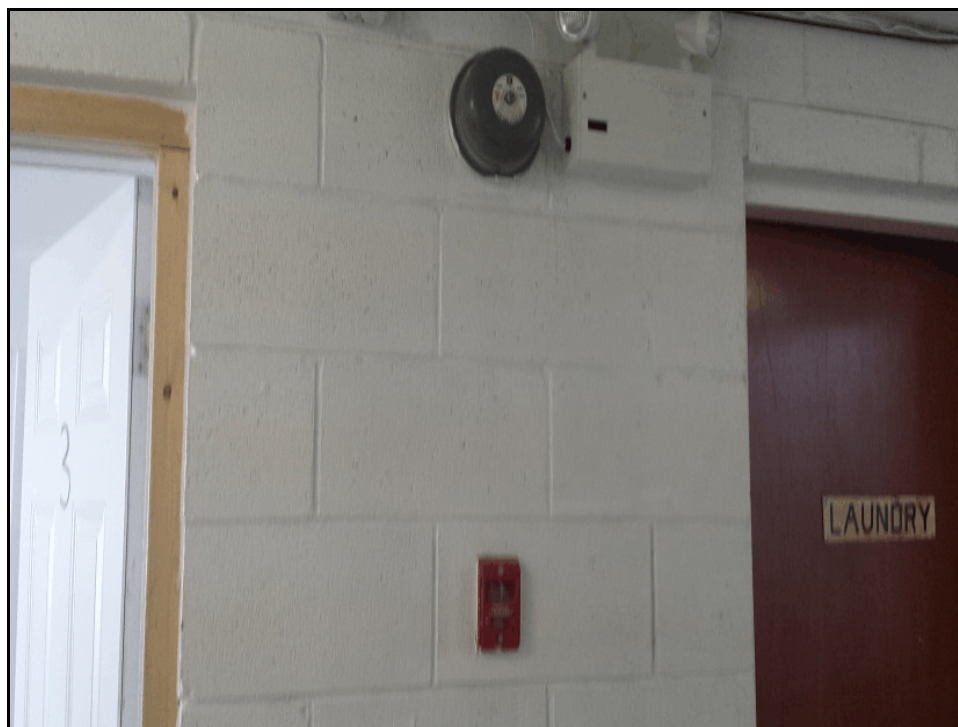
Photograph 8: A close-up of the fire alarm and emergency light system in the hallway of the building (March 5, 2015).

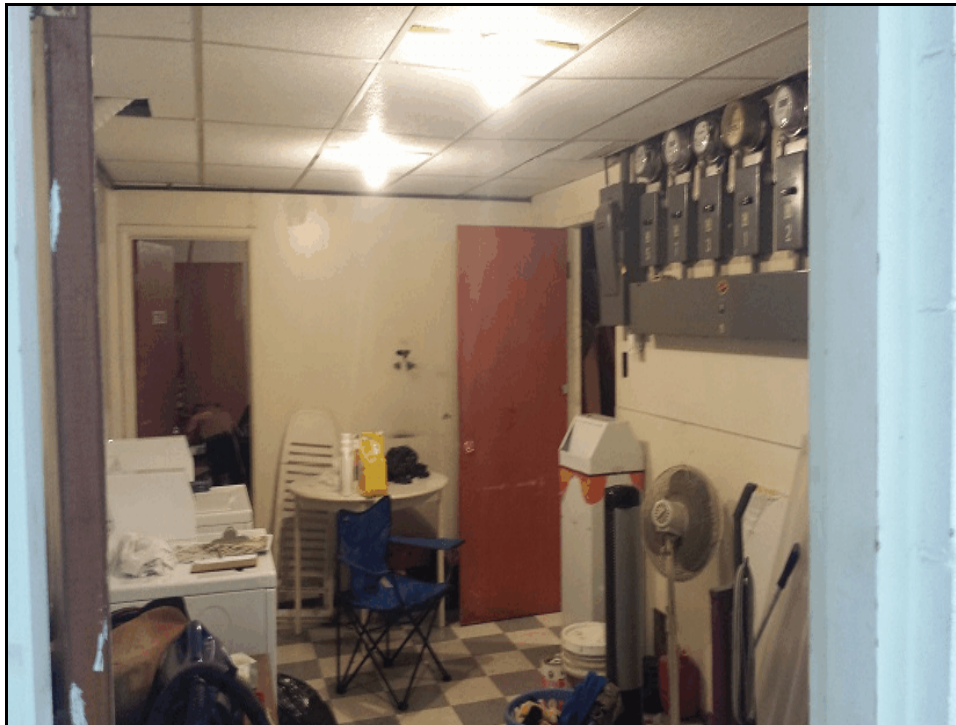
The laundry room was located on the main floor and featured painted drywall, a drop-tile ceiling and vinyl tile flooring. The electrical meters and controls for the building were located in this room, as well as a washing machine and dryer. Miscellaneous storage was noted at the time of the inspection (Photographs 9 and 10).

Photograph 9: Facing the laundry room, showing painted drywall and drop-tile ceiling finishes, vinyl flooring, electric panel meters and controls, laundry machines and miscellaneous storage (March 5, 2015).

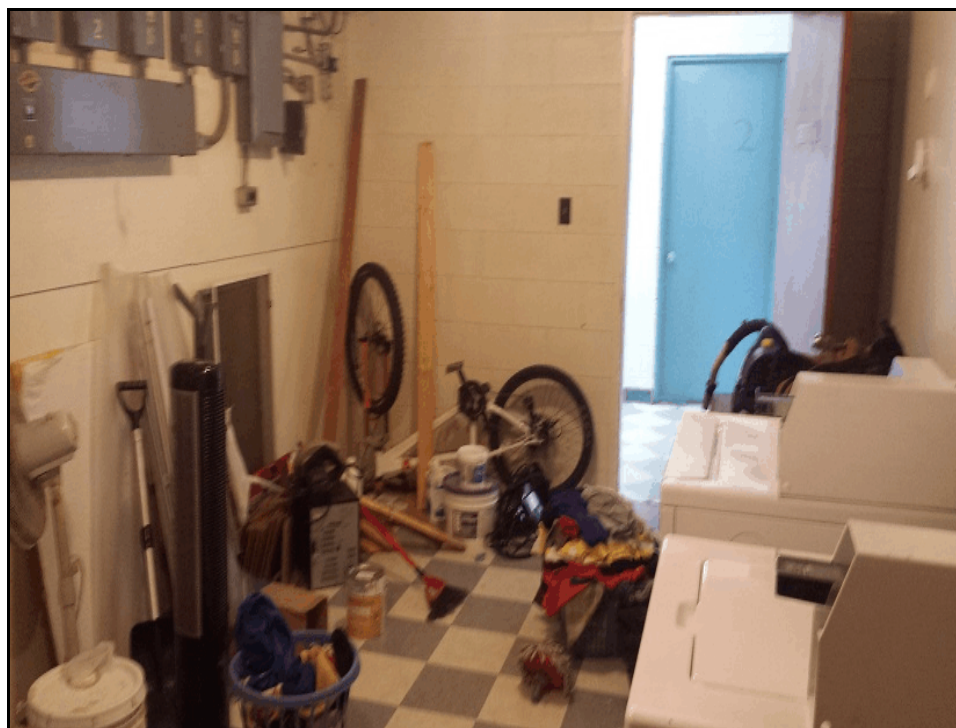
Photograph 10: Viewing the miscellaneous storage in the laundry room at the time of inspection (March 5, 2015).

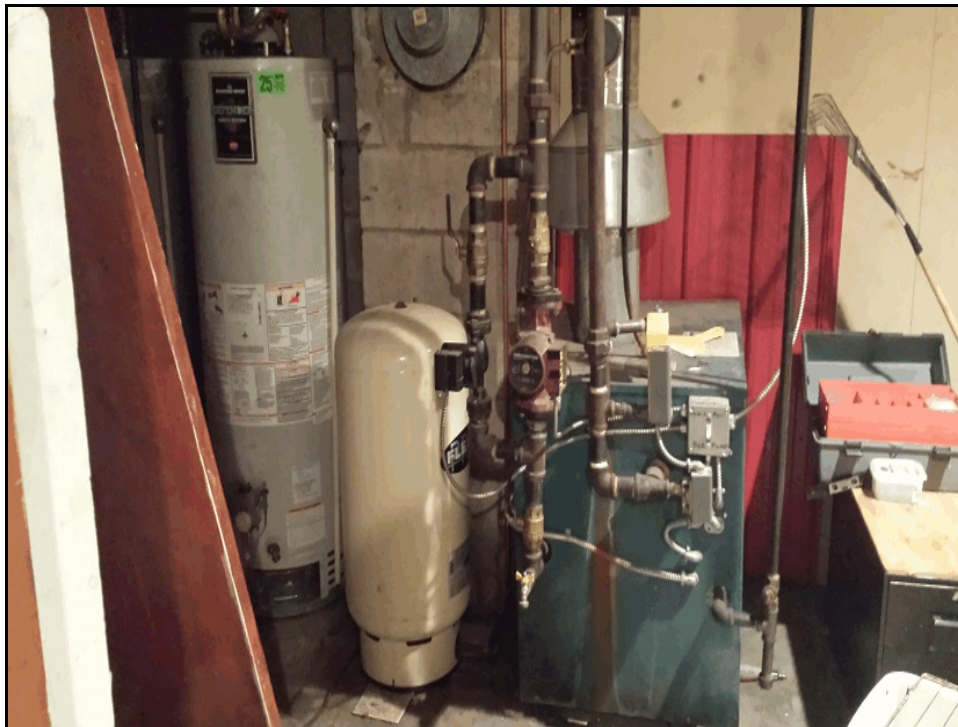
The utility room featured two hot water tanks, the boiler, miscellaneous storage and had unpainted drywall and a concrete floor. A storage room was located beside the boiler room and featured refrigerators, microwaves, cleaning supplies, maintenance equipment and tools. Floor drains were not noted in any of the floors during the inspection (Photographs 11 and 12).

The building heating system featured a boiler, hot water tanks and baseboard heaters. No cooling systems were noted.

Photograph 11: Showing the boiler and hot water tanks in the utility room of the building, with concrete floors, unpainted concrete block and painted drywall finishes (March 5, 2015).

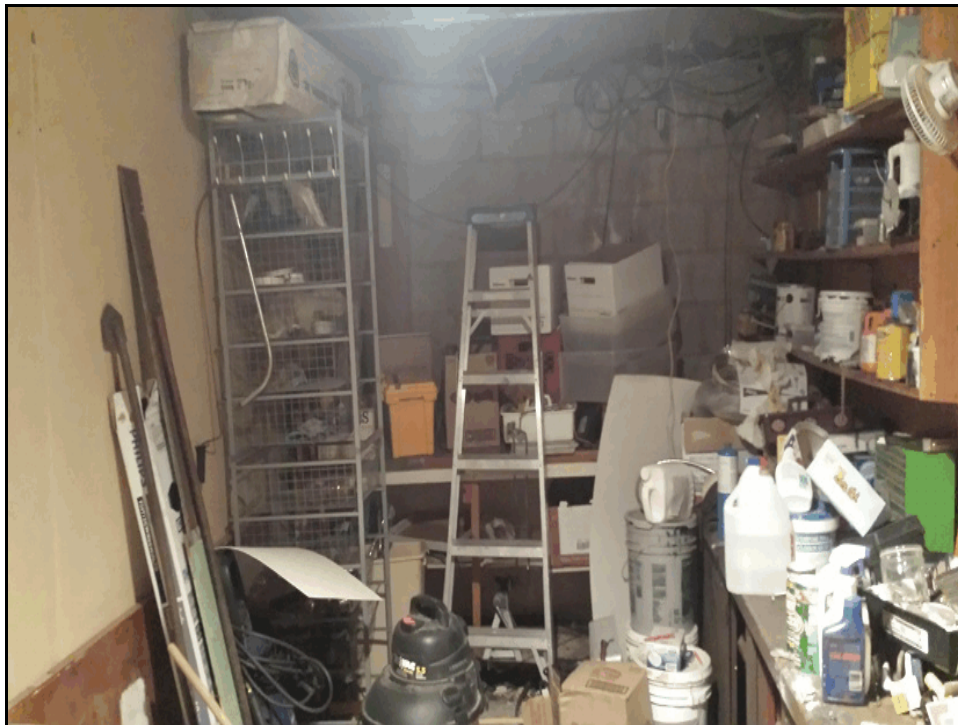
Photograph 12: Facing the maintenance tools, equipment and general storage in the utility room (March 5, 2015).

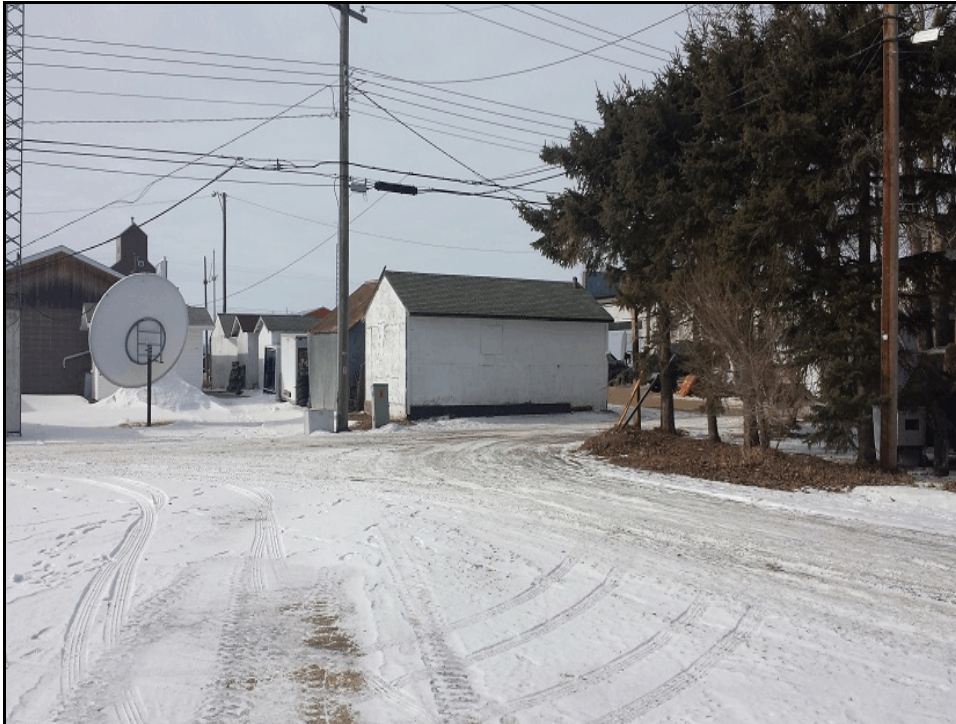
Photograph 13: Facing south from the southwest side of the back alley, showing the adjacent commercial development to the southwest (March 5, 2015).

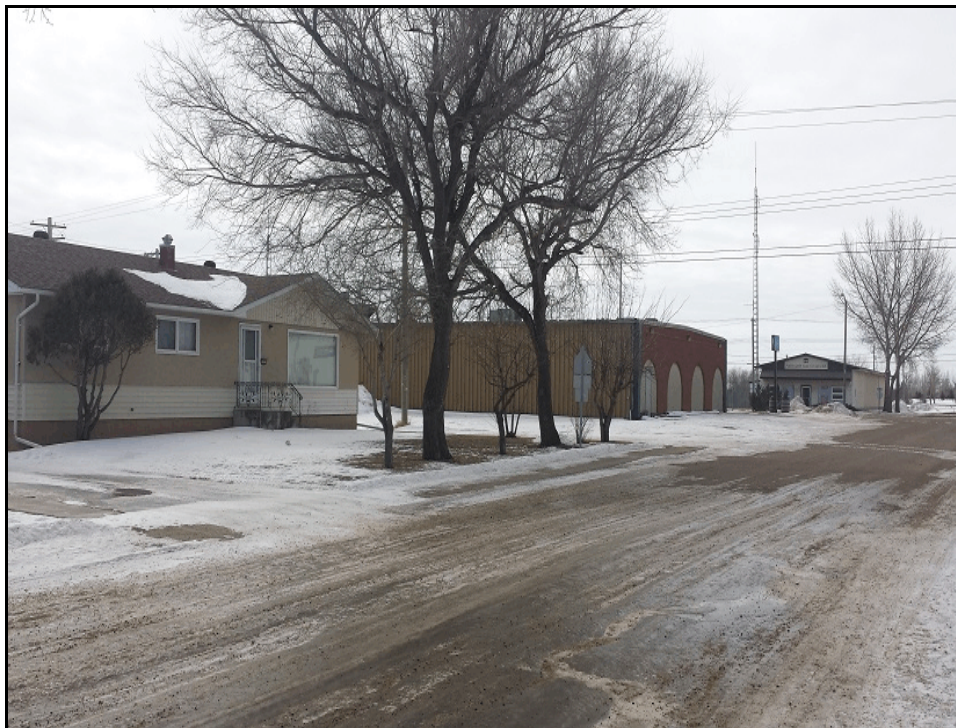
Photograph 14: Looking southeast from 53rd Street at the adjacent residential and commercial development southeast of the Property (March 5, 2015).

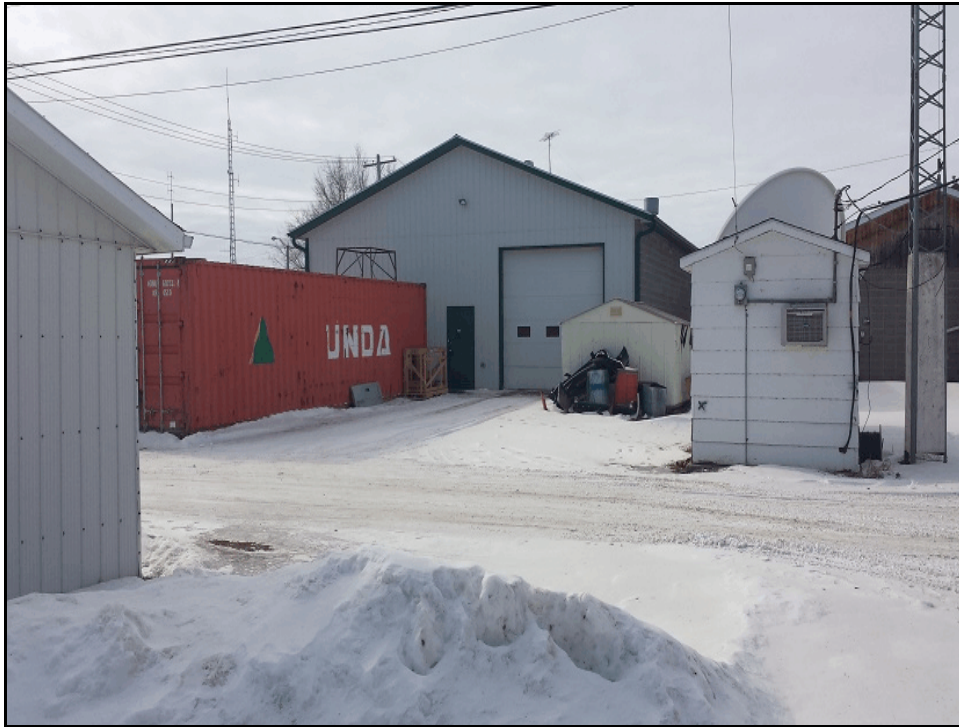
Mr. Bill Schaffner, owner of Performance Paint & Body, was interviewed by ParklandGEO regarding the commercial site to the south of the Property. The site operations mainly included collision repair, paint and body work on vehicles. Mr. Schaffner reported that the site had operated since 1998. The site did not store fuel, waste oil or chemicals in their storage yard. Mr. Schaffner reported no knowledge or concerns of environmental issues for the site and area.

Photograph 15: Looking south from beyond the south boundary of the Property, with an adjacent storage shed site to the left and Performance Paint & Body building and storage yard in the background (March 5, 2015).
