Home Inspection Report

PROPERTY INSPECTED:
5123 5 Street East
Claresholm, AB T0L 0T0

Date of Inspection: 09/06/2022

Inspection No. 1158-1-1475

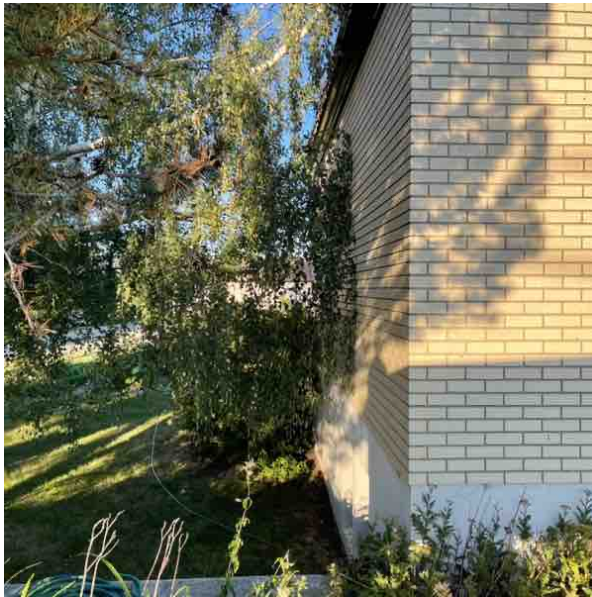
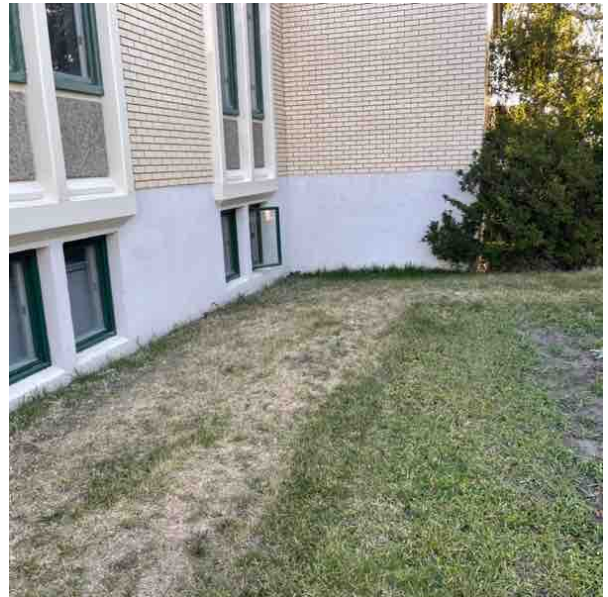
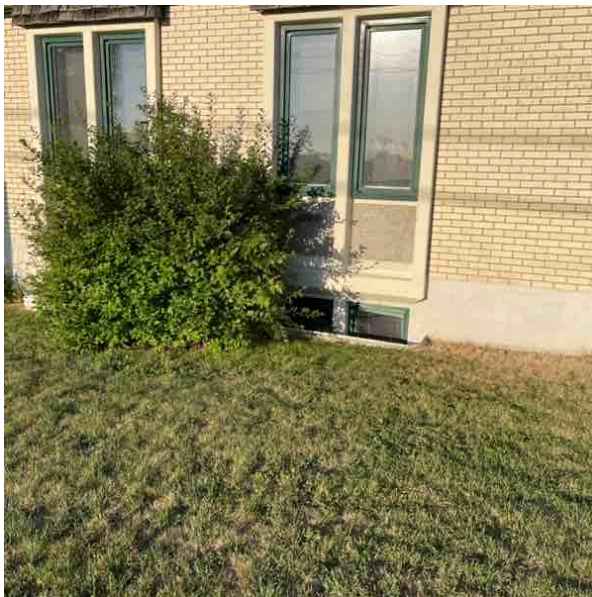
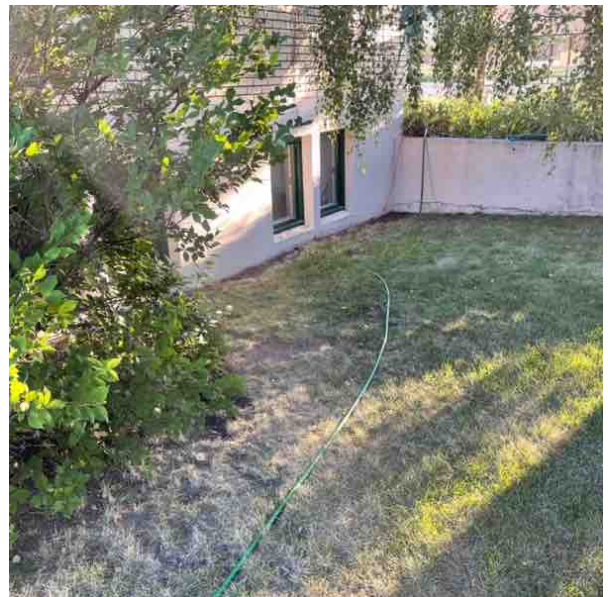
2.2.1 Recommend more slope away from the building, appears to be typical settlement. Soils could be added to achieve proper drainage away from the home

Trees and shrubs around the building are in need of trimming

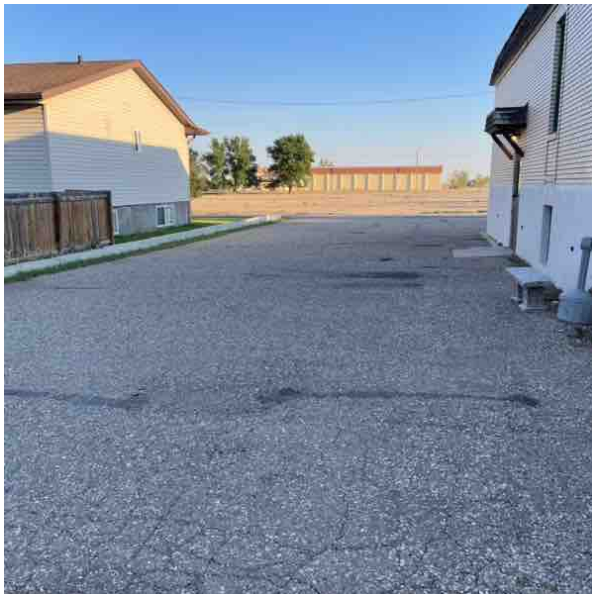
2.4.1 Age typical wear

2.4.2 Worn/deteriorated

2.4.3 Some age typical wear

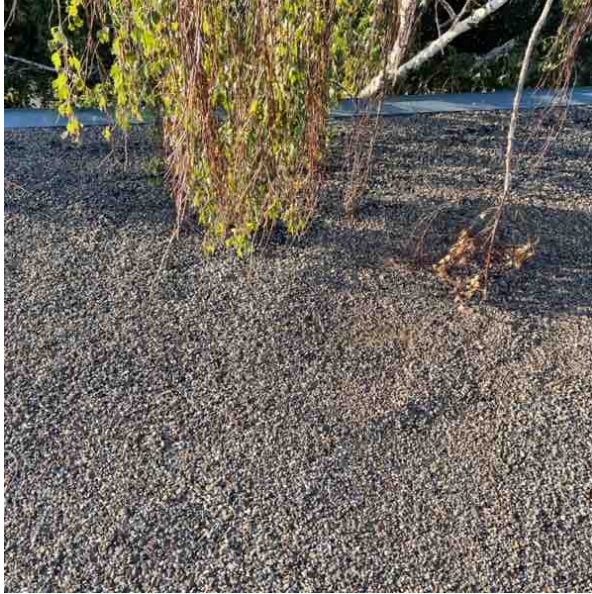
Some visible wear and patched areas. New building owner should budget for repairs, maintenance to roof. Recommend consulting with a qualified contractor as to costs

No visible current leaks at that the time of the inspection. There are some visible stains on main floor ceiling but all were found to be dry at the time of the inspection with the use of a moisture meter

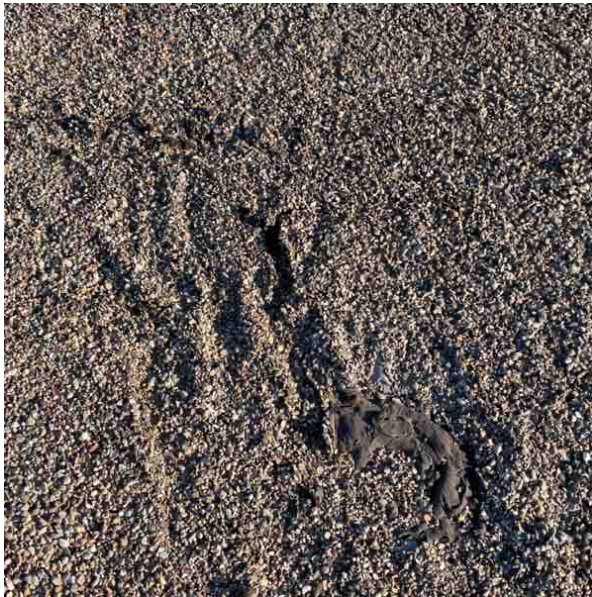
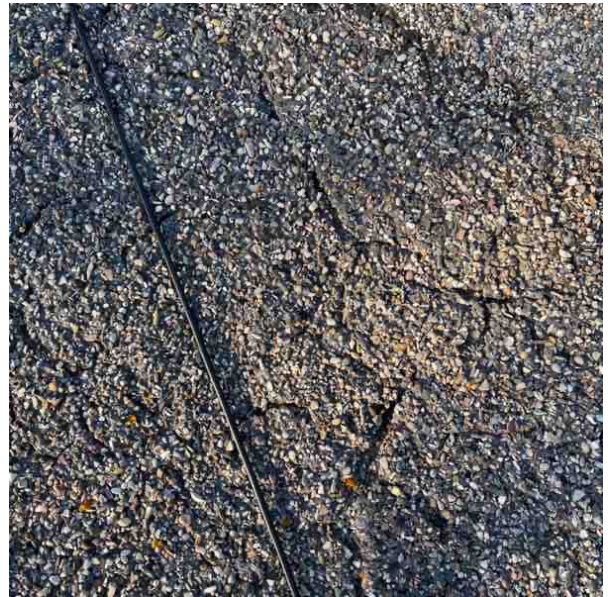
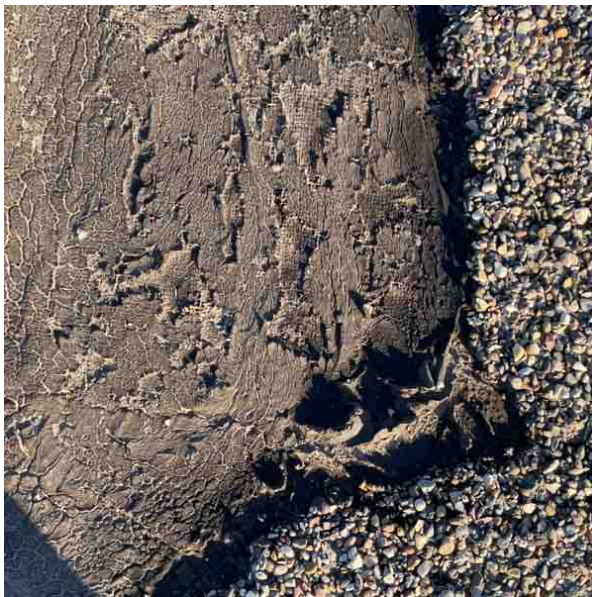
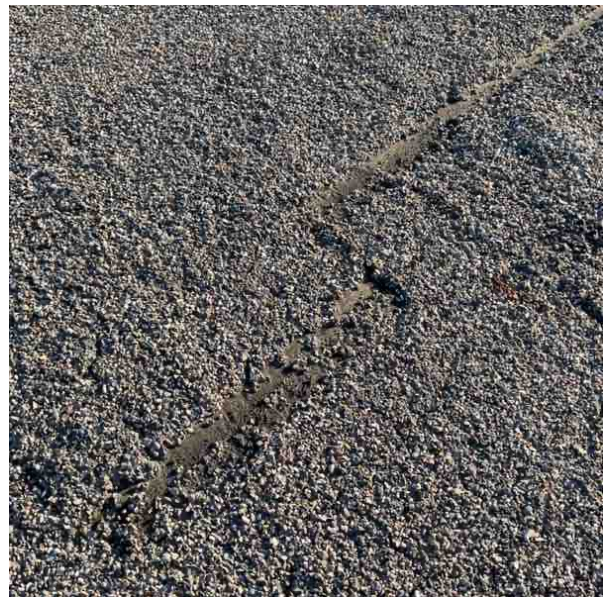
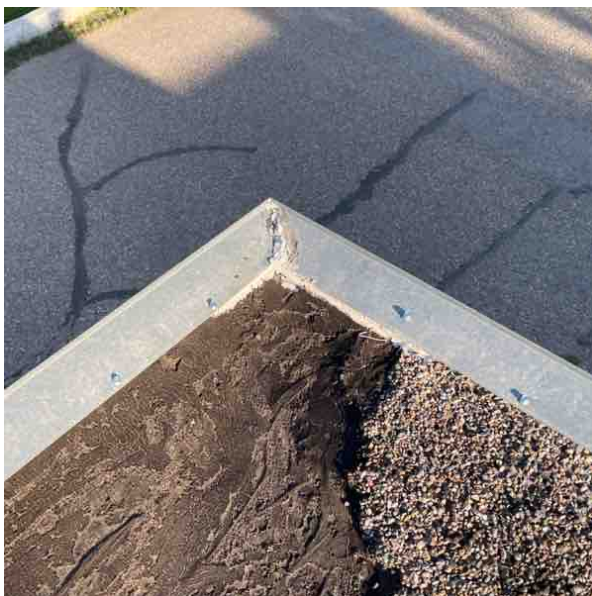
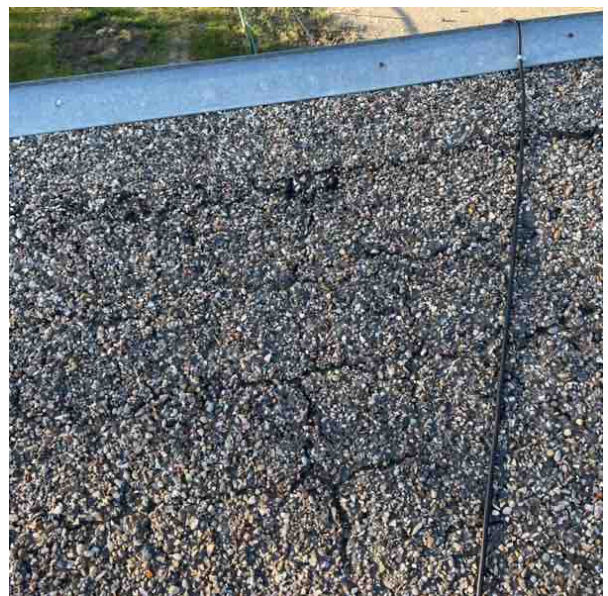
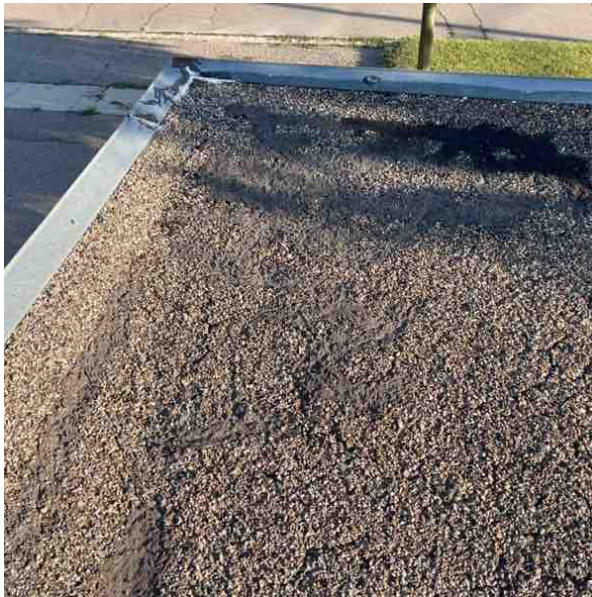
4.3.1 Damaged

4.3.2 Worn/deterioration

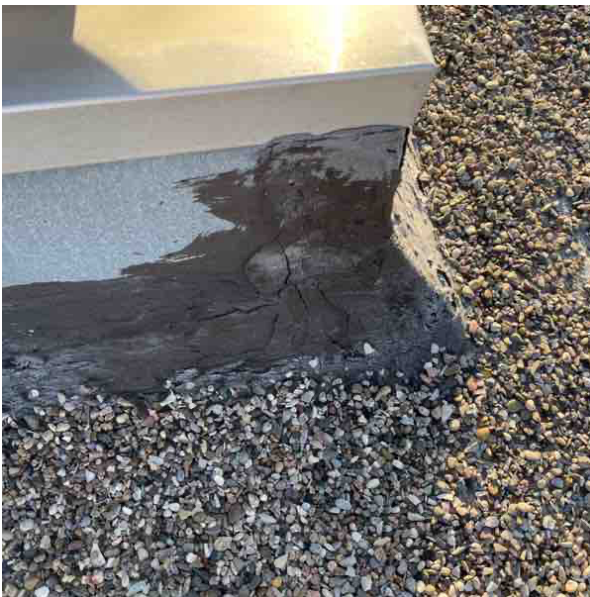
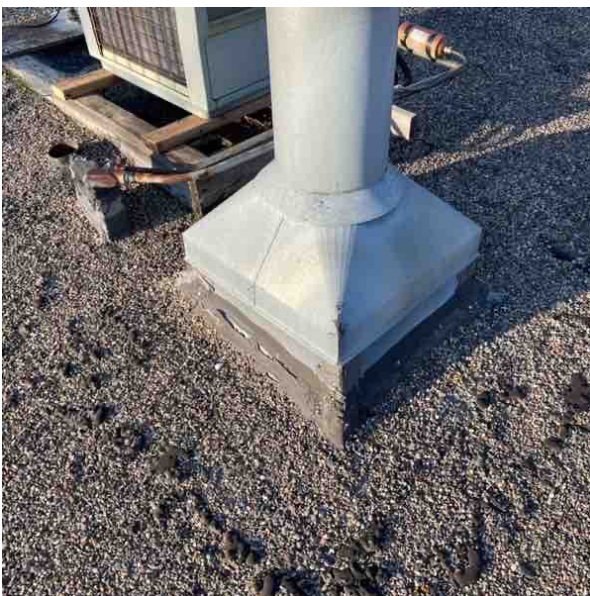
4.4 Flashings

4.4.1 Worn/ deterioration

Some visible worn areas, recommend repairs as needed

4.4.2 **Recommend annual caulking to insure water proof seal**

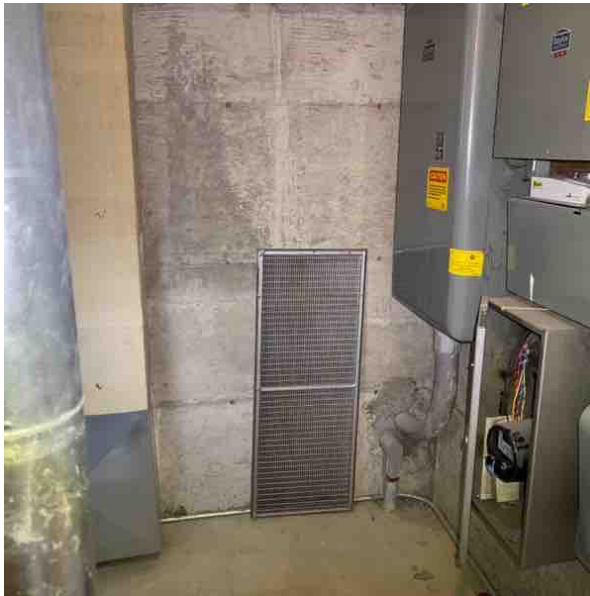
6.3 Foundation

6.3.1 No visible damage

6.3.3 **Where foundation was visible there were no major cracks or signs of settlement or structural issues**

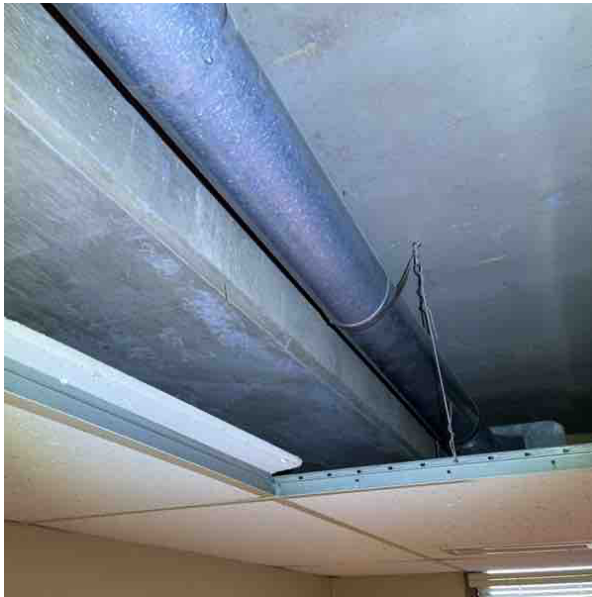
6.4 Support - Post / Beam / Column

6.4.1 No visible damage

6.4.2 **Building is a complete concrete structure. Concrete foundation with concrete main floor.**

No visible current structural issues with the building at the time of the inspection

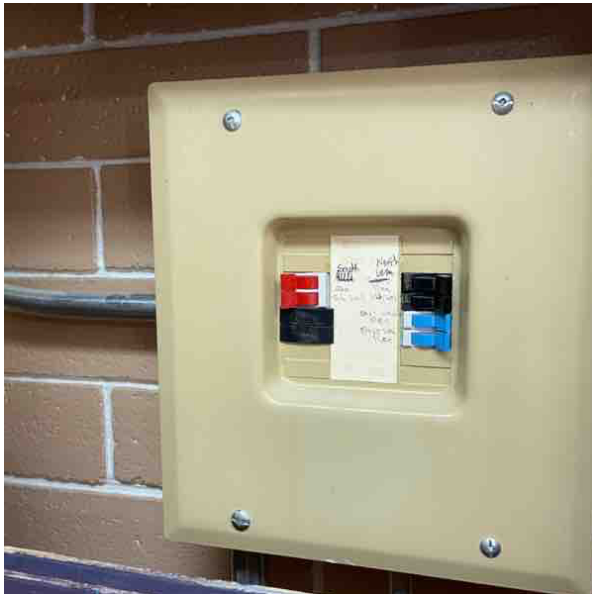
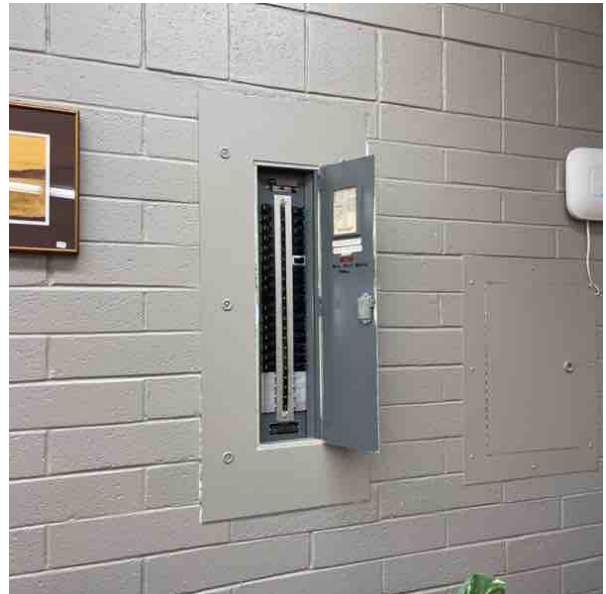
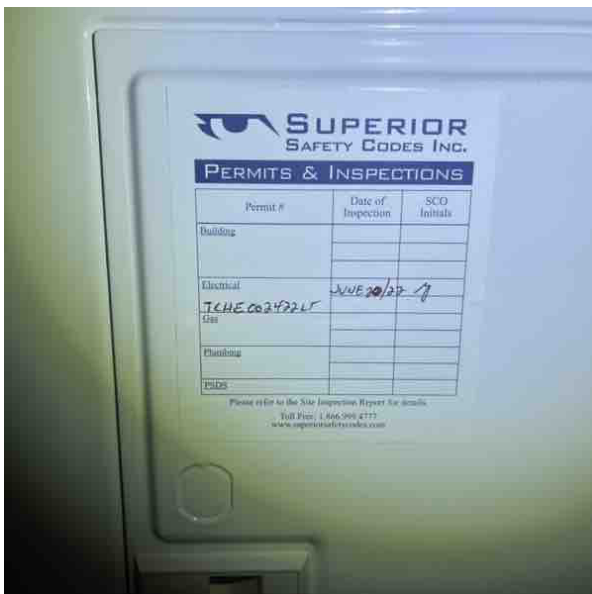
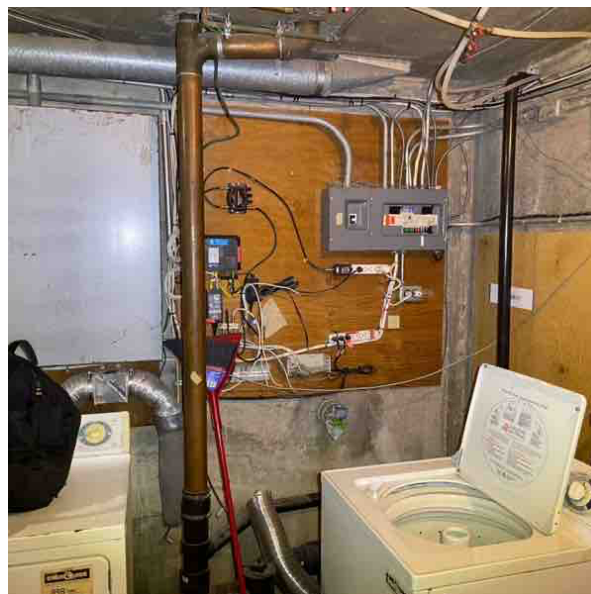
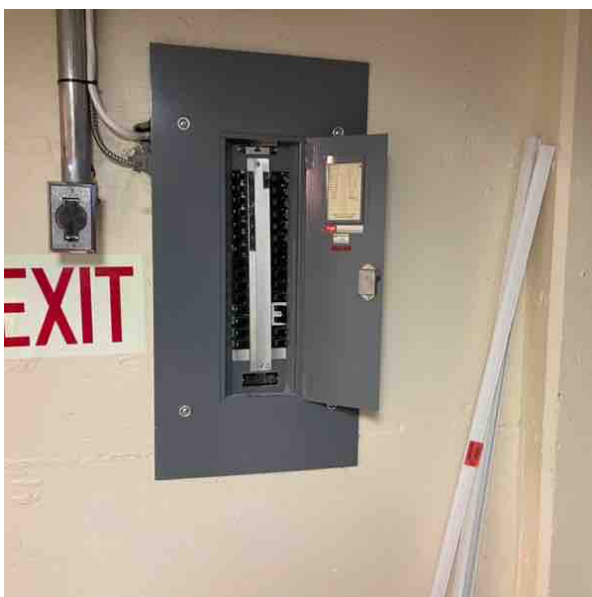
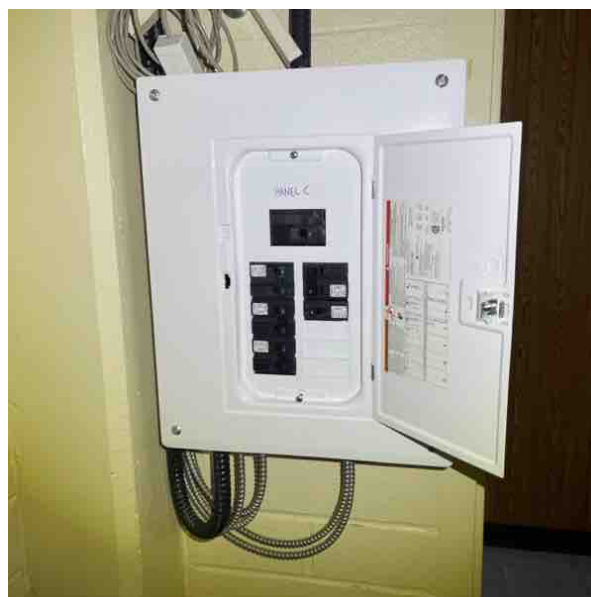
7.5.1 No visible damage

7.5.2 Multiple sub panels through the building.

Some newer wiring from 2022

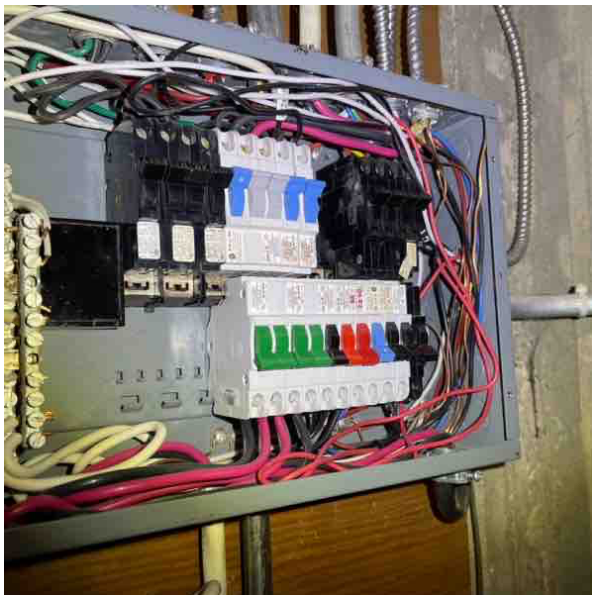
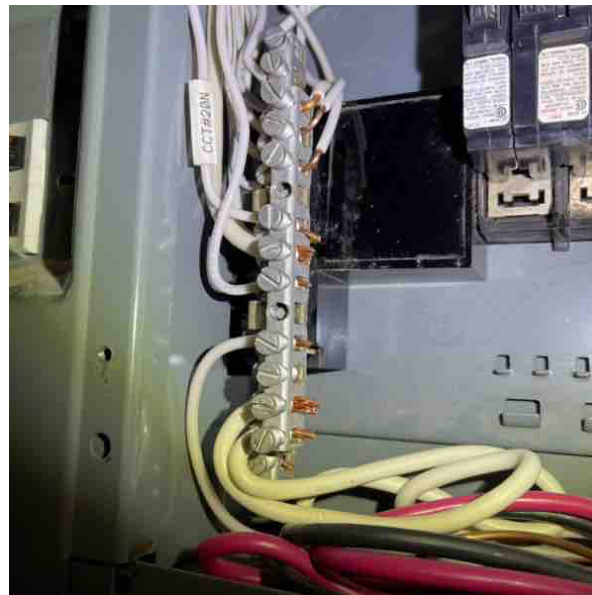
- 7.6 **Branch Circuit Wiring**
 - ⊙ Copper wire branch circuits.
- 7.6.1 Inspected where visible

7.6.2 Copper wiring was visible in panels that were opened

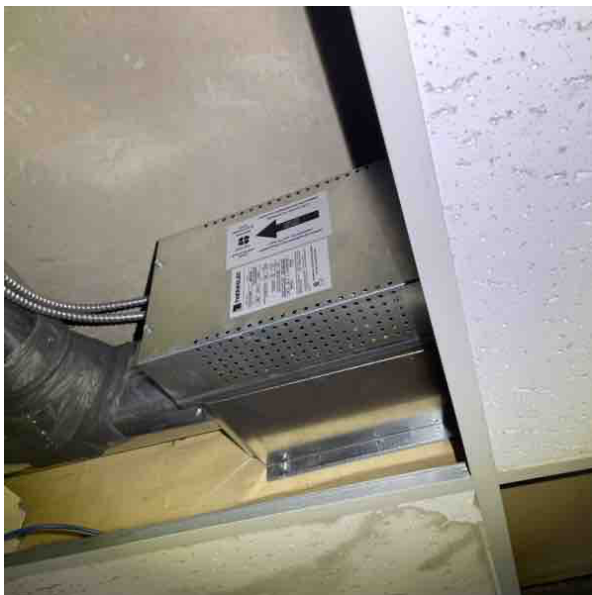
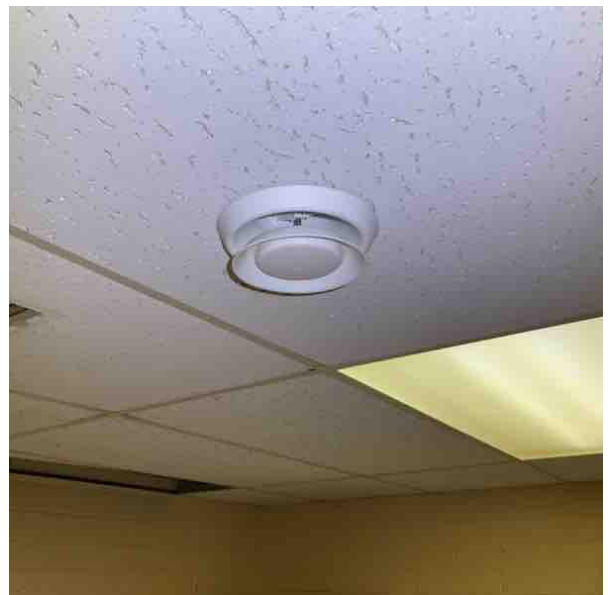
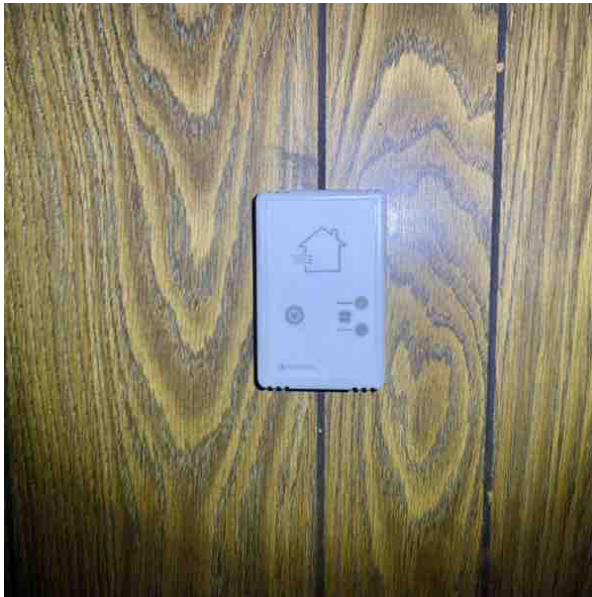
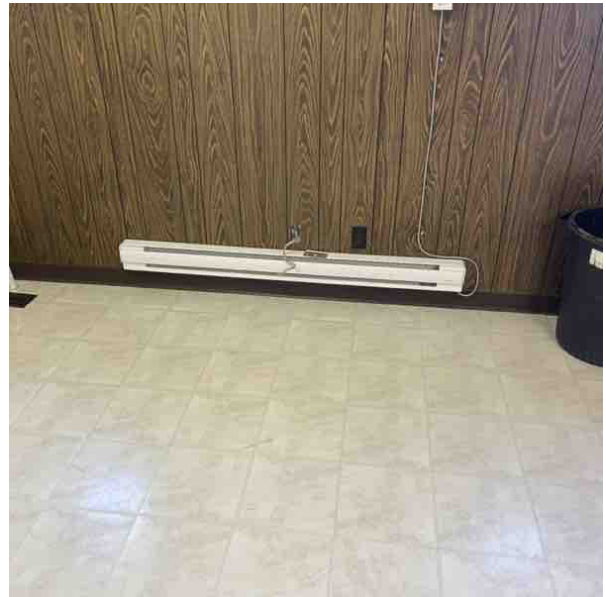
8.1.2 Some limited and operational electrical baseboard heating. In duct work heat system for the future potential suite was operational

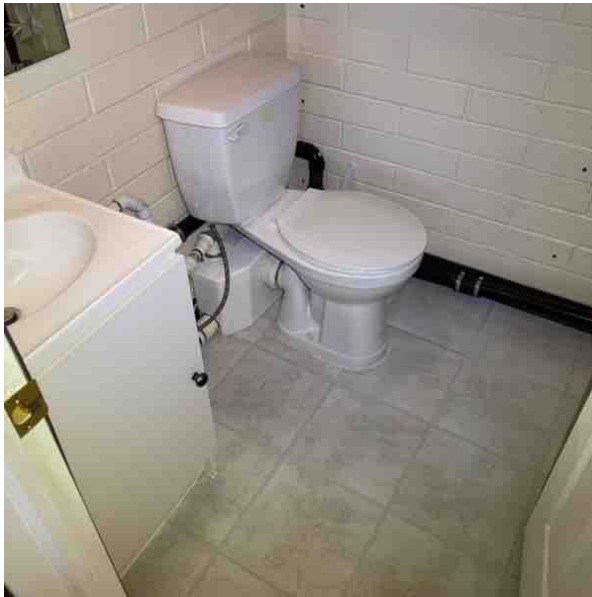
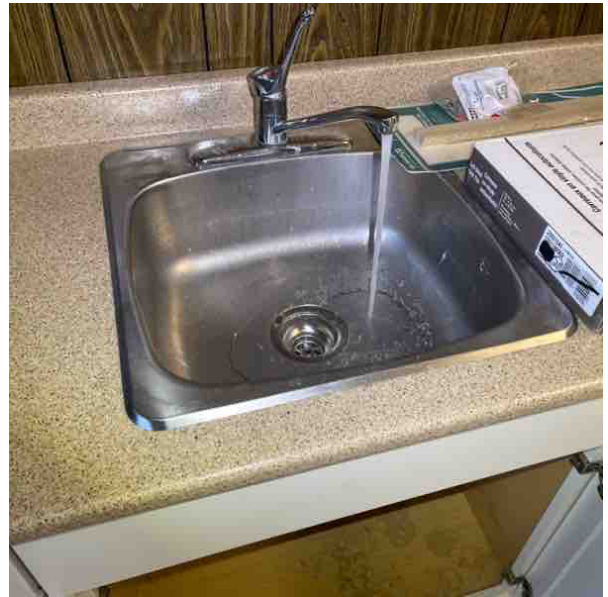
9.2.1 No visible leaks at any sinks, toilets and or showers at the time of the inspection

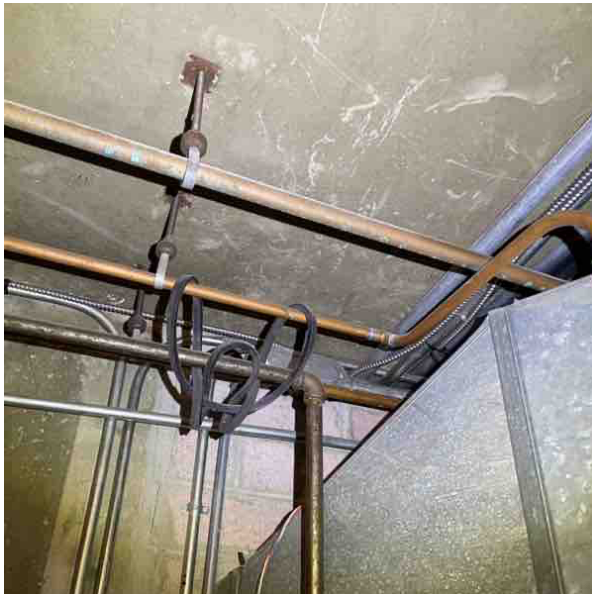
9.3 Distribution Piping

9.3.1 No visible damage

9.3.2 Where piping was visible it was found to be copper and pex piping

No visible current leaks at time of the inspection

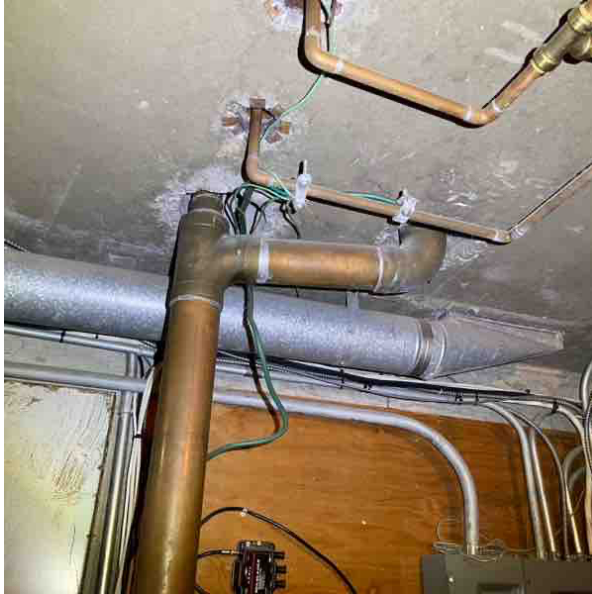
9.4 Drain, Waste, and Vent Piping

9.4.1 No visible damage

9.4.2 **Where piping was visible it was found to be Abs and copper piping**

No visible current leaks at the time of the inspection

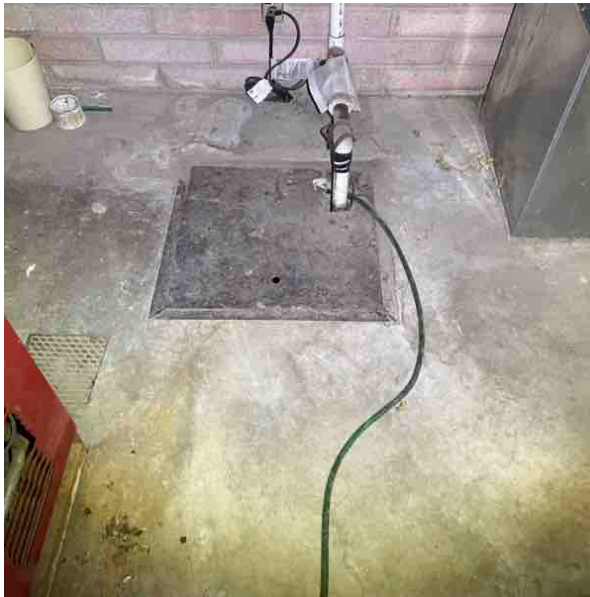
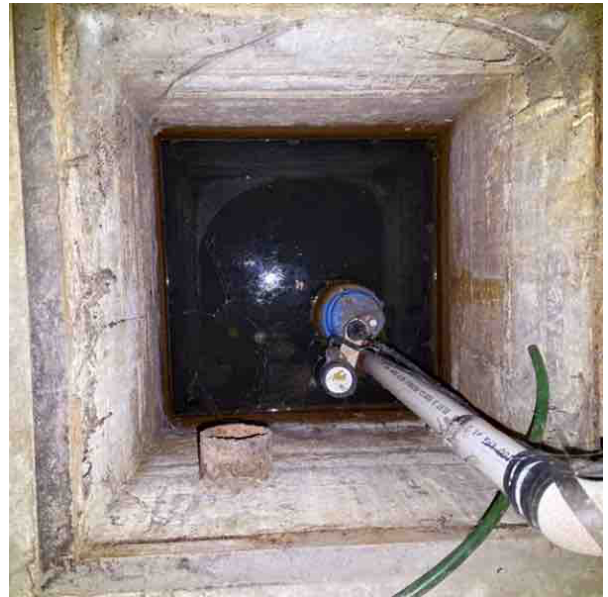
9.6.1 Operational

9.6.2 Sump pump was operational at the time of the inspection
