Your Inspection Report

5008 54 Avenue
Eckville, AB T0M 0X0

INSPECTION DATE:
Thursday, August 25, 2022

Report No. 2950, v.0
certapropertyinspections.com

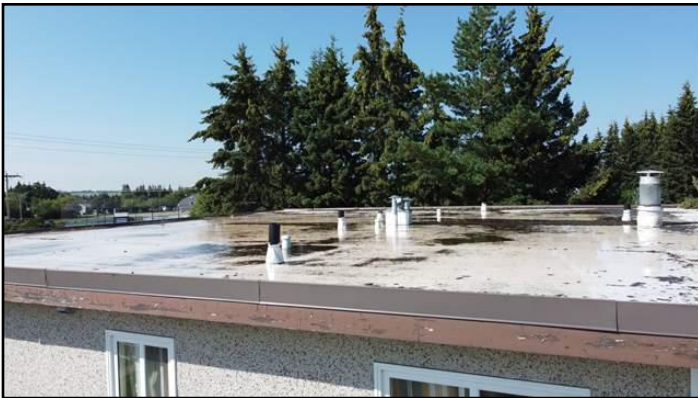
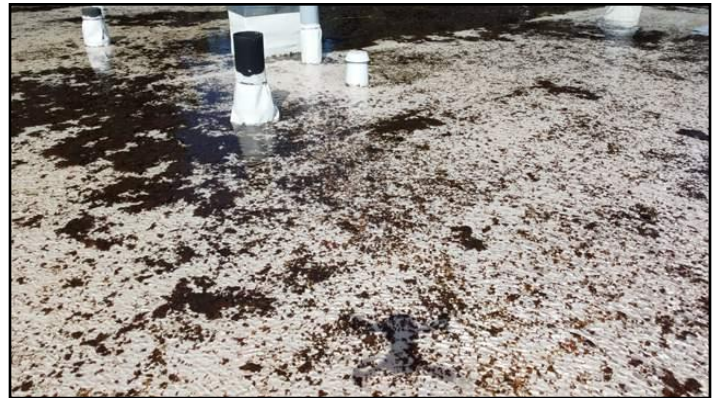
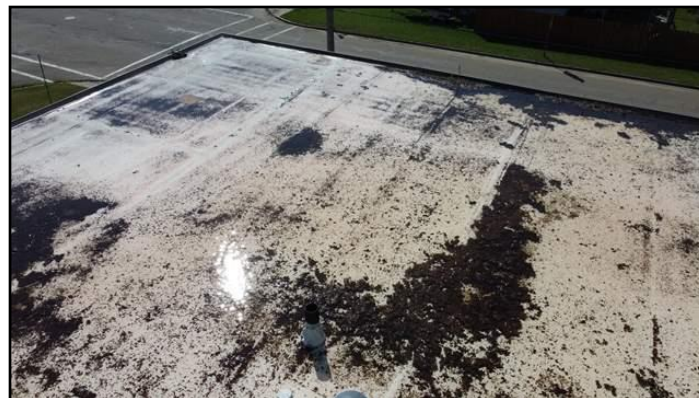
Condition: • Excessive ponding water noted on the roof as nearly the whole roof was holding water.

Ponding

Ponding water should not be left for more than 48 hours once the weather conditions are dry. If it is not addressed, it could damage your roof by:

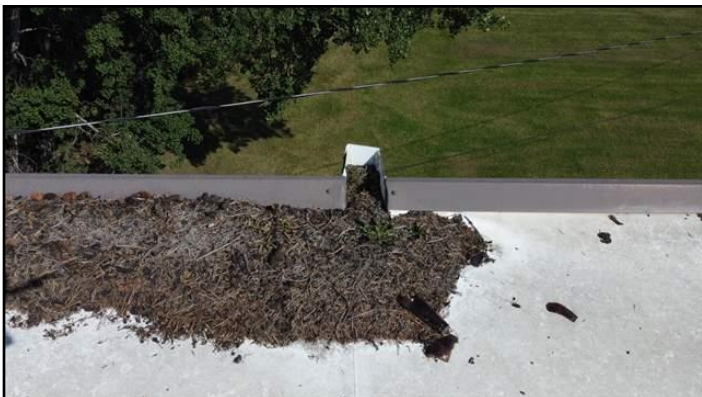
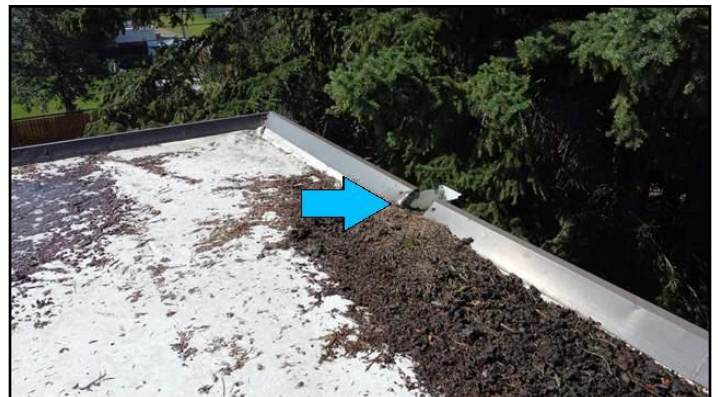
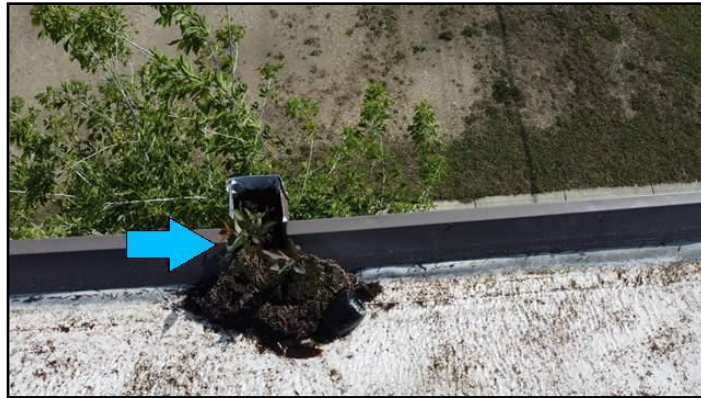
Condition: • Clogged

The scuppers on the roof were all found to be full of debris and vegetation. This is a likely cause for the ponding on the roof.

Clogged

These should be maintained regularly to ensure they are free of debris so that they can aid in the expulsion of water.

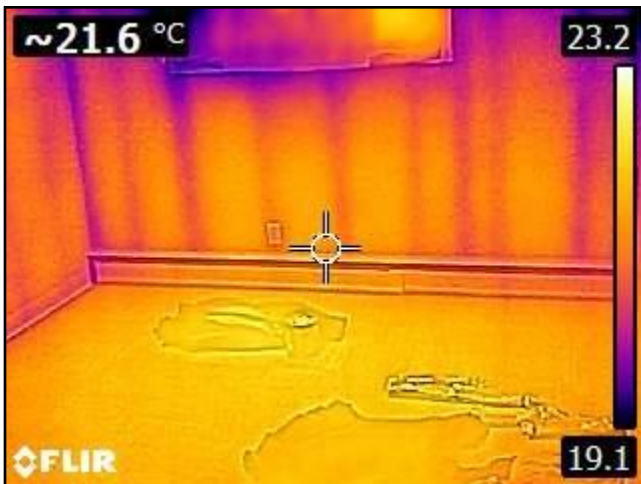
Unit 5

Condition: • The inspector was unable to get heat in units two and five. It appears that both have zone valves that need replacing as they would not function open even after switching from auto to manual.

valves for units 2 and 5 should be replaced

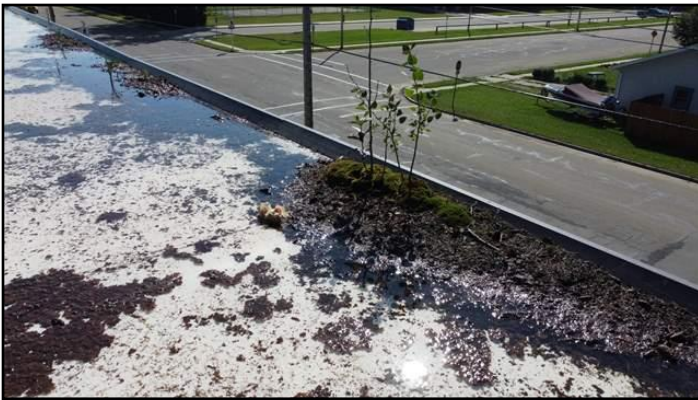
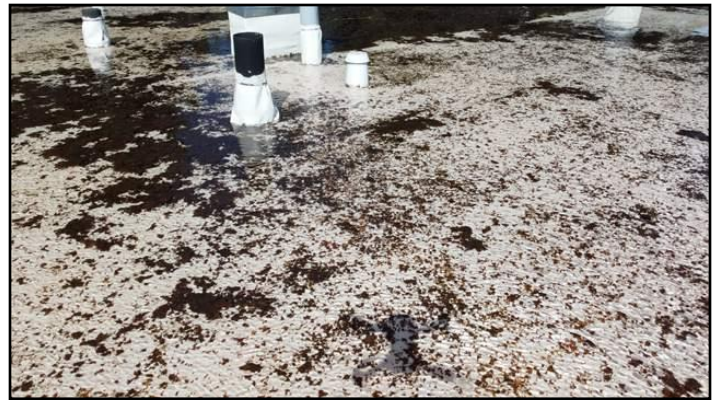
Inspection limited/prevented by: • Due to large amounts of debris and ponding on the roof, a limited inspection was performed.

Vegetation growing

Ponding

It is recommended to clean out the scuppers as they are plugged. Drain and clean the roof off and then recheck the roofing materials to evaluate the condition.

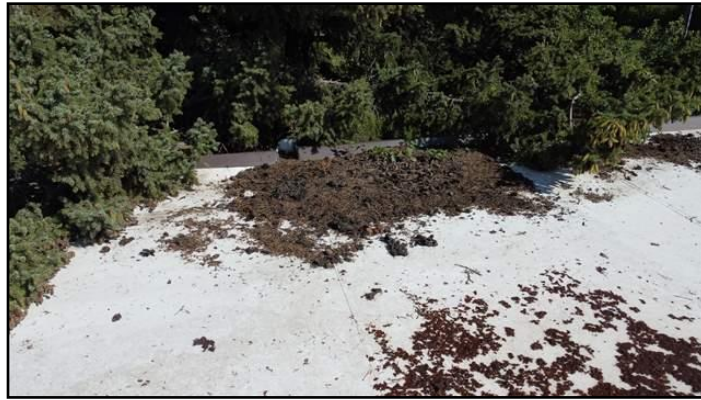
Debris on roof

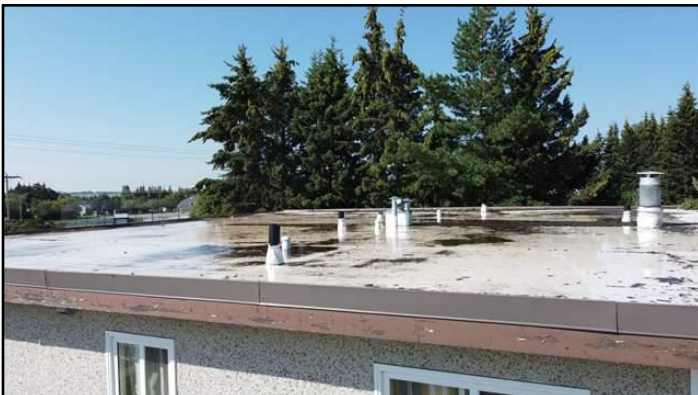
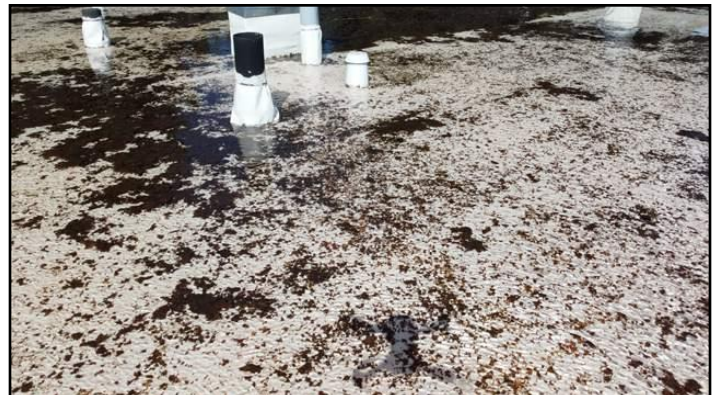
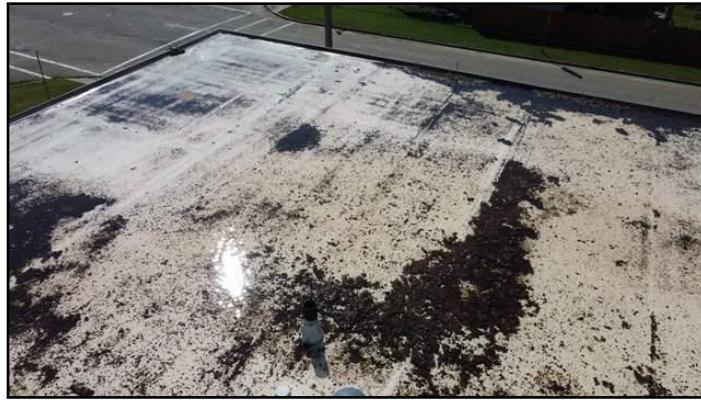
2. Condition: • Excessive ponding water noted on the roof as nearly the whole roof was holding water.

Ponding

Ponding water should not be left for more than 48 hours once the weather conditions are dry. If it is not addressed, it could damage your roof by:

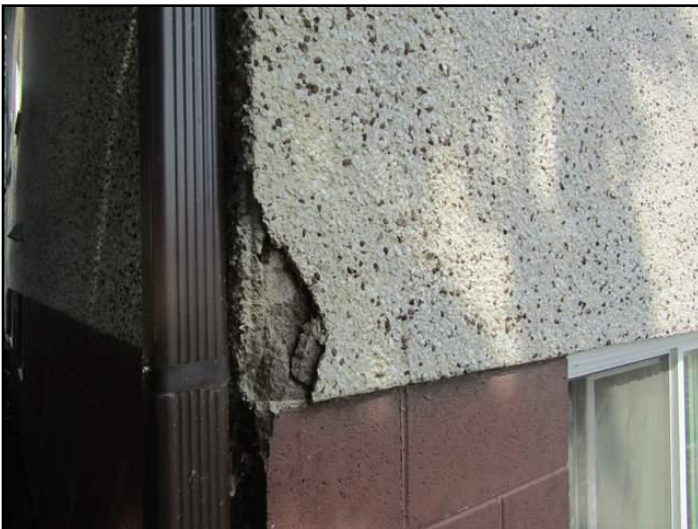
Seal openings

Any cracks and openings should be sealed and monitored for further expansion. The stucco appeared to be in good condition at the time of the inspection. Any deterioration should be addressed to prevent water intrusion into the building.

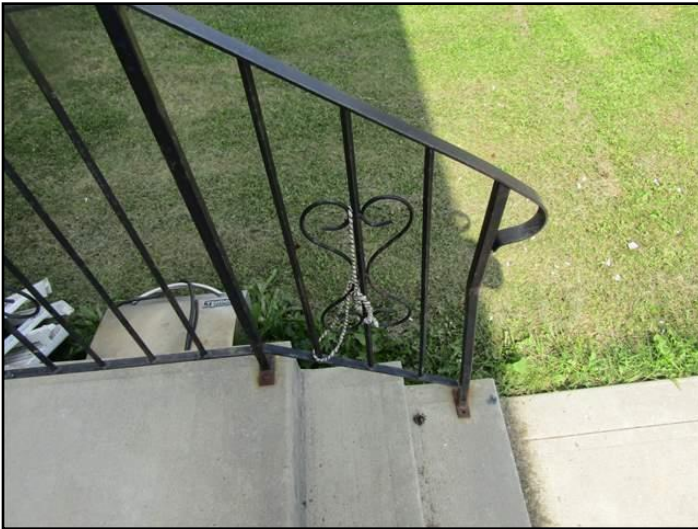
The handrail was noted to be loose and should be secured for safety measures.

Loose

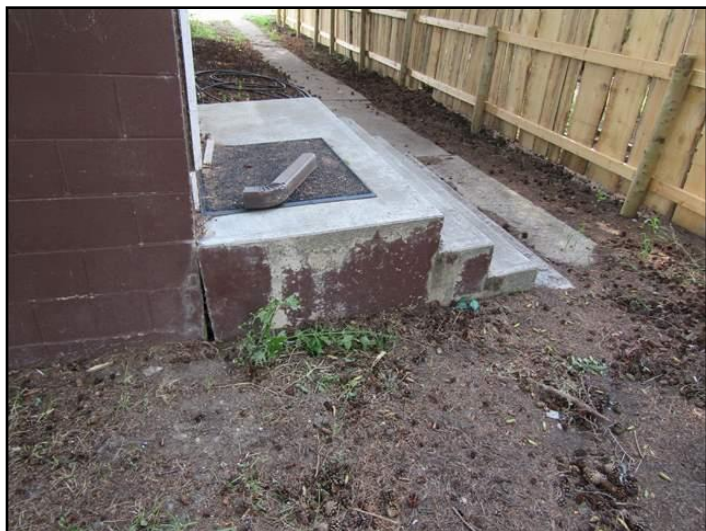
The stairs were noted to have shifted and are currently slanted. This is likely from the freezing and thawing weather cycles. As this is a possible tripping hazard, it is recommended to have this corrected.

Shifted

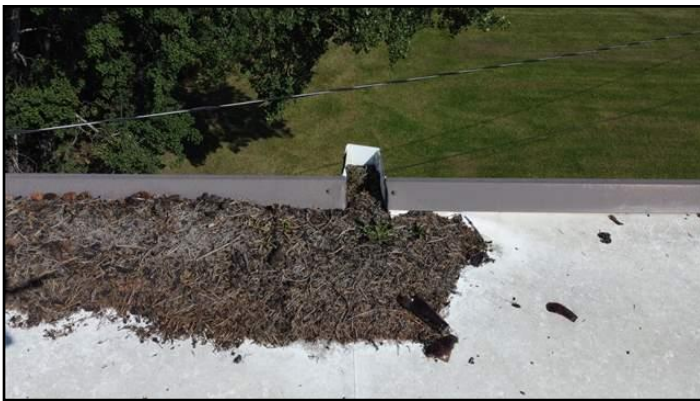
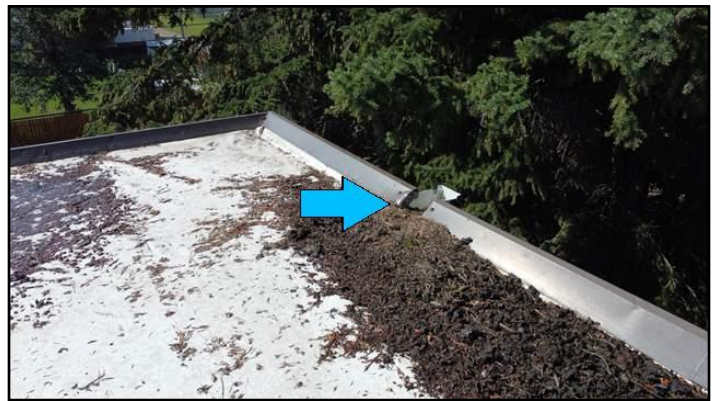
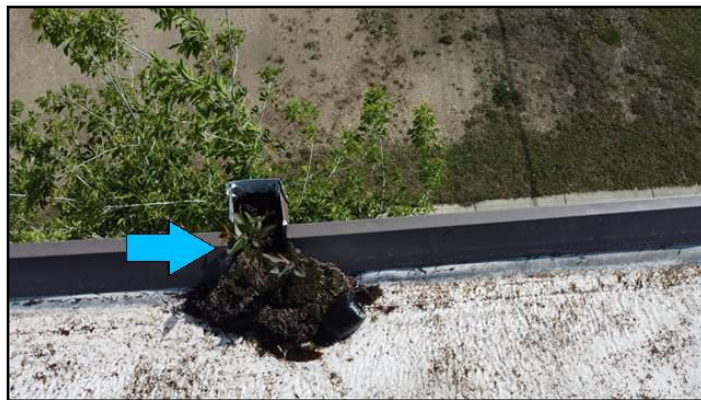
4. Condition: • Clogged

The scuppers on the roof were all found to be full of debris and vegetation. This is a likely cause for the ponding on the roof.

Clogged

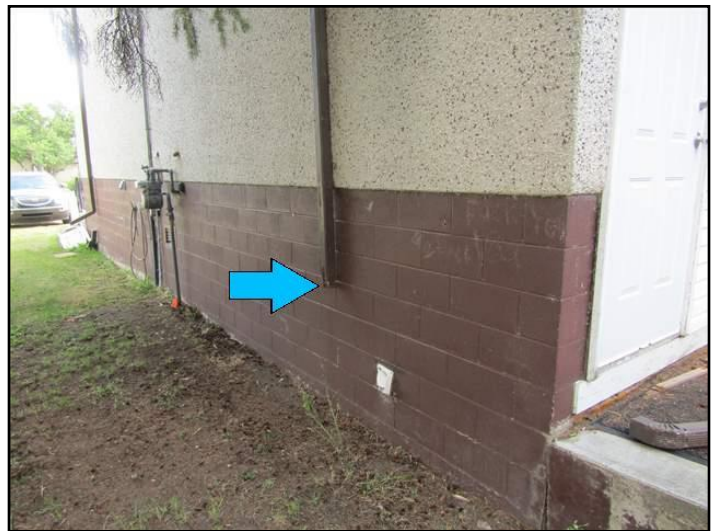
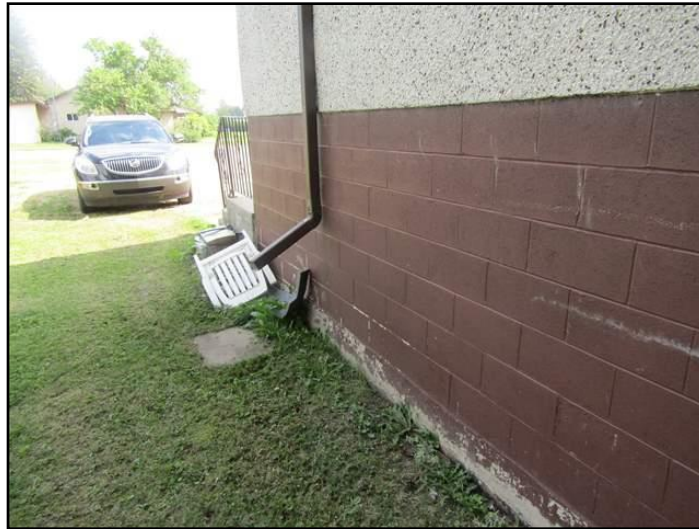
5. Condition: • Should discharge 6 feet from building

Should discharge 6 feet from building

Downspout extensions should be secured to downspouts and positioned 6 feet away from the structure. This helps to prevent water migrating into the foundation and potentially causing structural issues. In addition, the downspout extensions should be checked that the run off does not make its way back towards the foundation of the structure.

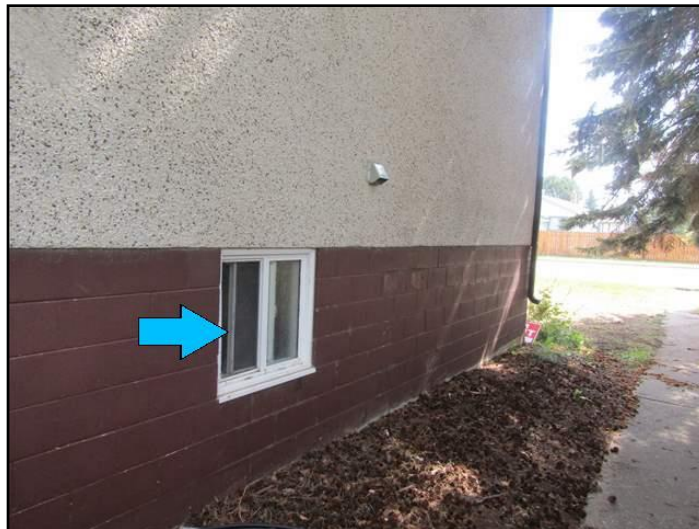
Unit 2 bathroom window

6. Condition: • Cracked

The following window was found to be cracked should be replaced.

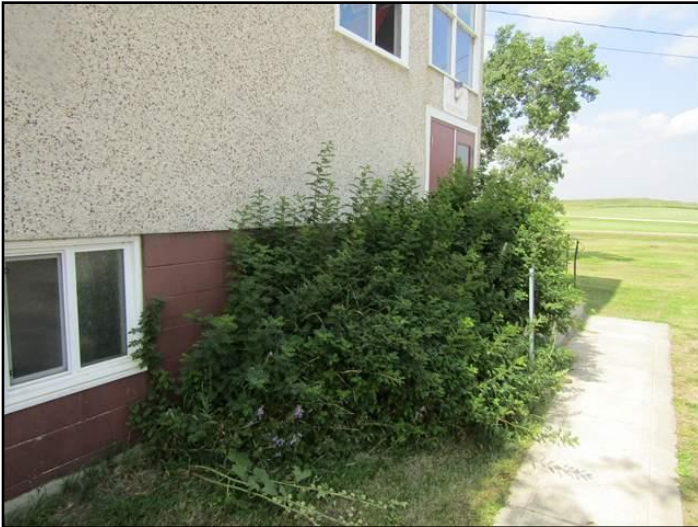
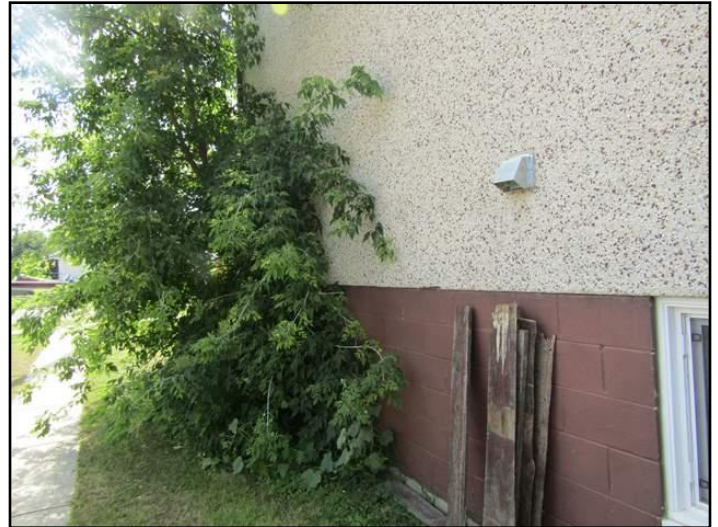
8. Condition: • Trees or shrubs too close to building

Trees or shrubs too close to building

Trees and shrubs should be kept away from structures as they can damage them. In addition, vegetation gives off lots of moisture and often harbours critters.

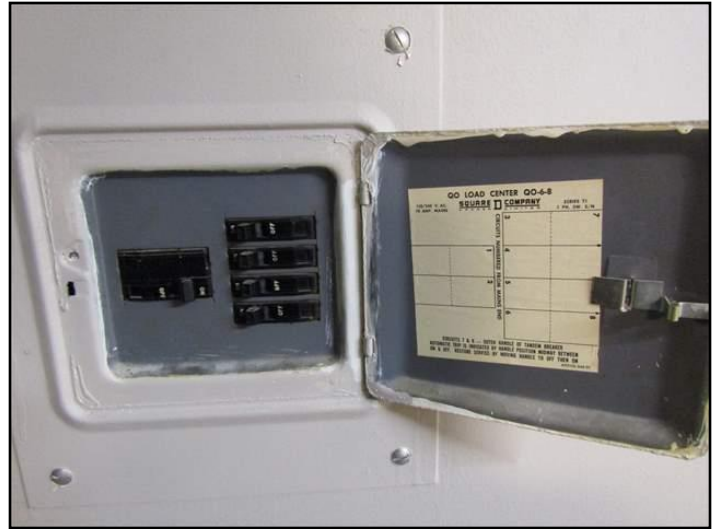
Unit 6

12. Condition: • Circuits not labeled

Some of the breakers in the units were not labelled, all breakers should be labelled. It is recommended to have this done by a qualified person.

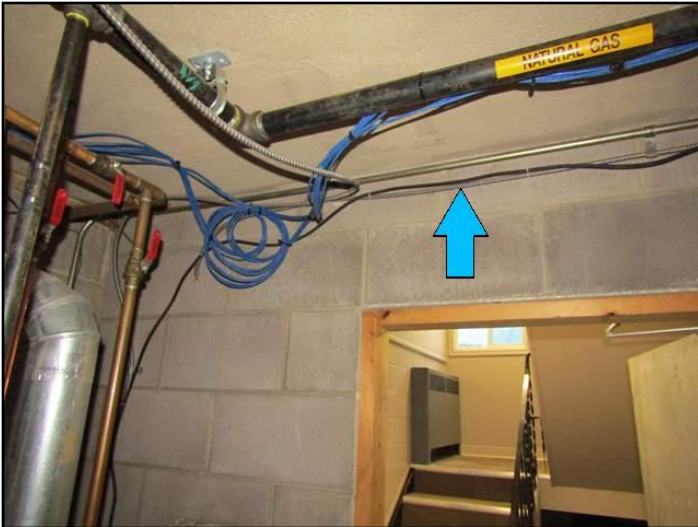
14. Condition: • Extension cord used as permanent wiring

Extension cords should not be used as a permanent power source. It is recommended that proper circuit wiring be used.

Implication(s): Electric shock | Fire hazard

Extension cord used as permanent wiring

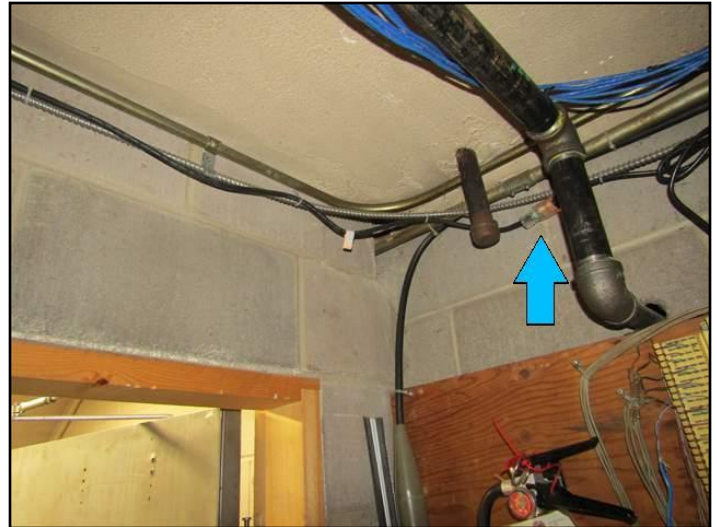
Extension cord used as permanent wiring

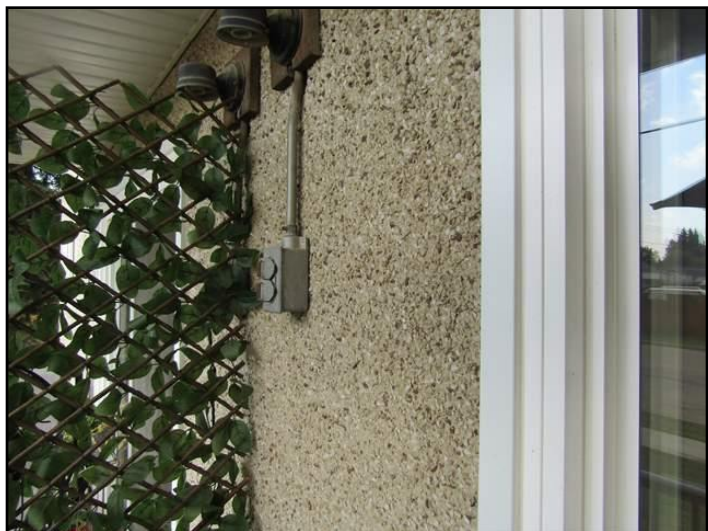
Outdoor receptacle

16. Condition: • Not suitable for outdoor (exterior) use
- A proper weather rated cover should be installed for the following outdoor receptacles.
Implication(s): Shock hazard or interruption of electrical service

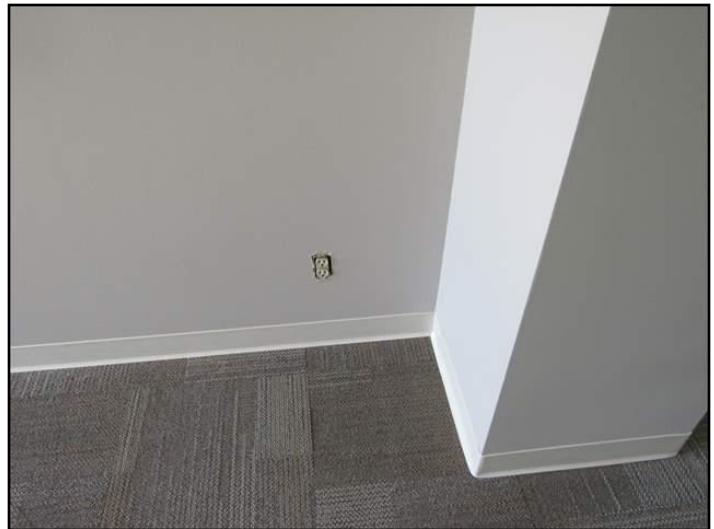
hallway

18. Condition: • Missing

It is recommended to have cover plates on junction boxes, switches, and outlets.

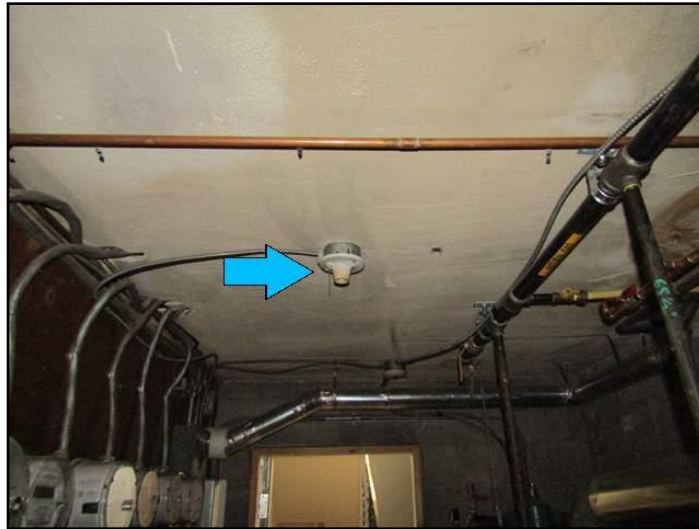
19. Condition: • Inoperative

The following fixture could not be operated. This may be due to a burnt/missing bulbs, hidden switches, or a wiring / transformer issue.

Implication(s): Inadequate lighting

Missing bulb

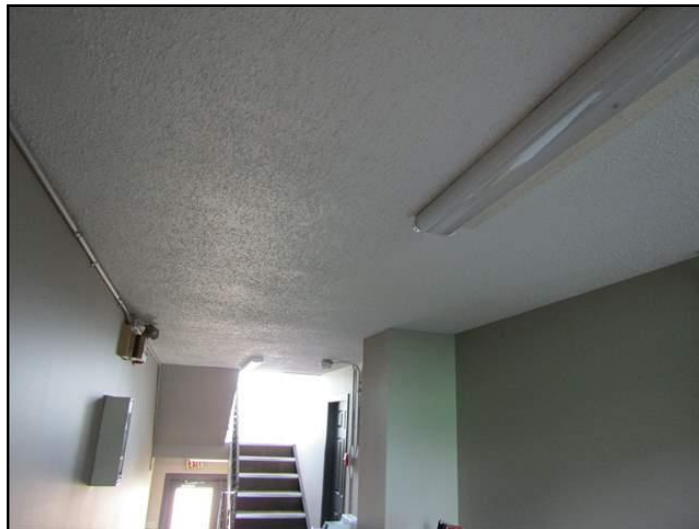
20. Condition: • The hallway lights on the main floor were found to continually flicker on and off. It is recommended to investigate this further and if necessary have an electrician remedy the issue. This could be a loose bulb, incorrect bulb being used, wiring issue...etc

Lights flickering continually

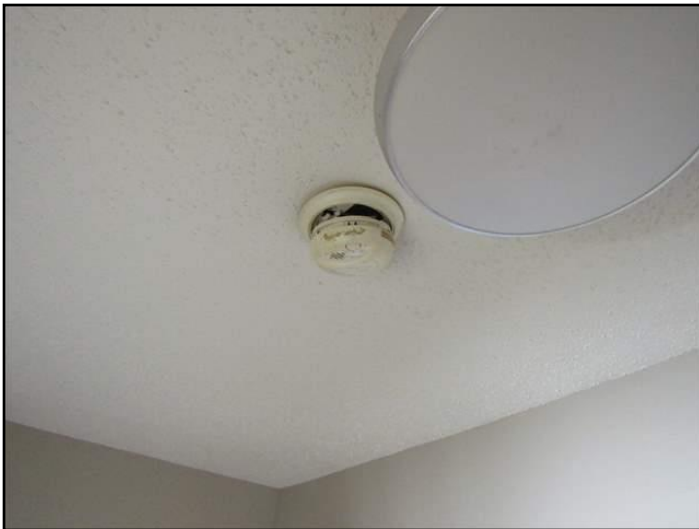
Unit 5

22. Condition: • The following smoke detector should be properly secured.

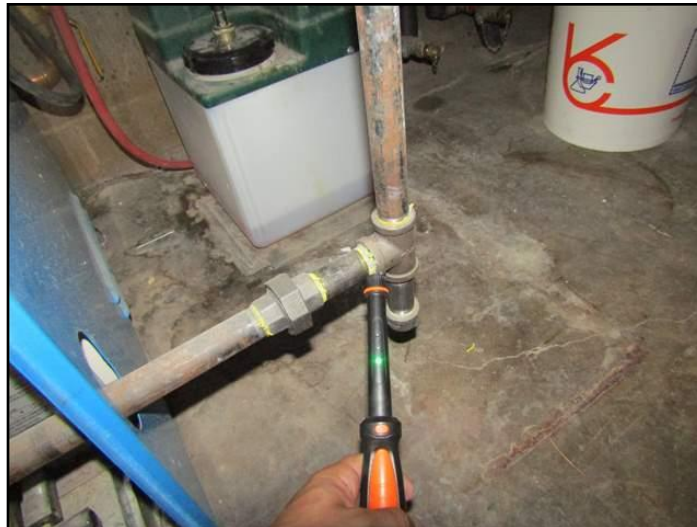
Gas

A combustible gas detector was used to inspect readily accessible gas fittings. No issues were found at the time of the inspection.

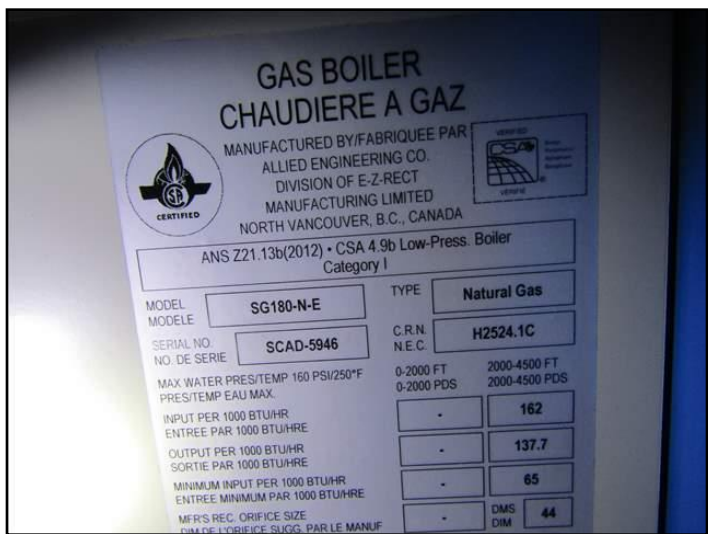
Although no date showing the age was seen on the boiler, the CSA standard that it conforms to is from 2012. The boiler is approx. 10 years old.

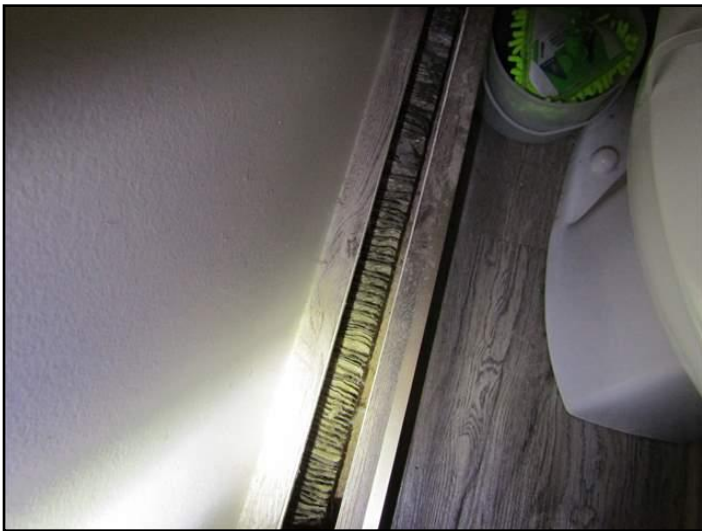
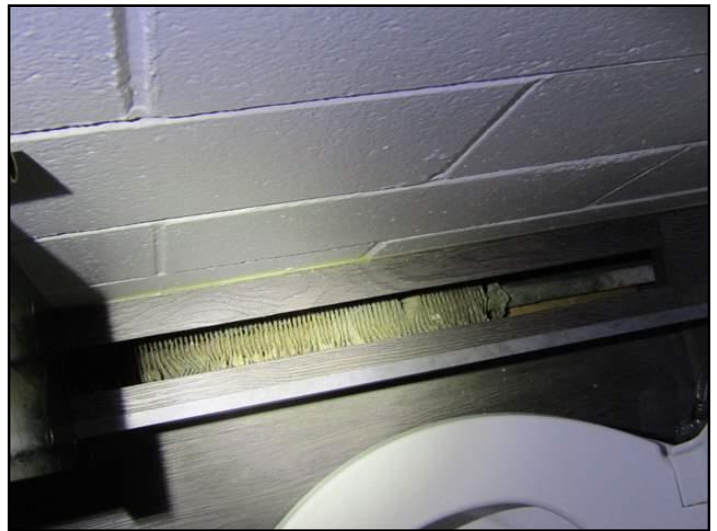
Dirty

24. Condition: • It is recommended to clean the baseboard heater fins in the units. Keeping the fins clean increases heating efficiency and baseboard heat radiators should be cleaned at least once a year, and more often if you have dogs or cats.

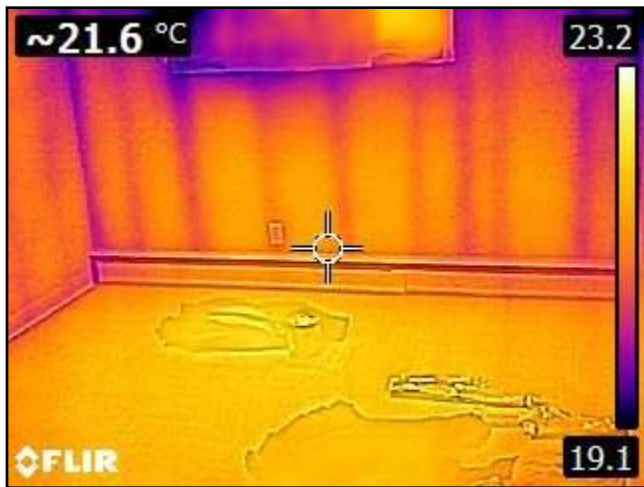
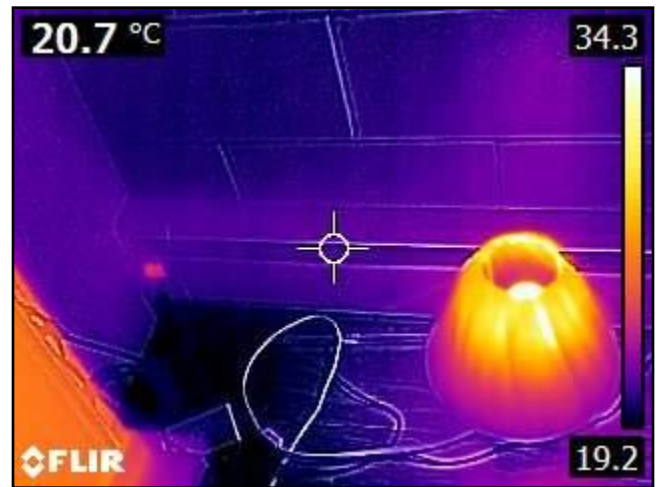
25. Condition: • The inspector was unable to get heat in units two and five. It appears that both have zone valves that need replacing as they would not function open even after switching from auto to manual.

Unit 5

Unit 2

valves for units 2 and 5 should be replaced

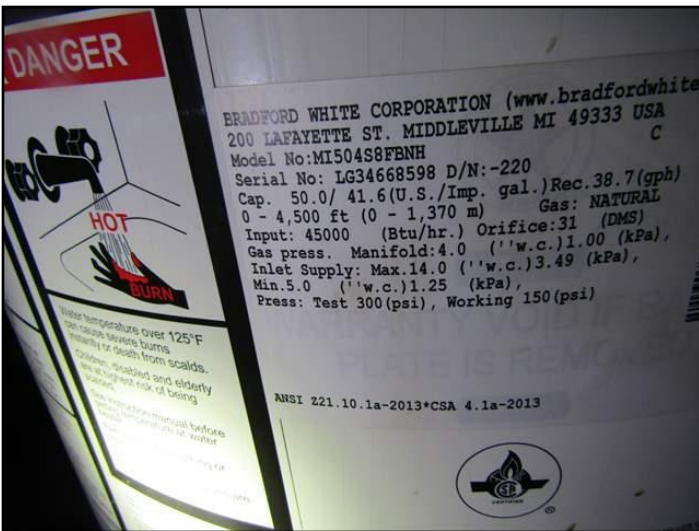
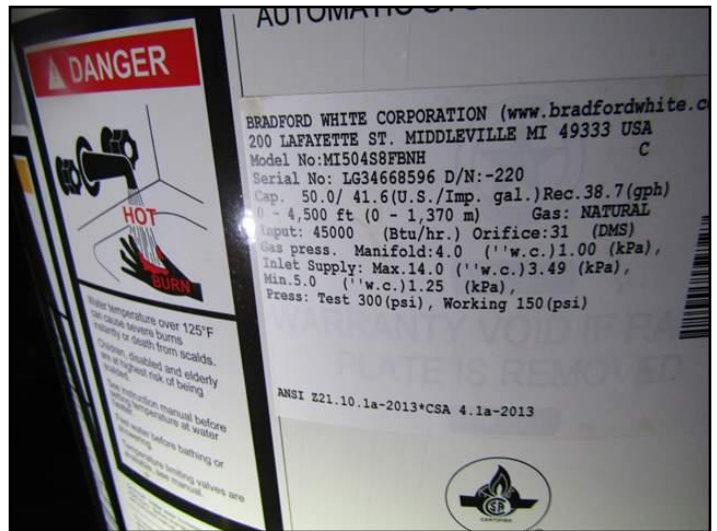
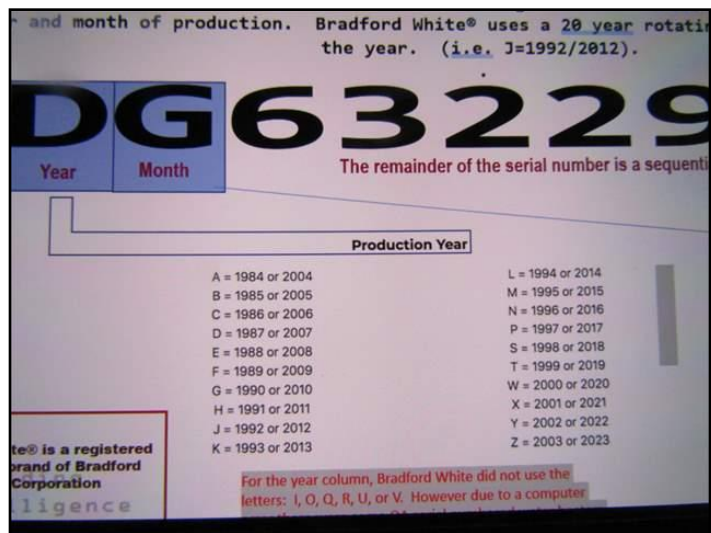
Both of the water heater for the building were found to be 8 years old.

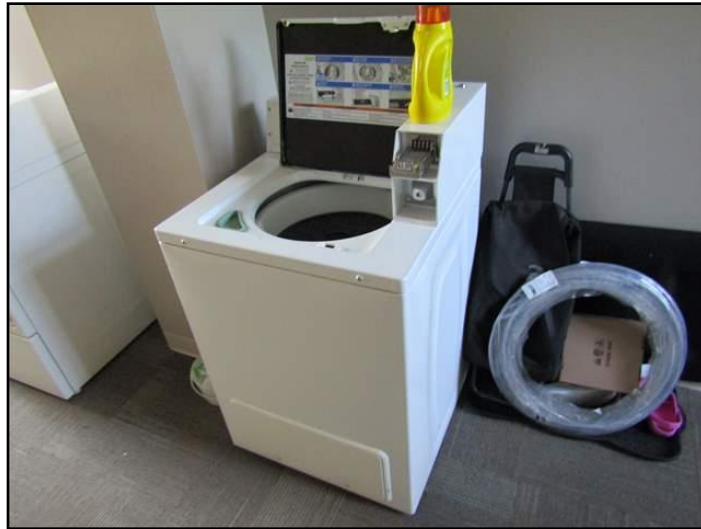
Inventory Washing Machine: • The coin operated washing machine in the hallway was not tested at the time of the inspection.

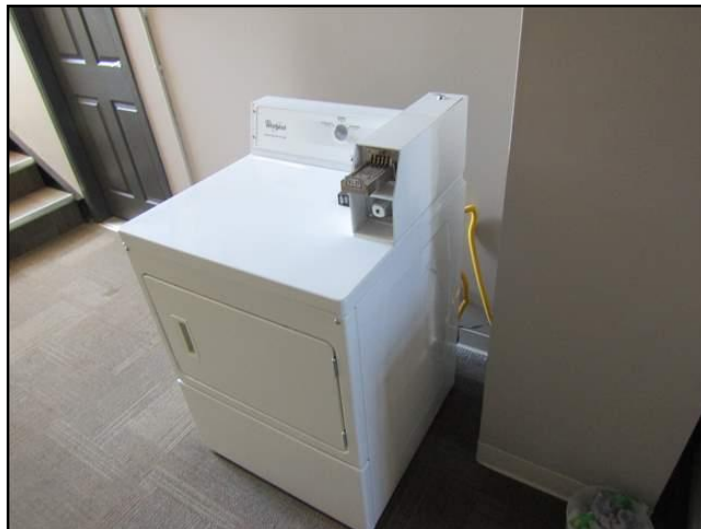
Inventory Dryer: • The coin operated Dryer in the hallway was not tested at the time of the inspection.

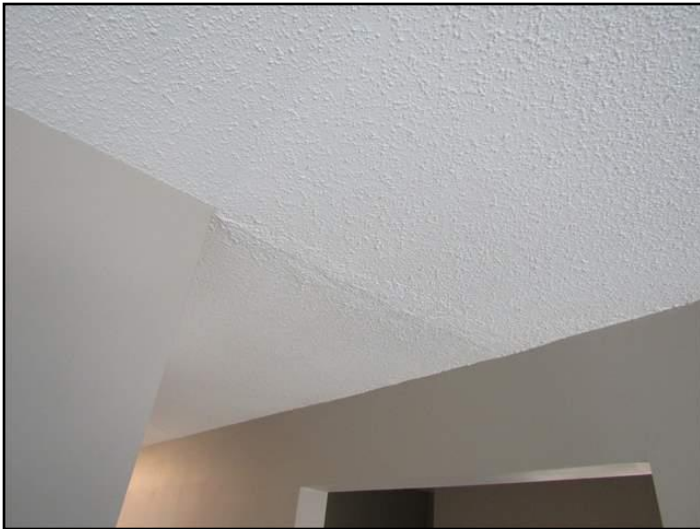
Settlement cracks

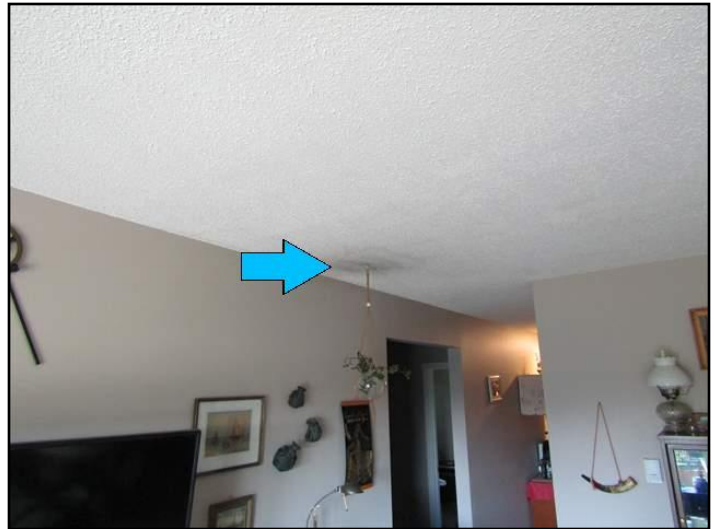
Marks on ceiling (unit 6)

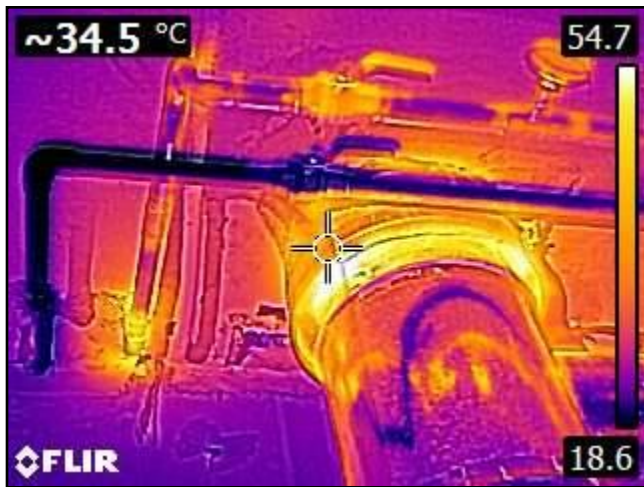
31. Condition: • Water damage

The following area in the mechanical room was found to have excess amounts of water damage but no current moisture. It was unclear what caused this but it may be condensation from the heat in winter. It is recommended to have a professional evaluate this further and to have the affected materials replaced.

No current moisture

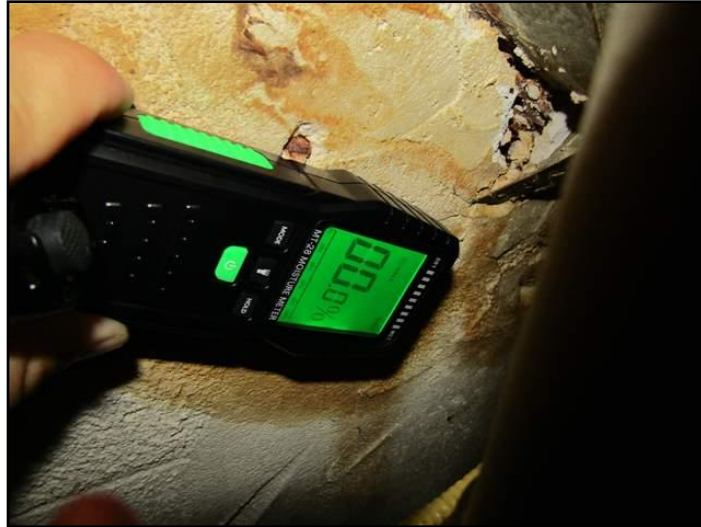
No current moisture

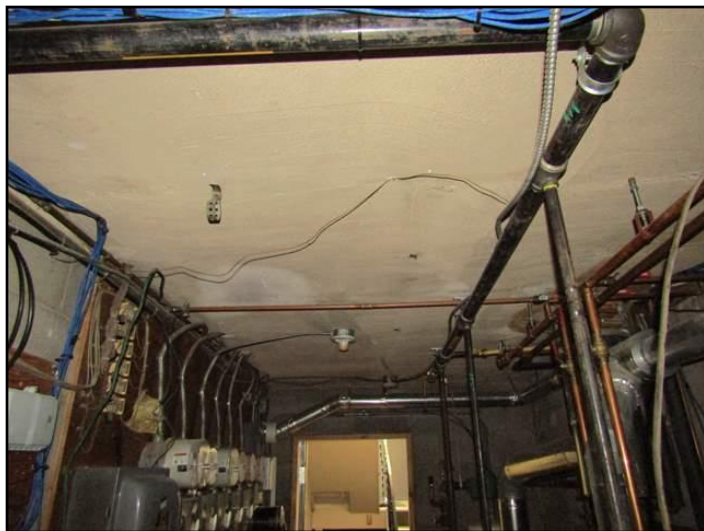
41. Condition: • Possible asbestos containing materials

Possible asbestos ceiling board
